AIRPROX REPORT No 2023024

Date: 23 Feb 2023 Time: 1533Z Position: 5411N 00128W Location: 3NM W Topcliffe

PART A: SUMMARY OF INFORMATION REPORTED TO UKAB

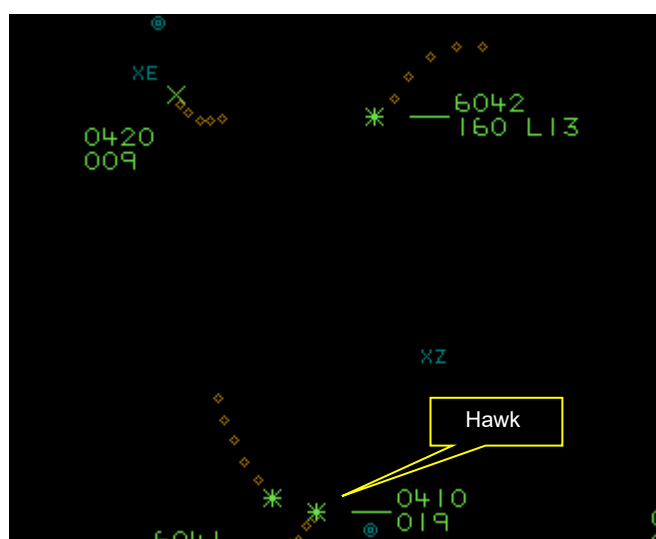
Figure 1 - 1532:10. Traffic Information was passed to the Hawk pilot regarding a faint radar contact (not displayed by NATS radar).

At 1532:10, the Hawk was 10NM from touchdown having just been turned onto a heading to intercept the centreline. Prompted by the instructor, the Leeming Approach Screen controller observed a faint contact to the east of the centreline and passed Traffic Information to the Hawk pilot, *“traffic left 11 o'clock, 5 miles, crossing right to left ahead, slow moving no height information”*.

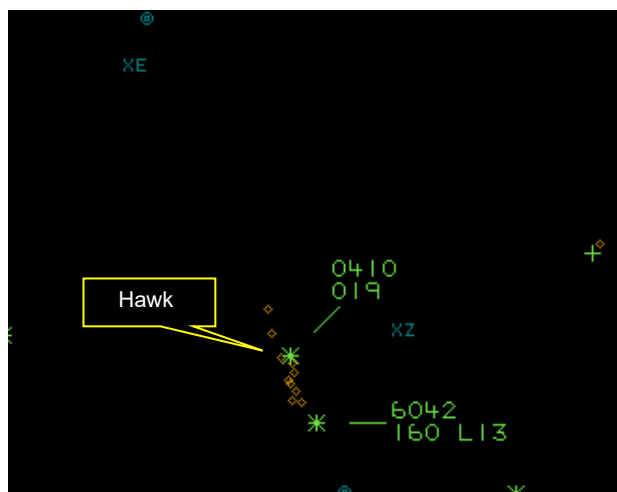
Figure 2 - 1533:05. Avoiding action was issued to the Hawk pilot.

Following discussion between the Leeming Supervisor and both instructors, at 1533:05, the Leeming Surveillance Radar Approach controller issued the Hawk pilot with avoiding action, “*avoiding action, turn left immediately heading 270 degrees, traffic 12 o’clock, 1 mile, opposite direction no height information*”. In following the avoiding action turn, the Hawk pilot became visual with the glider.

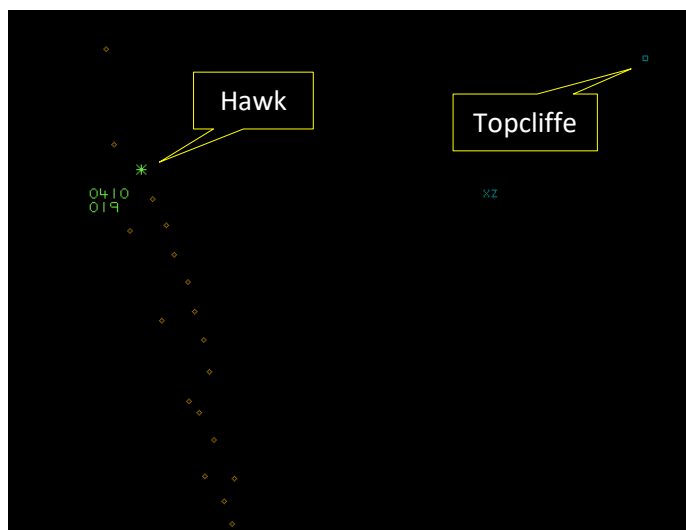
Figure 3 – CPA at 1533:24

An analysis of the NATS radar replay was undertaken and the Hawk could be positively identified from Mode S data (see Figure 3). An appropriate conversion factor was applied to the Flight Level observed on radar to convert it to an altitude. The LS8 was observed on radar a few minutes before CPA but the returns faded and the LS8 was not observed at the time of CPA. The pilot of the LS8 kindly supplied GPS track data for their flight. It was by combining the GPS and radar data that the diagram was constructed and the separation at CPA determined.
