**AIRPROX REPORT No 2023034**

Date: 27 Mar 2023 Time: 1313Z Position: 5247N 00018W Location: 4.5NM W Spalding

**PART A: SUMMARY OF INFORMATION REPORTED TO UKAB**

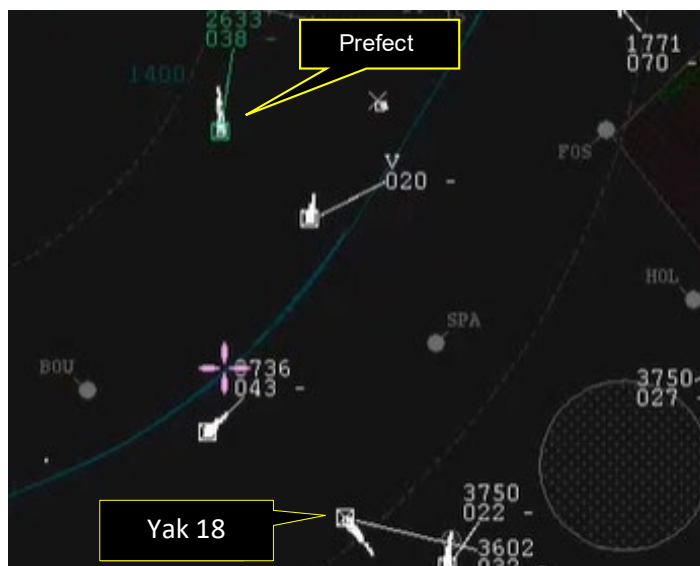
Figure 1 - 1310:16. Handover commenced by the Cranwell Departures controller.

At 1310:16, the Cranwell Departures controller commenced the handover of the Prefect to the Wittering Approach controller. Within the handover, previously called traffic was pointed out by the Cranwell Departures controller *“Has traffic southeast 3 miles tracking south squawking 7000”* (see Figure 1). The Wittering Approach controller acknowledged this traffic before pointing out further traffic at 1310:52 *“Roger, has further traffic left 11 o'clock 6 miles opposite direction squawking 3602 ... indicating 600 feet below”*.

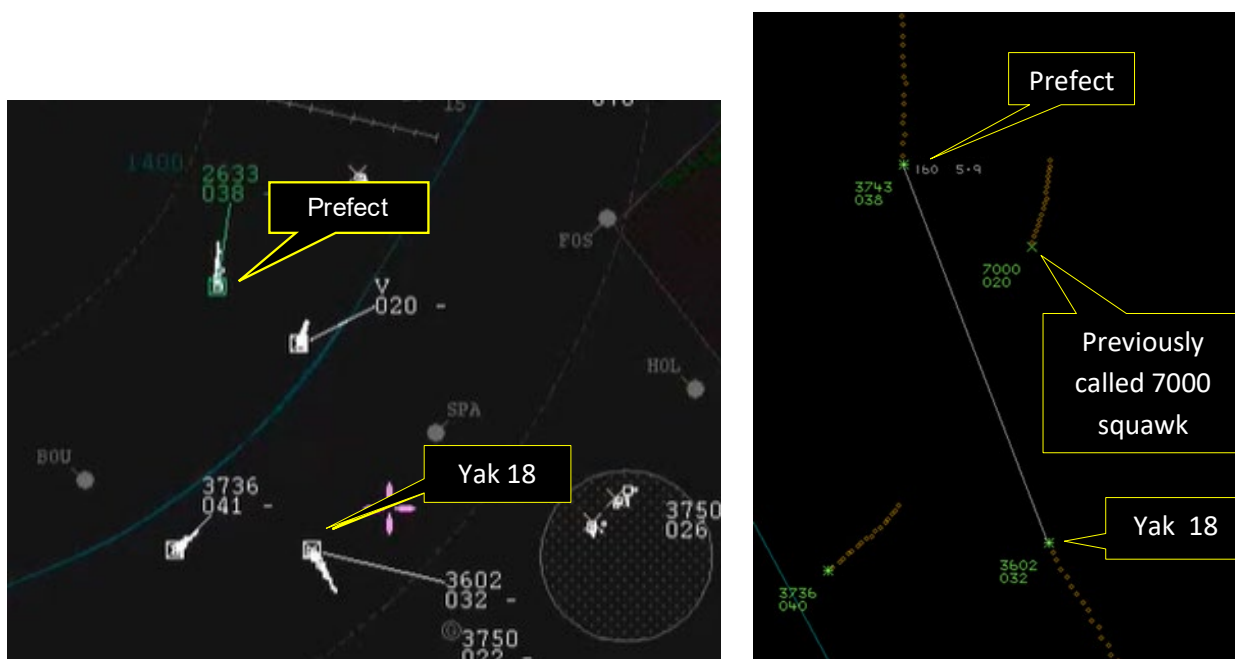
Figure 2 - 1310:59. Traffic Information was provided to the Prefect pilot on the Yak 18 by the Cranwell Departures controller. The separation was 6.8NM. Unit (left) and NATS (right) radar displays shown.

Prompted by the Wittering Approach controller’s traffic point-out, at 1310:59 the Cranwell Departures controller provided Traffic Information to the Prefect pilot on the Yak 18 *“further traffic south southeast 6 miles tracking northwest indicating 600 feet below believed to be light civilian”* (see Figure 2). The Prefect pilot acknowledged the Traffic Information and reported *“not sighted”*.

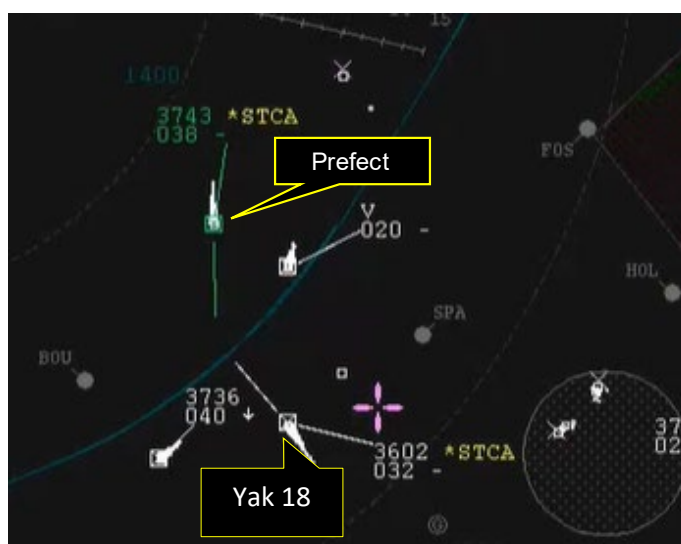
Figure 3 - 1311:19. Short Term Conflict Alert. The separation was 5.4NM.

At 1311:19, both the Cranwell Departures and Waddington Zone controllers received Short Term Conflict Alerts regarding the Yak 18 and Prefect (see Figure 3).

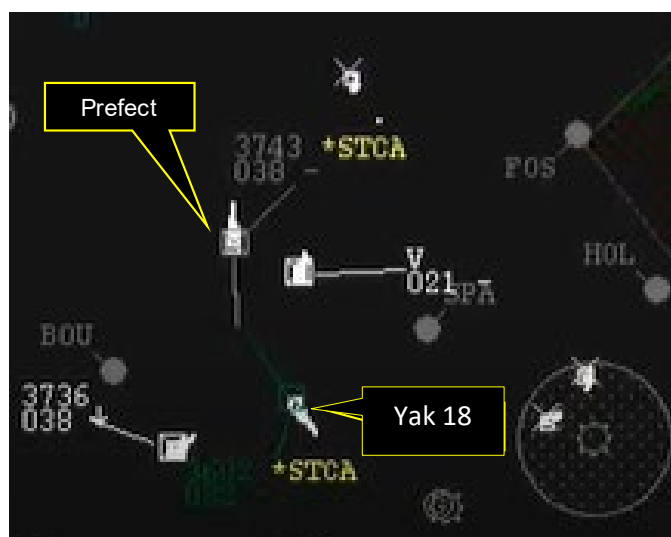
Figure 4 - 1311:30. Traffic information was provided to the Yak 18 pilot on the Prefect by the Waddington Zone controller. The separation was 4.5NM.

At 1311:30, the Waddington Zone controller provided the Yak 18 pilot with Traffic Information on the Prefect, "*Traffic er, northwest 5 miles tracking south, indicating 400 feet above*". No further Traffic Information was provided to the Prefect pilot, although the Cranwell Departures controller did correct the initial frequency readback by the Prefect pilot, instructing the Prefect pilot to contact Wittering Approach on the correct frequency at 1311:34.

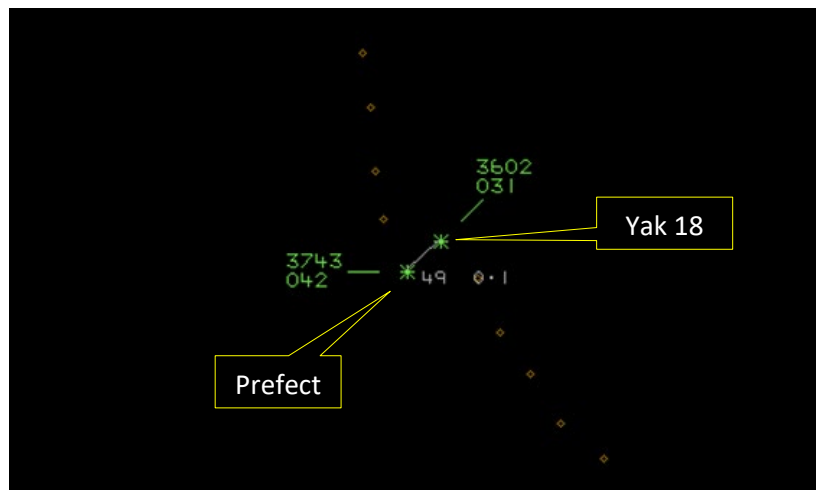
Figure 5 – CPA at 1312:34

CPA was measured at 0.1NM and 1100ft separation. On initial contact with the Wittering Approach controller at 1312:55, the Prefect pilot reported the Airprox.

The local investigation conducted by RAF Coningsby identified the cause of the Airprox as a loss of situational awareness by both the Prefect and Yak 18 pilots, with no deviation of course occurring until the Prefect pilot received a TAS alert. Several BM-related causal/aggravating factors were then identified that were believed to have contributed to the Airprox:

As a result of the causal factors identified, the following mitigation for local action was proposed:

- The requirement for aircrew to be fully cognisant of their responsibilities, with regards to the ATS (iaw CAP 774), to be positively addressed during Air Traffic Control liaison activities.
