AIRPROX REPORT No 2023030

Date: 14 Mar 2023 Time: 1145Z Position: 5202N 00237W Location: 3.5NM SE Hereford

PART A: SUMMARY OF INFORMATION REPORTED TO UKAB

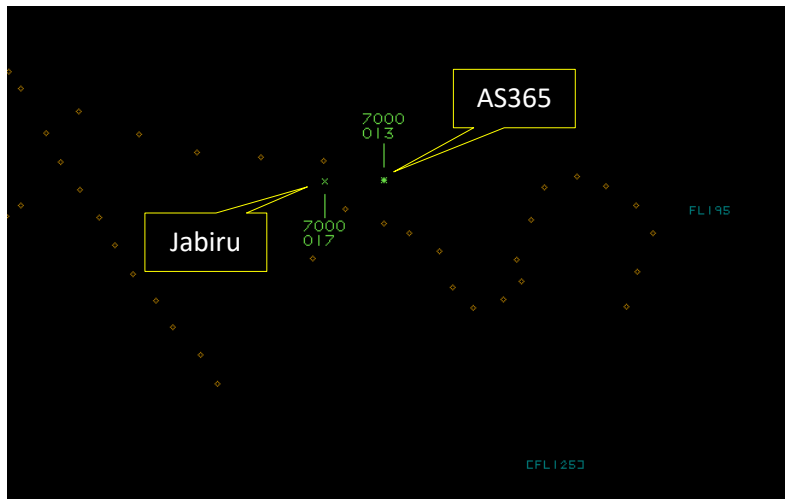
Radar data from a single-source radar was used, and both aircraft were observed. Notwithstanding, the periodicity of the radar sweep was 8 seconds and the moment of CPA could not be precisely determined (see Figure 1). A multi-source radar replay was used which, having a 4 second data refresh rate, meant the CPA could be observed (see Figure 2). However, the observed tracks of the aircraft, given that they had been combined by the radar system from the multiple radar sources, were not clear. The moment of CPA and the separation between the aircraft were determined by comparison of the two radar replays. Additionally, the radar replays presented the aircraft at Flight Levels so an appropriate conversion factor was used to display the aircraft altitudes in the diagram.

Figure 1 - The relative positions of the aircraft at 1145:12 using single-source radar data. The aircraft tracks appear smooth but the CPA could not be determined.

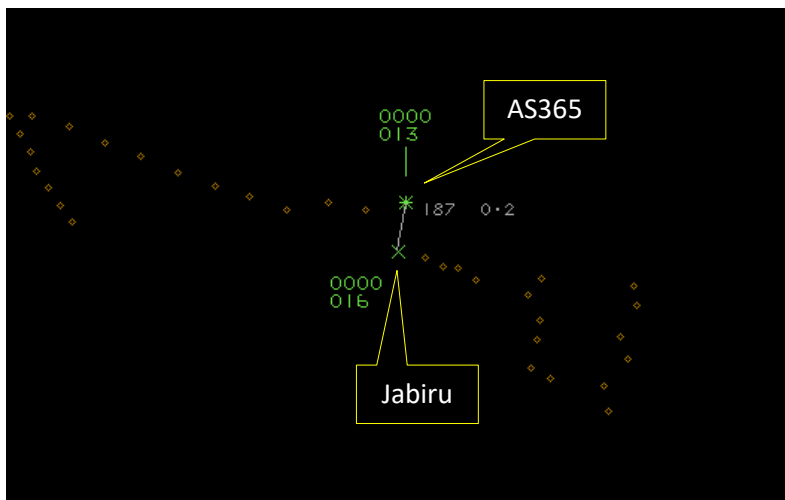
Figure 2 - The relative positions of the aircraft at 1145:07 using multi-source radar data. This is the moment determined to have been CPA but the aircraft tracks from the replay were not smooth.

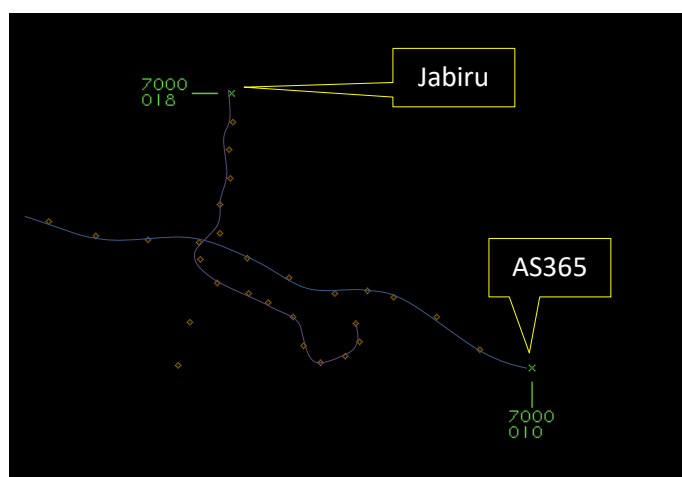
Further radar screenshots have been included to highlight the relative positions of the aircraft at approximately 1min and 2min after CPA (see Figure 3 and 4).

Figure 3 - The relative positions of the Jabiru and AS365 approximately 1min after CPA. The tracks have been coloured for clarity (blue: AS365, purple: Jabiru).

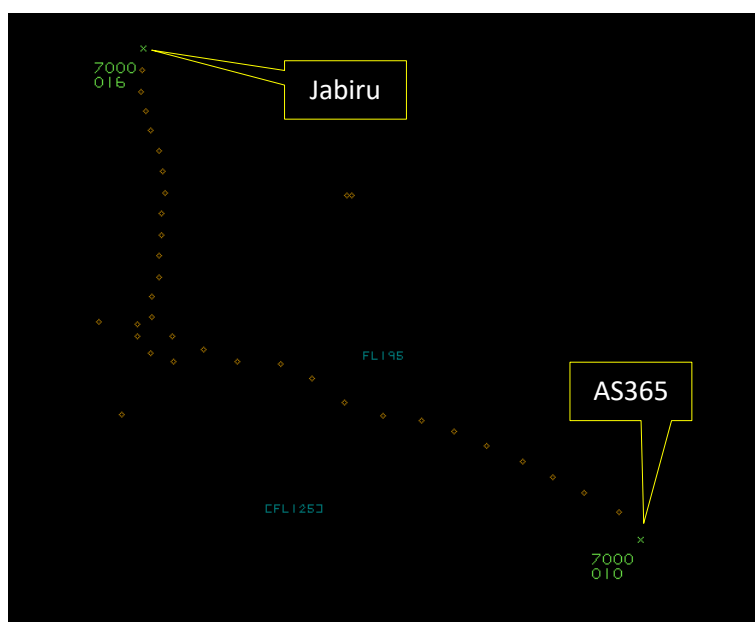
Figure 4 - The relative positions of the Jabiru and AS365 approximately 2min after CPA.
