**AIRPROX REPORT No 2023036**

Date: 24 Mar 2023 Time: ~1124Z Position: 5225N 00030W Location: 2NM NE Thrapston

**PART A: SUMMARY OF INFORMATION REPORTED TO UKAB**

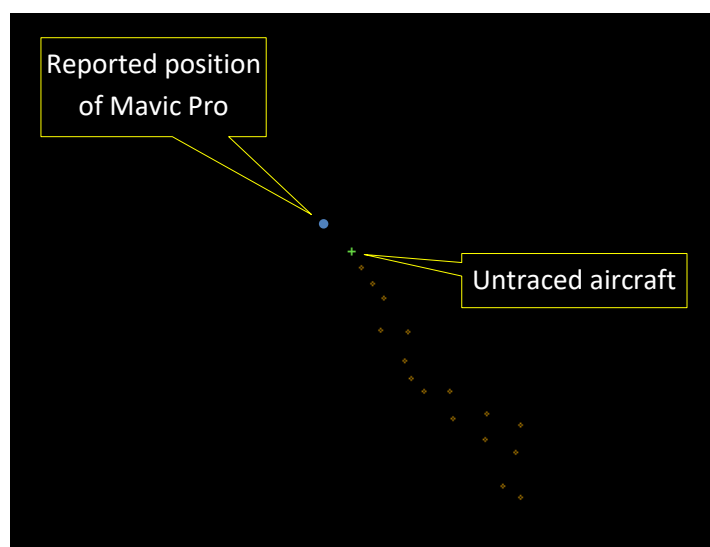
Figure 1 – 1123:38

An analysis of the NATS radar replay was undertaken. The Mavic Pro was not observed on radar at any point. A primary-only return was observed on radar to have tracked towards the reported position of the Mavic Pro. At 1423:38, this aircraft was observed to have been approximately 0.3NM from the position of the reported CPA (see Figure 1). The returns faded on the next sweep.
