AIRPROX REPORT No 2023027

Date: 02 Mar 2023 Time: 1510Z Position: 5110N 00145W Location: Boscombe Down

PART A: SUMMARY OF INFORMATION REPORTED TO UKAB

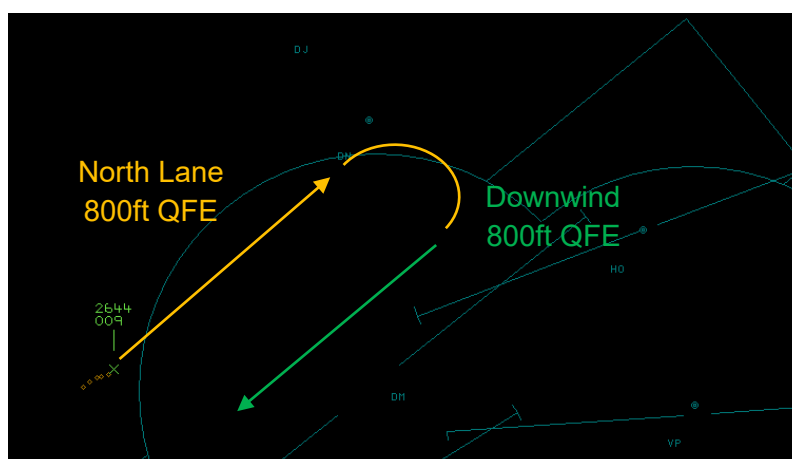
Figure 1: North Lane recovery profile to the Northern Circuit .

In lieu of any radar information, Figure 1 provides an illustration of the profile taken by the Tutor when conducting the join via north lane. It is based upon standard Boscombe Down operating procedures and therefore may not be an accurate representation of the profile flown.
