AIRPROX REPORT No 2023032

Date: 15 Mar 2023 Time: 1137Z Position: 5204N 00108W Location: Turweston

PART A: SUMMARY OF INFORMATION REPORTED TO UKAB

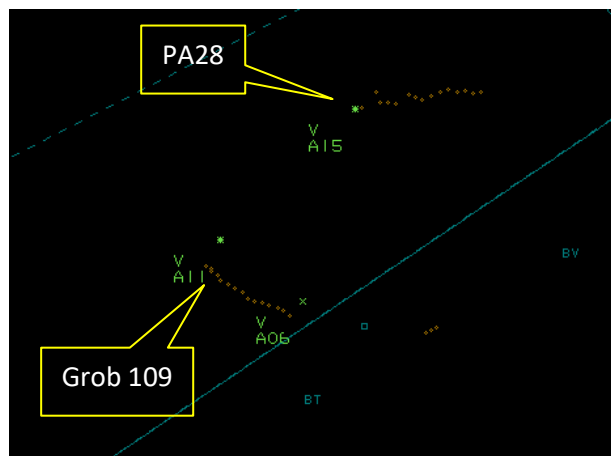
Figure 1 – 1135:38

An analysis of the NATS radar replay was undertaken and both aircraft could be seen and identified using Mode S information. At 1135:36 (Figure 1), the PA28 was to the northeast of Turweston, indicating 1500ft (radar QNH 1018hPa). The Grob 109 had climbed out and appeared to be turning crosswind, indicating 1100ft.

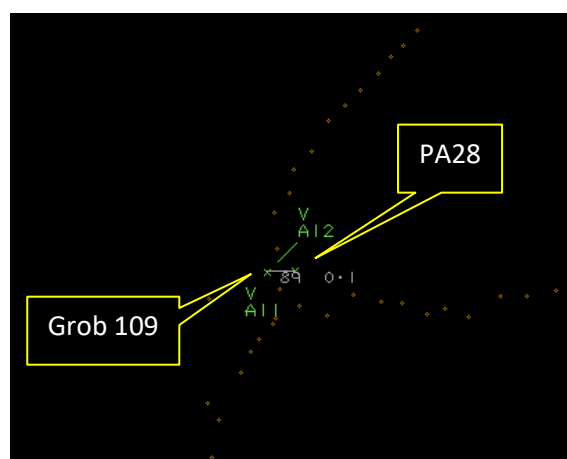
Figure 3 – 1136:51 – CPA

The two aircraft continued to converge until CPA at 1136:51 when radar separation was 0.1NM horizontally and 100ft vertically (Figure 3).
