AIRPROX REPORT No 2023059

Date: 17 Apr 2023 Time: 1737Z Position: 5213N 00049E Location: 3NM SE Rougham

PART A: SUMMARY OF INFORMATION REPORTED TO UKAB

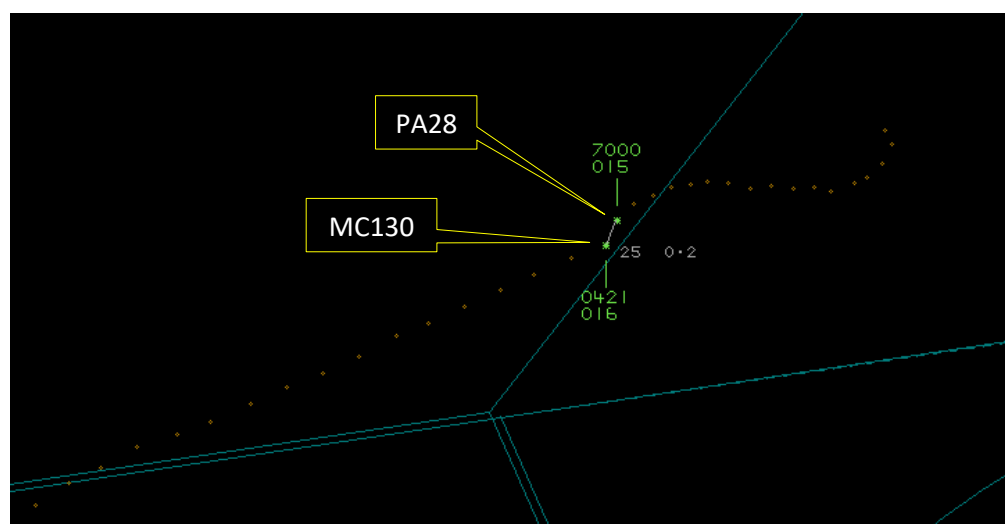
Figure 1 – CPA at 1737:06

An analysis of the NATS radar replay was undertaken. Both aircraft could be identified from their squawks and by reference to each pilot's narrative report. The aircraft were observed on radar to be at Flight Levels and an appropriate conversion factor was used to calculate their respective altitudes. The diagram was constructed and the separation at CPA determined from the radar data.
