## AIRPROX REPORT No 2023050

Date: 03 Apr 2023 Time: 1415Z Position: 5305N 00014W Location: 1NM WSW RAF Coningsby

### PART A: SUMMARY OF INFORMATION REPORTED TO UKAB

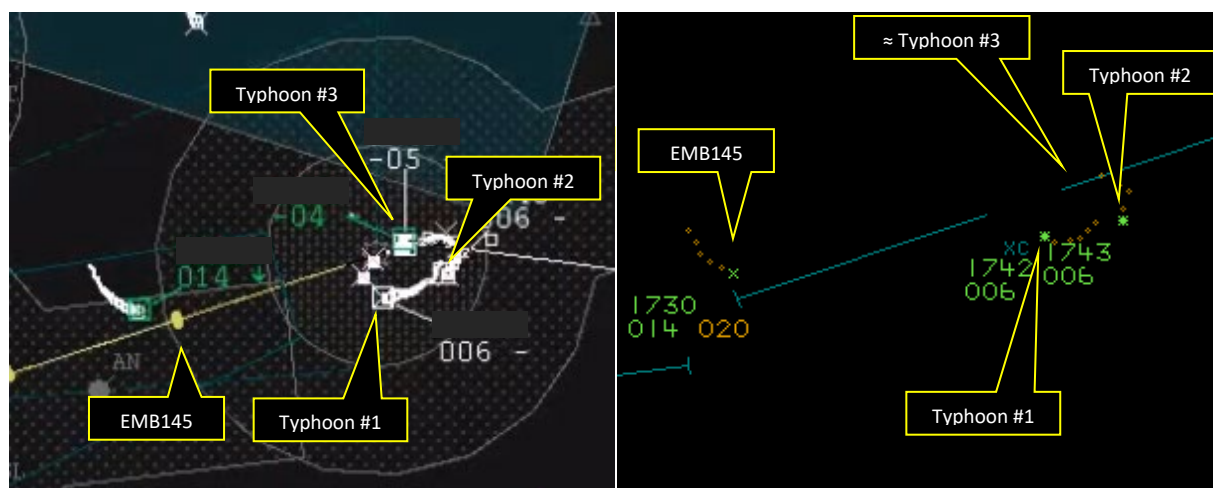
Figure 1 (1413:31): Coningsby tower controller approved the EMB145 to join (unit radar left, NATS radar right)

At 1413:31, the Coningsby Tower controller acknowledged EMB145 check-in and approved their visual join for RW07, informing them of the three Typhoons in the visual circuit.

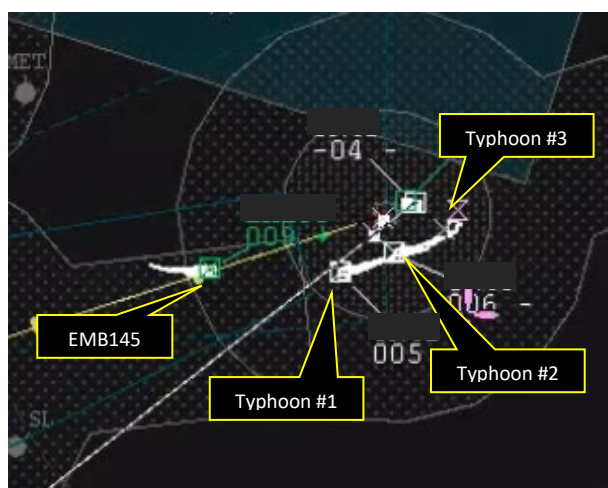
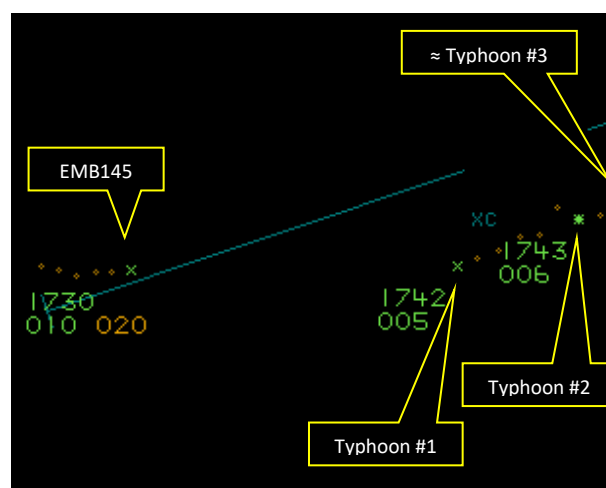
Figure 2 (1413:53): Coningsby tower controller approved the EMB145 to join (unit radar left, NATS radar right)

At 1413:53, Typhoon #2 reported downwind to touch-and-go, which was acknowledged and informed by the Coningsby Tower controller of “2 ahead”. The two ahead consisted of Typhoon #1 to touch-and-go, and the EMB145 to land. At 1414:02, Typhoon #1 reported “final, gear down” but was instructed by the Coningsby Tower controller to “go around, circuit height”. At 1414:07, Typhoon #3 reported downwind to land with minimum fuel, which was acknowledged and informed by the Coningsby Tower controller of “2 ahead”. The two ahead now consisted of the EMB145 to land and Typhoon #1 to touch-and-go. At 1414:20, Typhoon #2 reported going around at circuit height.

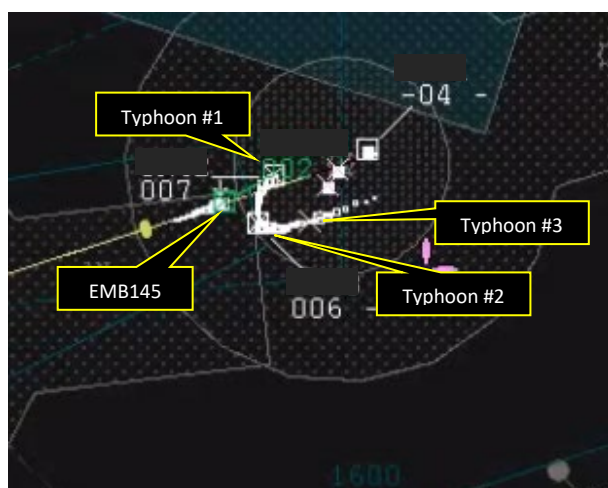
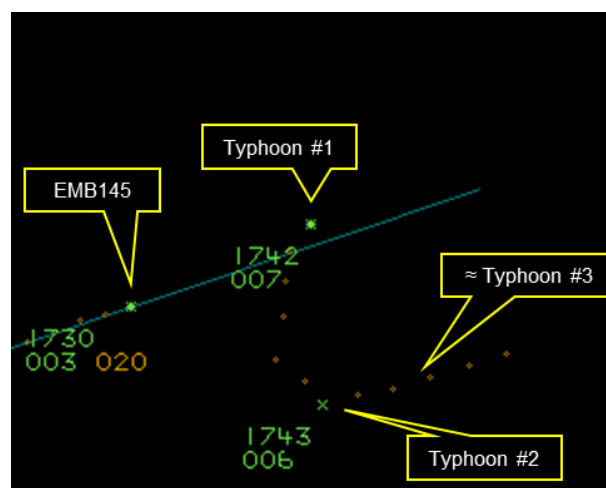
Figure 3 (1414:31): Coningsby Tower controller informed the EMB145 of Typhoon #3 (unit radar left, NATS radar right)

At 1414:31, the Coningsby Tower controller informed the EMB145 of Typhoon #3 and the change of priority order “you have one ahead, with minimum fuel, join or go around dead side”. The EMB145 [pilot] responded with the intention to join.

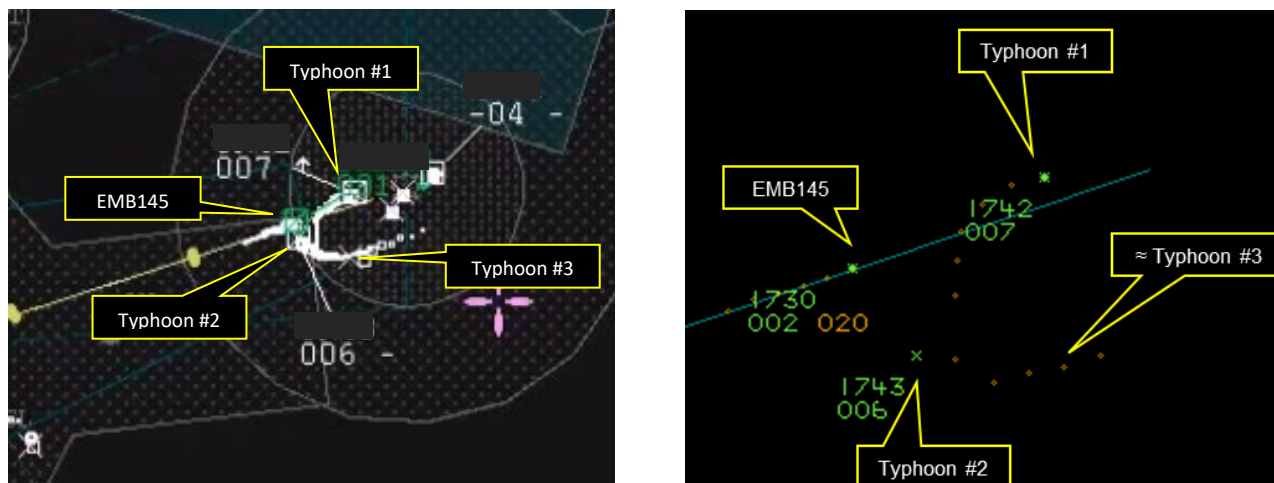
Figure 4 (1414:41): Coningsby Tower controller cleared Typhoon #3 to land (unit radar left, NATS radar right)

At 1414:41, Typhoon #3 reported “*final, gear down*” and was cleared by the Coningsby Tower controller to land. At 1414:49, the EMB145 [pilot] who was still established on the approach, requested “*confirm we are continue approach?*”. The Coningsby Tower controller responded with “*negative, go around circuit height*” which was acknowledged by the EMB145 [pilot].

CPA was judged to have occurred during the final turn of Typhoon #3 with the EMB145 still established on the approach. CPA was unmeasured as Typhoon #3 did not display on NATS radar but was estimated by the EMB145 [pilot] as 1.0NM and 0ft separation and Typhoon #3 as 0.6NM and 0ft separation. Typhoon #2 subsequently extended upwind to provide sufficient spacing for the EMB145 to conduct the go-around procedure before joining the visual circuit for a further approach.
