AIRPROX REPORT No 2023051

Date: 16 Apr 2023 Time: 1426Z Position: 5150N 00117W Location: Oxford ATZ

PART A: SUMMARY OF INFORMATION REPORTED TO UKAB

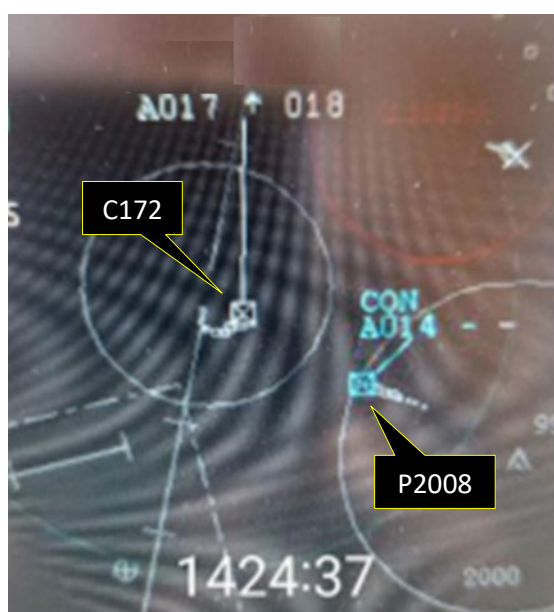
Figure 1 – 1424:37

1424 [The pilot of the C172] was passed Traffic Information on [the P2008]: “traffic joining from Beckley is a Tecnam joining downwind”. There was no acknowledgement.

Tower repeated: “traffic from the east joining downwind is a Tecnam.” [The pilot of the C172] acknowledged this. At that moment, the aircraft was on an approximately southerly routeing.

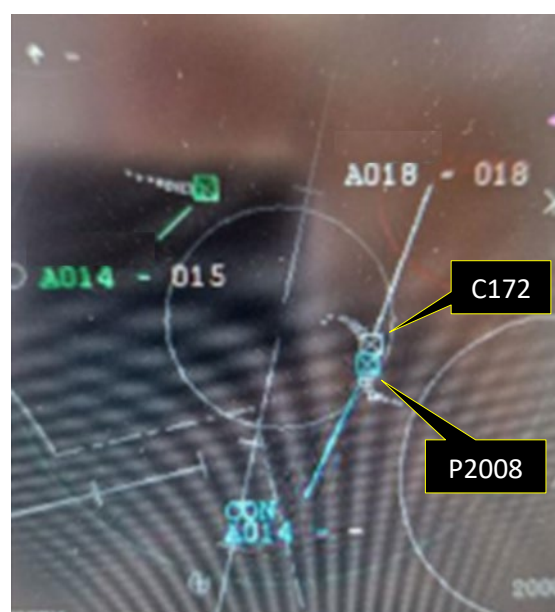
Figure 2 - 1426

1426 [The pilot of the P2008] reported downwind, stating, “visual with the aircraft ahead of us... above us.”

Tower then sequenced them behind other traffic in the left-hand visual circuit, and the pilot acknowledged, stating, “that was a close call.” Tower responded, “that wasn’t an anticipated manoeuvre from the other aircraft but I was visual, and happy.”

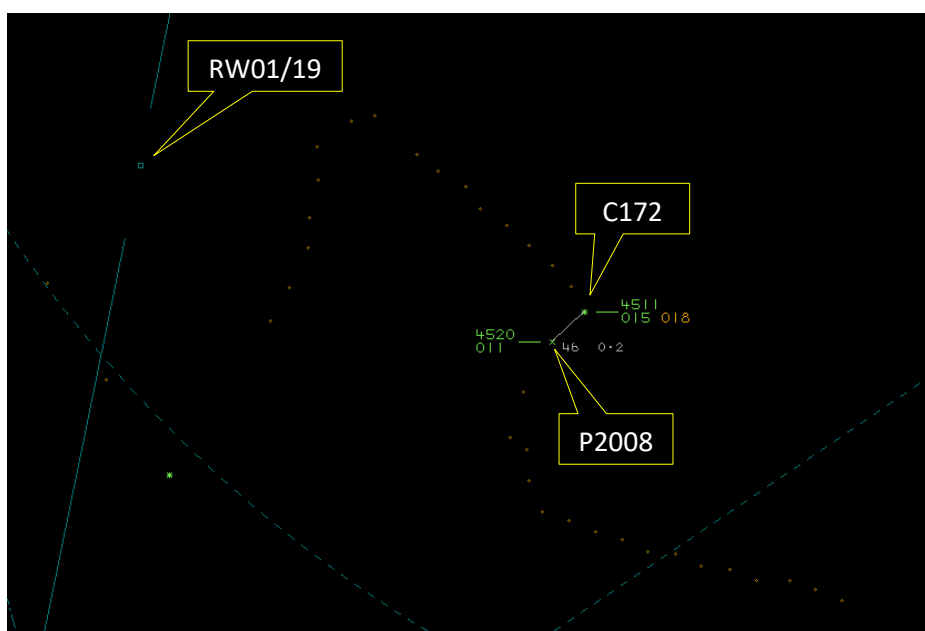
Figure 3 – CPA at 1425:38

An analysis of the NATS radar replay was undertaken and both aircraft could be positively identified from Mode S data. The separation was determined and the diagram constructed from the radar data.

not been a risk of collision. It was agreed that it had been the unexpected manoeuvres by the pilot of the C172 that had introduced confusion to the situation such that safety margins had been degraded, and that they had flown close enough to the P2008 to have caused concern (**CF5**). As such, the Board assigned Risk Category C to this event.
