AIRPROX REPORT No 2023052

Date: 15 Apr 2023 Time: 1407Z Position: 5324N 00030W Location: 6NM North of Scampton

PART A: SUMMARY OF INFORMATION REPORTED TO UKAB

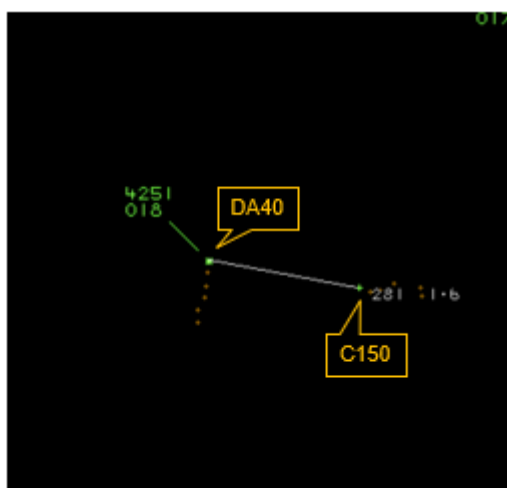
Figure 1 – 1402:45

At 1402:45 the Humberside controller took the DA40 off the northeasterly heading originally used for delaying action, turning the aircraft left onto a heading of 270°. According to the unit investigation report, a primary radar contact, later identified as the C150, had not been visible up until this point, but coincidentally appeared 1.6NM to the east of the DA40 observed to be on a westerly track, placing it astern of, and on a similar track to, the DA40 (Figure 1).

The controller advised the DA40 pilot of their range from touchdown and position in traffic (Number 3). No Traffic Information was passed to the pilot on the C150 behind them.

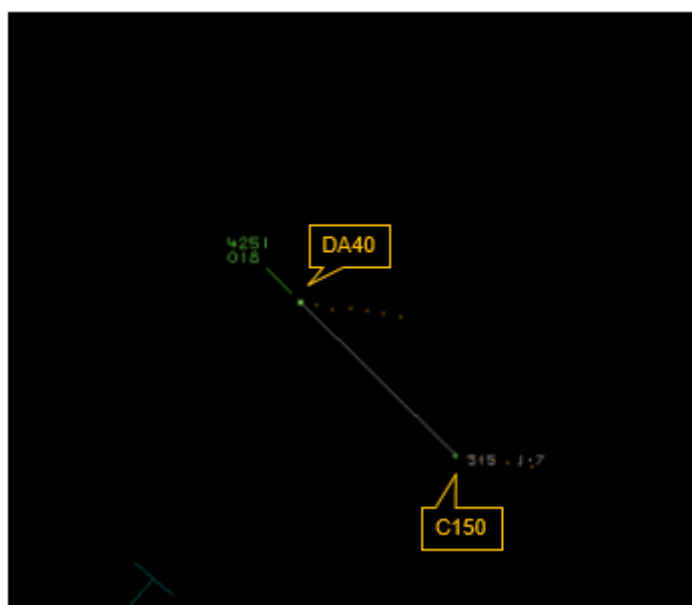
Figure 2 – 1403:50

At 1403:50 the IFR aircraft inbound from the east was turned onto an oblique base-leg and provided with Traffic Information on two aircraft, one approaching from the northwest and one holding to the

south of the airfield. Both the DA40 and C150 were continuing on their westerly tracks, separated by 1.7NM, with the C150's track offset to the south of the DA40's (Figure 2).

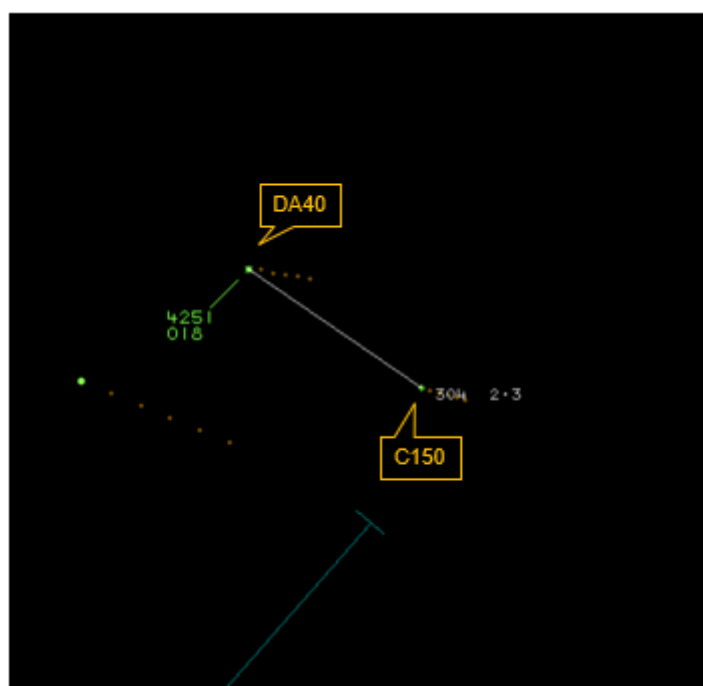
Figure 3 – 1405:08

The Humberside controller then made repeated (5) attempts to contact an aircraft tracking in from the northwest to coordinate action which would keep them clear of the final approach. The pilot did not respond immediately, because the controller was using the registration, not the callsign. Agreement was ultimately reached for them to orbit clear of the final approach at 1405:08 (Figure 3).

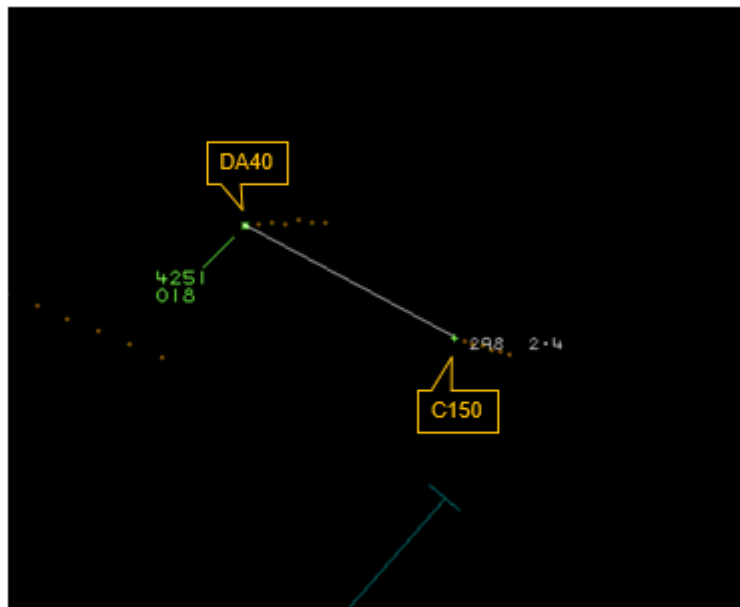
Figure 4 – 1405:24

At 1405:24 the controller instructed the DA40 pilot *“if you do a left-turn, I say again, a left-turn and report passing KULOS, RNP approach Runway 02 (QNH). Unknown traffic to the south-southeast of you by 2 miles, tracking westbound no height.”*

The DA40 pilot replied *“left turn to KULOS”* but did not acknowledge the Traffic Information, and this lack of readback went unchallenged by the controller (Figure 4).

The decision by the controller to instruct the pilot of the DA40 to make a left turn back towards conflicting traffic at that moment, even with the provision of Traffic Information does appear questionable, compounded then by a lack of any further Traffic Information.

The pilot did not acknowledge the Traffic Information, and the controller did not challenge that lack of acknowledgement. The unit argued that the passing of Traffic Information is not a mandatory readback. It is possible that the DA40 pilot remained unaware of the presence of the C150, with no Traffic Information having even been passed at all up to this point in time.

Options available might have included a new heading that would increase the distance between the two aircraft and/or allow a tactical repositioning back towards the start of the RNP approach, perhaps with a right-turn to a point where a release to resume own navigation would keep it clear of any other potential conflicts.

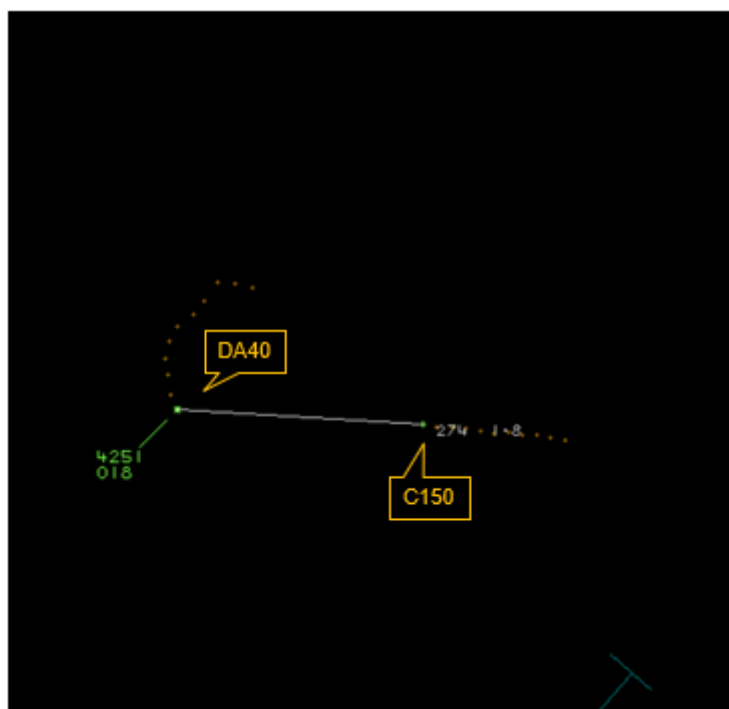
Figure 5 – 1406:30

At 1406:30 the controller turned the first inbound [aircraft] onto a heading to intercept final approach (Figure 5).

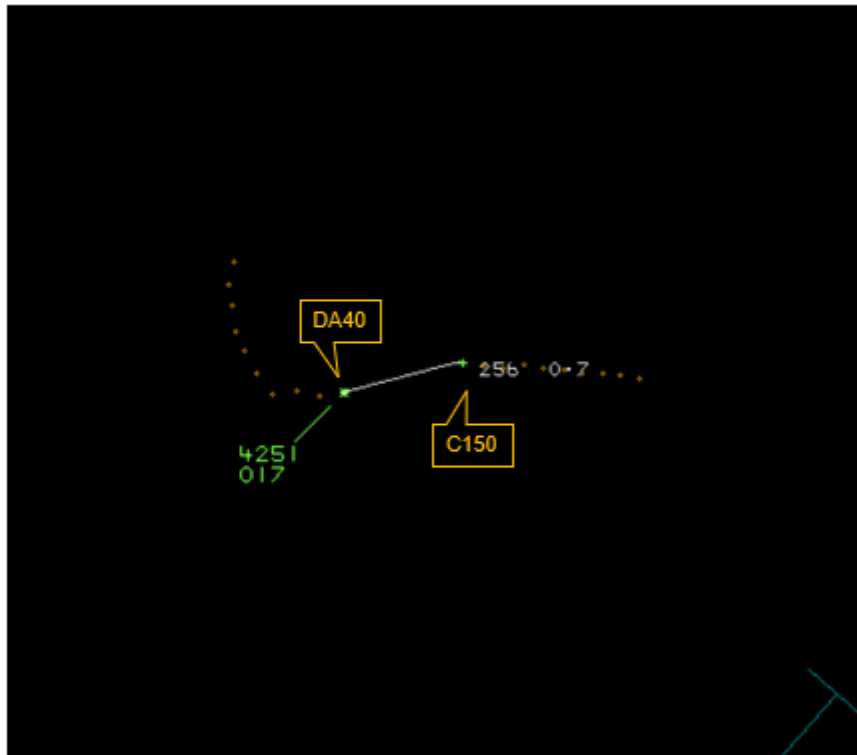
Figure 6 – 1406:52

The controller then dealt with a call from another pilot requesting a Traffic Service and passed relevant Traffic Information to that pilot at 1406:52 (Figure 6).

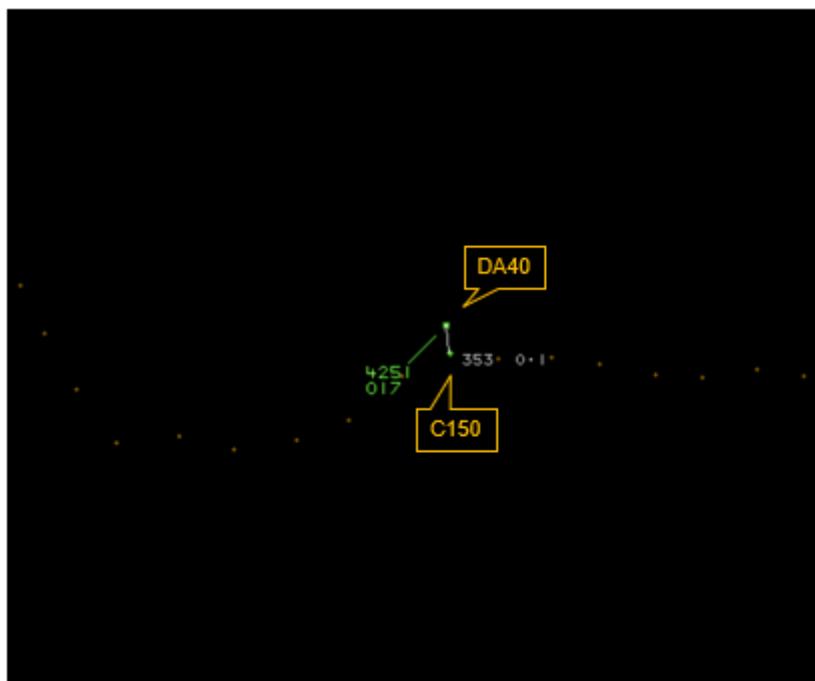
Figure 8 – 1407:03 CPA

CPA occurred at 1407:03 (Figure 8).
