AIRPROX REPORT No 2023042

Date: 07 Apr 2023 Time: 1123Z Position: 5317N 00053W Location: 2.5NM E Gamston

PART A: SUMMARY OF INFORMATION REPORTED TO UKAB

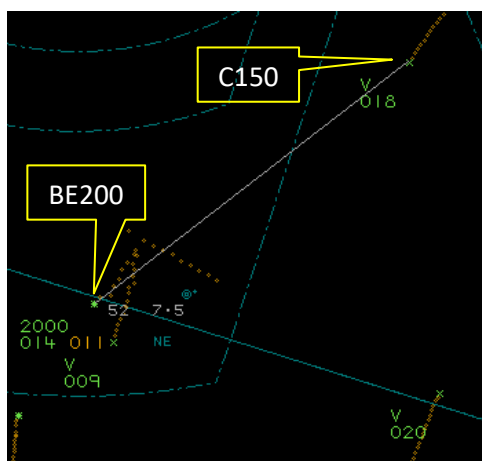
Figure 1 - 1120:36

An analysis of the NATS radar replay was undertaken and both aircraft could be seen and identified using Mode S information. At 1120:36 (Figure 1) the C150 was northeast of Gamston indicating FL018. By 1122:46 (Figure 2) the BE200 had flown to the east of Gamston, as described in their report and the C150 was 3NM north of them.

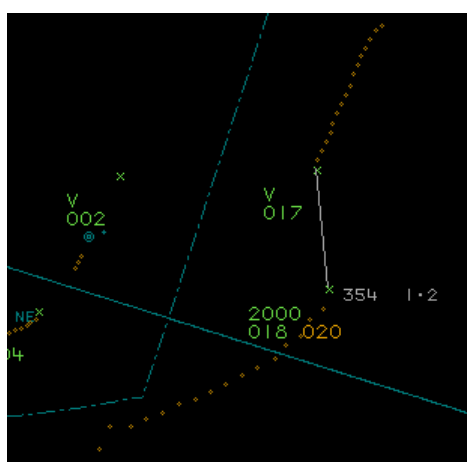
Figure 3 - 1123:14

The two aircraft continued to close at a similar altitude (Figures 3 and 4).

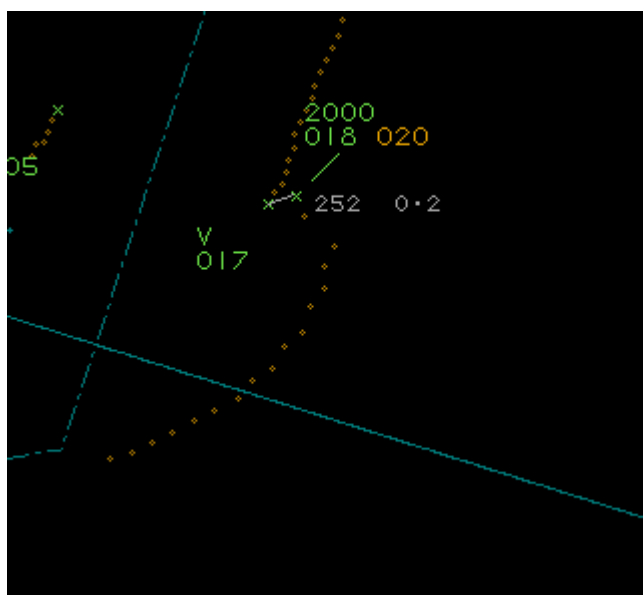
Figure 5 - 1123:34, CPA.

CPA occurred at 1123:34 with the BE200 passing 0.2NM behind the C150 and with an indicated vertical separation of 100ft (Figure 5).
