AIRPROX REPORT No 2023070

Date: 07 May 2023 Time: 1438Z Position: 5201N 00134W Location: 4NM north of Chipping Norton

PART A: SUMMARY OF INFORMATION REPORTED TO UKAB

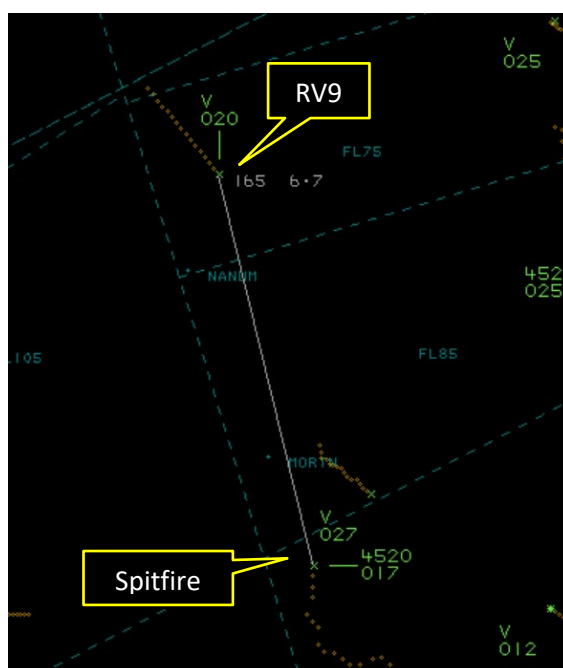
An analysis of the radar replay showed that the Spitfire pilot departed Oxford to the northwest in a climb to 1700ft via the Oxford Area of Intense Aerial Activity (AIAA) and the RV9 passed to the southeast of Shipston-on-Stour at 2000ft at time 1437, approximately where the RV9 pilot reported making an initial call to Enstone Radio for an Air Ground Communication Service (Figure 1).

Figure 1 – Spitfire operating in the Oxford AIAA northwest of Oxford at 1437

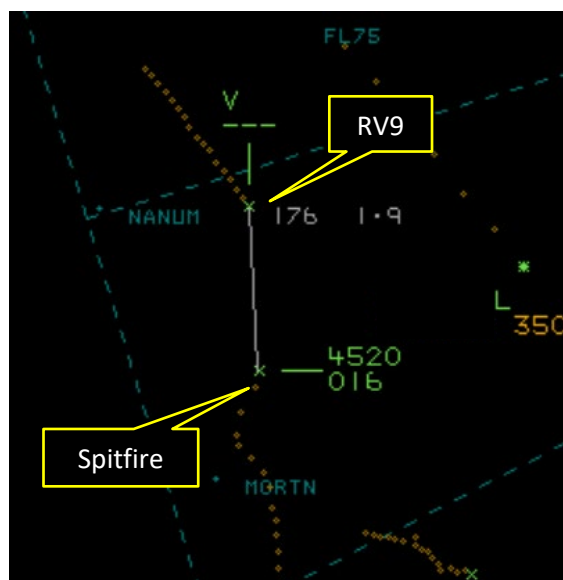
One minute later at 1438 the two aircraft continued on converging headings with the Spitfire indicating an altitude of 1600ft and the RV9's Mode C altitude was not known (Figure 2). Their relative distance decreased from 6.7NM to 1.9NM.

Figure 2 – Spitfire and RV9 remain on converging headings at 1438

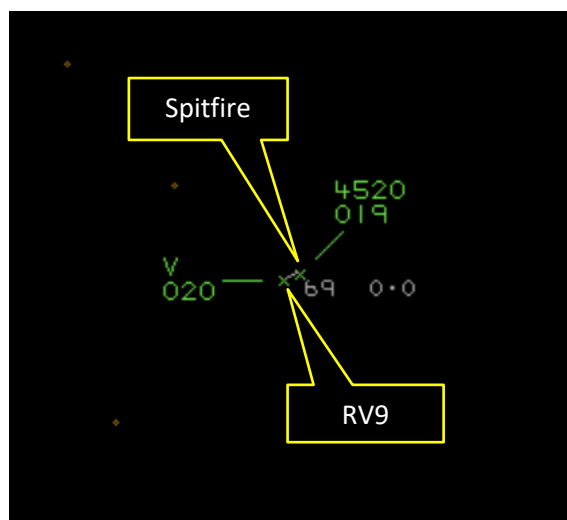
The RV9 passed overhead the Spitfire at time 1438:30 (Figure 3)

Figure 3 – The Spitfire and RV9 closest point of approach at 1438:30
