**AIRPROX REPORT No 2023064**

Date: 01 May 2023 Time: 1311Z Position: 5142N 00049W Location: 1.5NM SE Princes Risborough

**PART A: SUMMARY OF INFORMATION REPORTED TO UKAB**

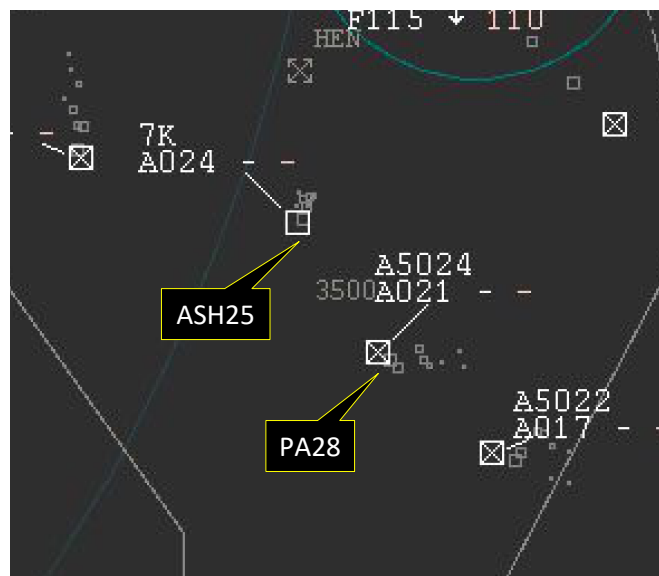
Figure 1 - 1309:24

**THE OXFORD RADAR CONTROLLER** reports that they submitted a report on behalf of the pilot of [the ASH25] who contacted Oxford Radar to report the incident via RT at approximately 1420. Based on the information given, Oxford was not providing an ATS nor in contact with either aircraft at the time of the incident. Figure 1 is a screenshot from the Oxford Radar.

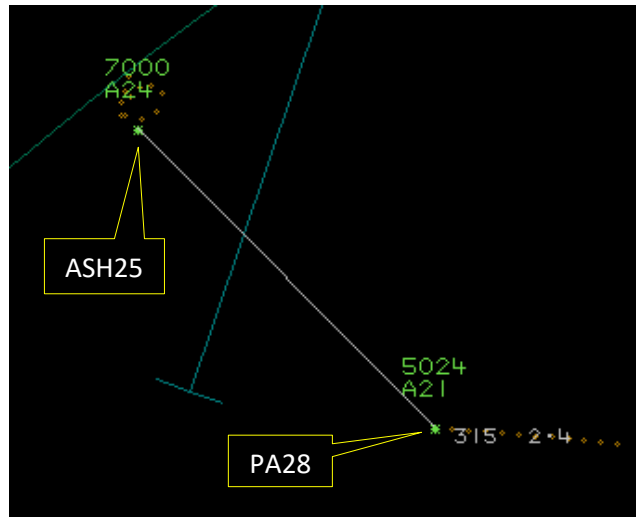
Figure 2 – 1308:49

At 1308:49, the aircraft were 2.4NM apart with an indicated 300ft vertical distance. The ASH25 was in an orbit, and they were not a threat to each other. The controller was engaged in a lengthy RT exchange with a pilot making their initial call to request a service.

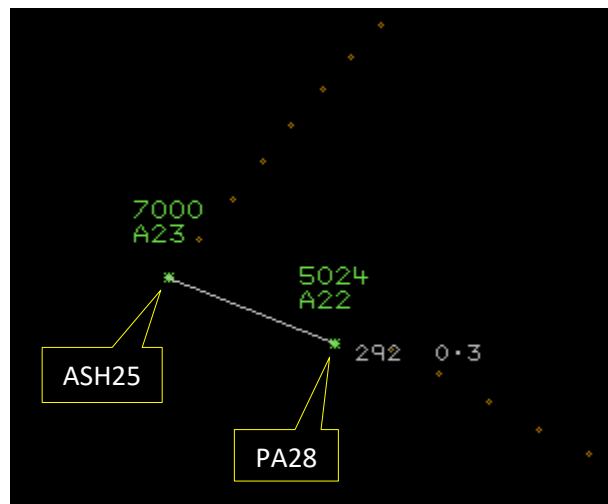
Figure 3 - 1310:17

At 1310:17, the above RT exchange concluded, and the aircraft were then 0.3NM apart with an indicated vertical distance of 100ft. The controller then engaged with the pilot of an aircraft who had previously stated their intention to leave the frequency but commenced a discussion about wishing to stay with the Farnborough controller.

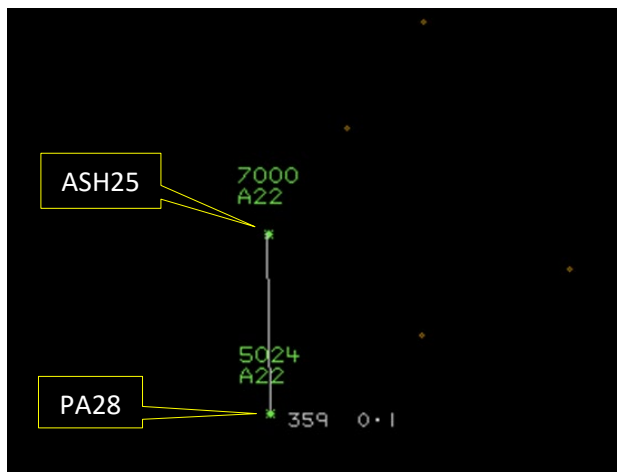
Figure 4 – 1310:42

At 1310:42, the above RT exchange concluded, with the two aircraft then 0.1NM apart and indicating the same altitude.

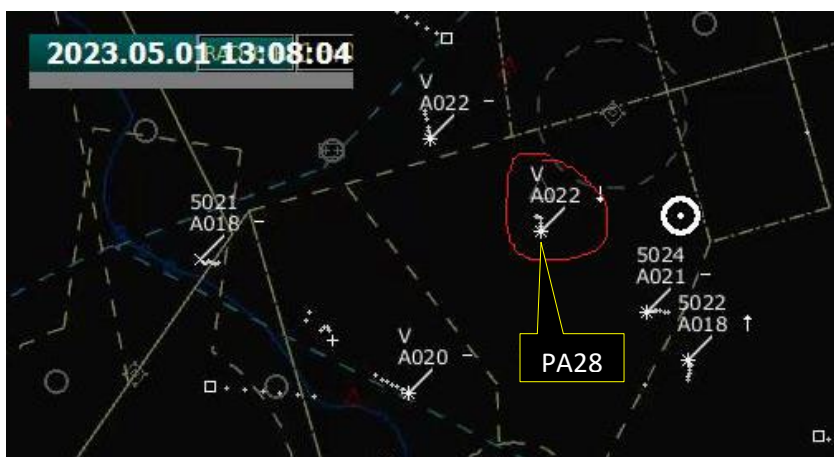
Figure 5 - 1308:04

1259:00 [The pilot of the PA28] checked-in on frequency. Their routing was via WCO NDB for general handling. [They were] issued with QNH 1018, a squawk of 5024 and a Basic Service. This was read back correctly, the aircraft was identified, validated and verified.

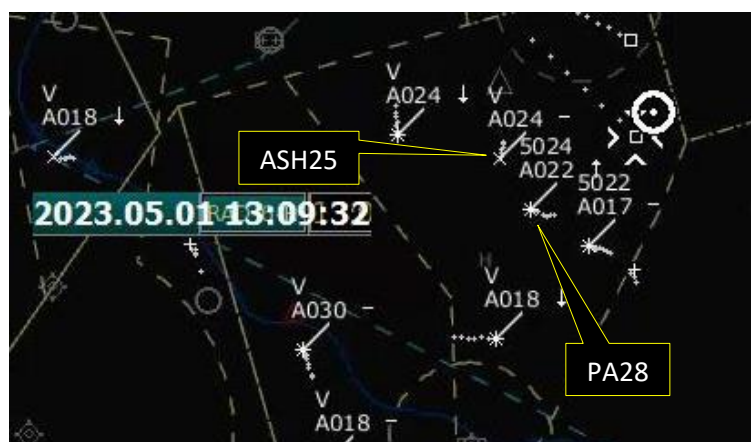
Figure 6 - 1309:32

1309:45 [The PA28] was north of Wycombe Air Park by approximately 5NM, tracking 280° indicating 2200ft. An aircraft squawking 7000 was seen tracking towards [the PA28] from the north at 2400ft.

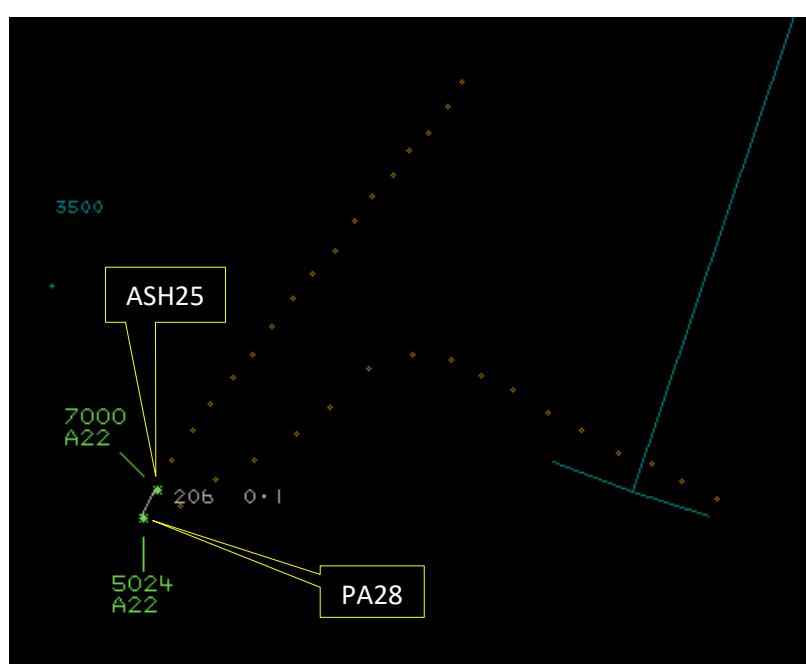
Figure 7 - CPA at 1310:46

An analysis of the NATS radar replay was undertaken and both aircraft could be positively identified from Mode S data (see Figure 7).

The ASH25 and PA28 pilots shared an equal responsibility for collision avoidance and not to operate in such proximity to other aircraft as to create a collision hazard.<sup>1</sup> If the incident geometry is considered as converging then the PA28 pilot was required to give way to the ASH25 and should have avoided passing over, under or in front of the ASH25, unless it had passed well clear and had taken into account the effect of aircraft wake turbulence.<sup>2</sup> If the incident geometry is considered as overtaking then the ASH25 pilot had right of way and the PA28 pilot was required to keep out of the way of the ASH25 by altering heading to the right, and no subsequent change in the relative positions of the two aircraft shall absolve the overtaking aircraft from this obligation until it is entirely past and clear.<sup>3</sup>
