AIRPROX REPORT No 2023075

Date: 16 May 2023 Time: 1048Z Position: 5216N 00007W Location: IVO Hilton

PART A: SUMMARY OF INFORMATION REPORTED TO UKAB

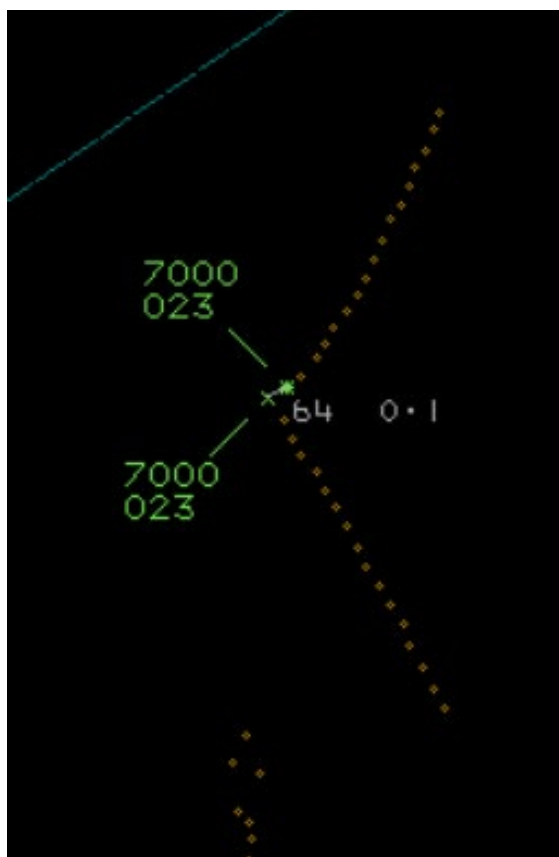
Figure 21 – Radar display at CPA

The aircraft appeared on the NATS radar replay, with CPA being displayed as follows:

The Lange Antares and C42 pilots shared an equal responsibility for collision avoidance and not to operate in such proximity to other aircraft as to create a collision hazard.¹ If the incident geometry is considered as converging then the C42 pilot was required to give way to the Antares.²
