AIRPROX REPORT No 2023071

Date: 12 May 2023 Time: 0938Z Position: 5136N 00117W Location: 1NM West of Didcot

PART A: SUMMARY OF INFORMATION REPORTED TO UKAB

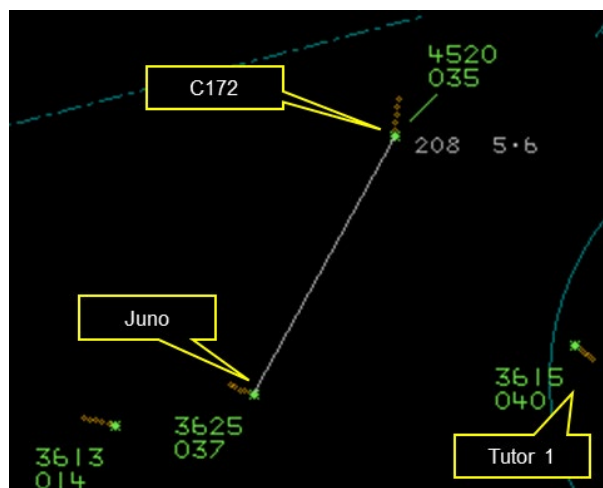
Figure 1 (0935:17). Position of the Juno and C172, on commencement of the recovery profile discussion. (Separation: 5.6NM)

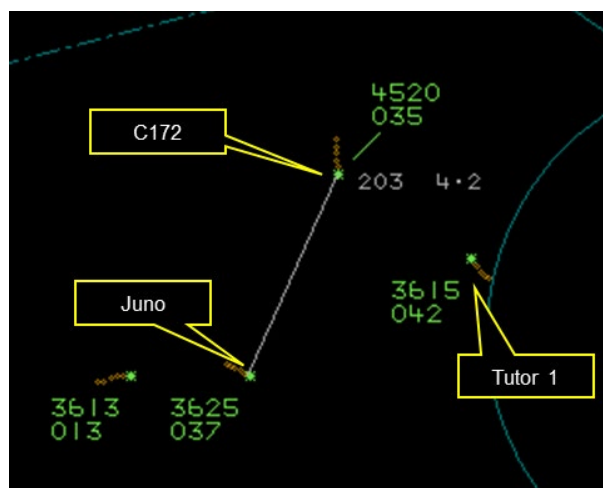
Figure 2 (0936:05). Traffic Information provided. (Separation: 4.2NM)

At 0936:05, the Benson Approach controller provided Traffic Information to the Juno pilot on the C172 *“traffic left nine o'clock, four miles, crossing left-right behind, indicating two hundred feet below”*. The Traffic Information had been acknowledged by the Juno pilot, who reported *“looking”* and that they were *“intermittent IMC”*.

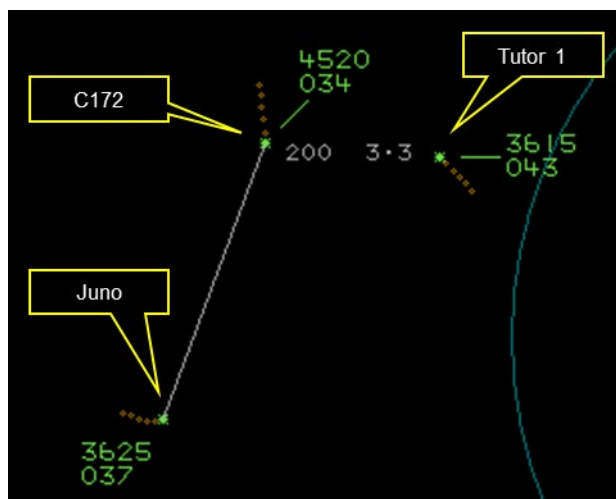
Figure 3 (0936:30). Juno turned inbound for the procedure. (Separation: 3.3NM)

At 0936:30, the Juno pilot intercepted the Compton 022R and turned northeast inbound for the VOR hold. Simultaneously the Benson Supervisor conducting the handover on behalf of the Benson Approach controller provided an SSR Code to the Benson Approach controller. This had subsequently been passed to Tutor #1 pilot to facilitate the continued handover.

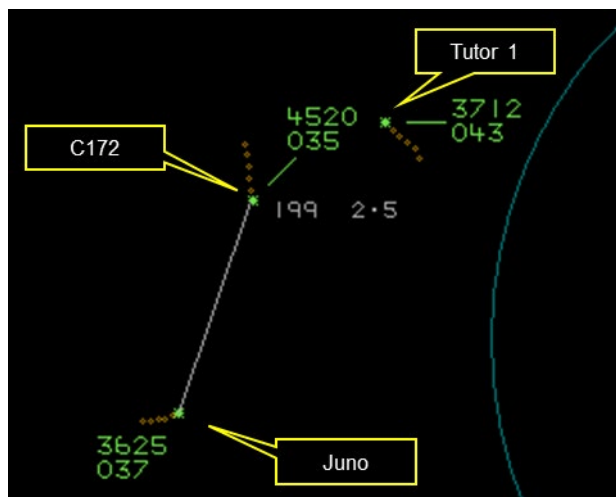
Figure 4 (0936:51). Position of the Juno and C172 on commencement of Tutor #2 contact. (Separation: 2.5NM)

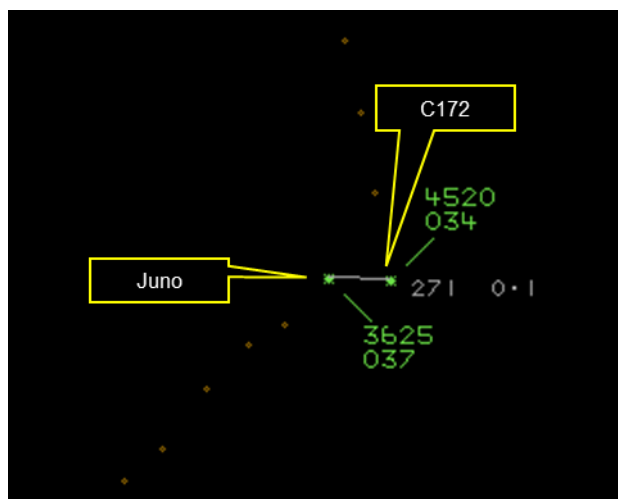
Figure 5 (0937:45): CPA - measured at 0.1NM and 300ft separation.

At 0937:46, the Juno pilot reported to the Benson Approach controller *“for your information we’ve had a err light-aircraft about two hundred foot below us crossing left-to-right”*. This report had been acknowledged and responded to at 0938:05 with *“the track I called you earlier”*.

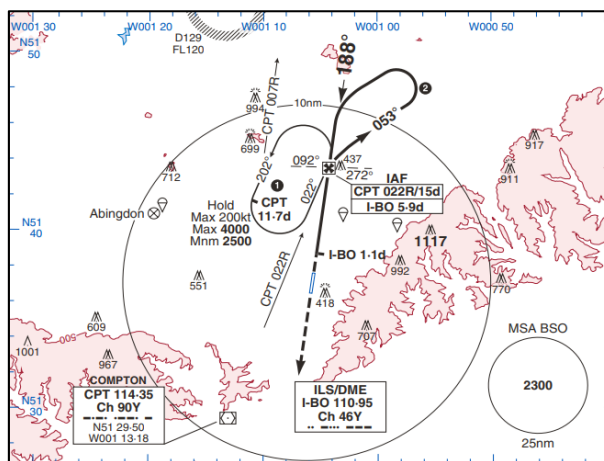
Figure 6 Benson Runway 19 VOR to ILS/DME procedure, with Compton 022R intercept.

The previous Traffic Information description of ‘crossing left-right behind’ no longer provided an accurate traffic picture to the Juno pilot and therefore limited their traffic avoidance ability. Under the requirements of a Traffic Service, the Benson Approach controller had been required to update the Traffic Information to the Juno pilot as the C172 continued to present a definite hazard.² Whilst the Benson Approach controller had been managing a range of tasks, as identified in the local investigation, there had been sufficient time for the Traffic Information to be updated either before or after the Juno pilot’s turn where separation reduced to within 3NM.

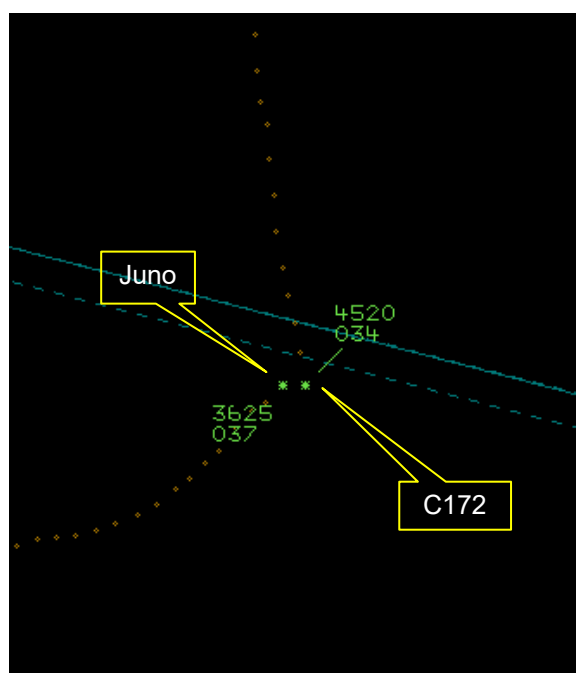
Figure 7 CPA 0937:45 300ftV/0.1NM H
