AIRPROX REPORT No 2023081

Date: 18 May 2023 Time: 1052Z Position: 5201N 00001W Location: 1NM S of Royston

PART A: SUMMARY OF INFORMATION REPORTED TO UKAB

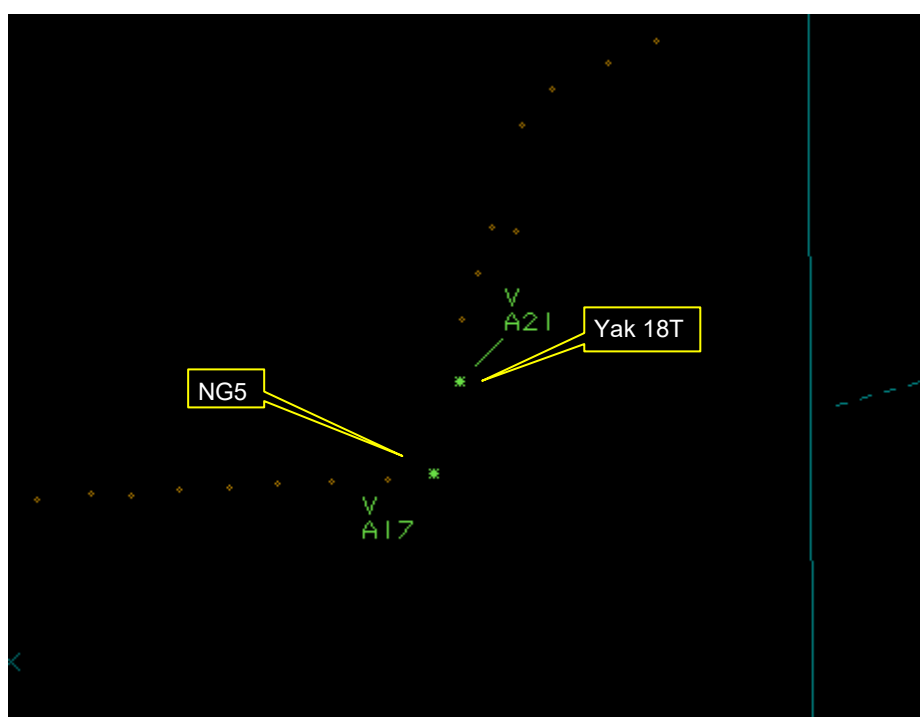
The NATS radar replay was reviewed and both the NG5 and Yak18 were identified using Mode S.

Figure 1: CPA 400ft V/0.2NM H at 1052:02
