AIRPROX REPORT No 2023076

Date: 16 May 2023 Time: 1356Z Position: 5059N 00050E Location: 4NM NW Lydd

PART A: SUMMARY OF INFORMATION REPORTED TO UKAB

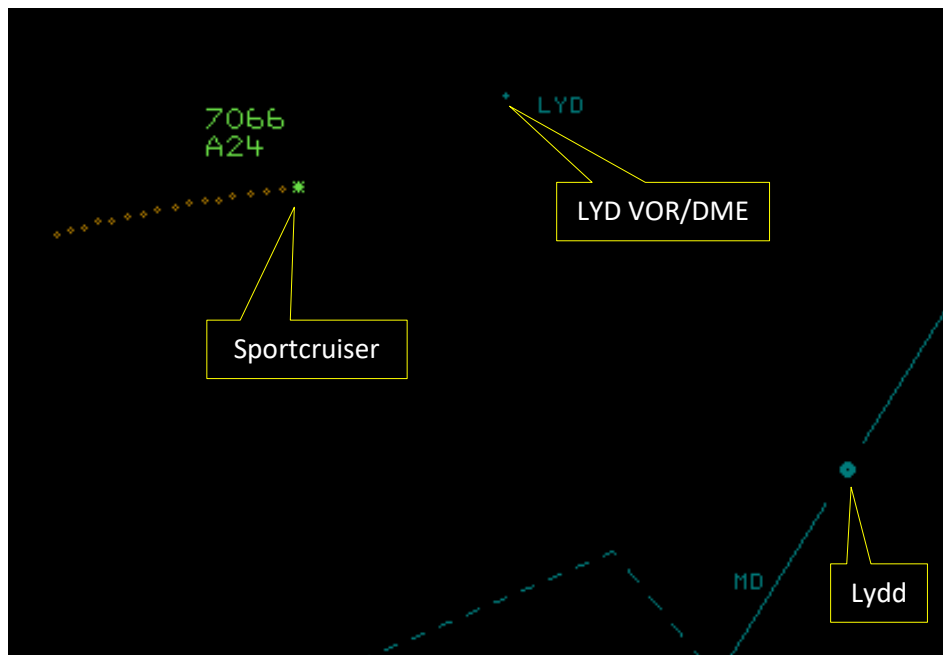
Figure 1 – CPA at 1355:38

An analysis of the NATS radar replay was undertaken. The Sportcruiser could be positively identified from Mode S data (see Figure 1). The paraglider was not observed on radar. The paraglider pilot kindly supplied GPS data for their track. It was by combining these separate data sources that the CPA was determined and the diagram constructed.
