AIRPROX REPORT No 2023086

Date: 19 May 2023 Time: 1040Z Position: 5239N 00250W Location: 5NM SW Shrewsbury

PART A: SUMMARY OF INFORMATION REPORTED TO UKAB

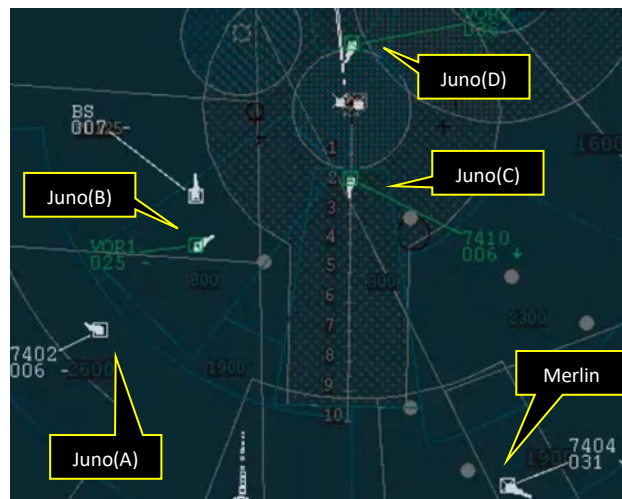
At 1037:21, Traffic Information was provided by the Shawbury Approach controller to Juno(B) pilot, on Juno(A); *“Traffic, twelve o’clock, three miles, crossing right-to-left ahead, indicating one thousand nine hundred feet below, Shawbury Rotary.”*

Figure 1 - (1037:21): Traffic Information provided to Juno(B) pilot on Juno(A).

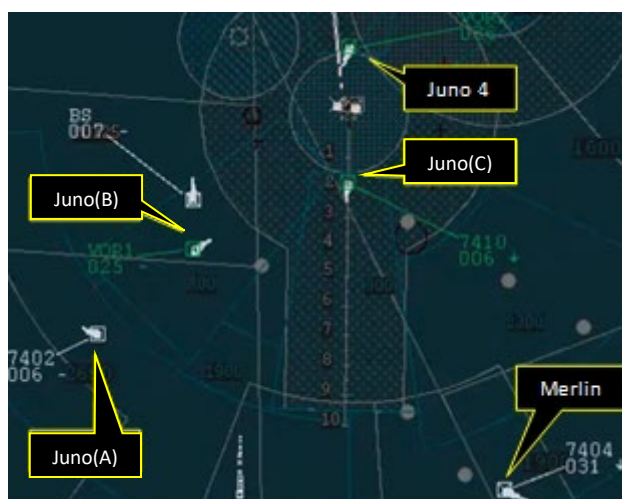
At 1037:27, following identification and application of a Traffic Service, the Shawbury Director controller issued the Juno(A) [pilot] with a climb to 2600ft (QFE 1019) on their current heading of 110°. With the climb, the Shawbury Director controller also informed the Juno(A) [pilot] that they were No5 in the Radar Training Circuit, with Junos (B), (C) and (D) under Shawbury Approach and the Merlin under Shawbury Director all prioritised ahead.

Figure 2 - (1037:27): Juno(A) pilot issued a climb by the Shawbury Director.

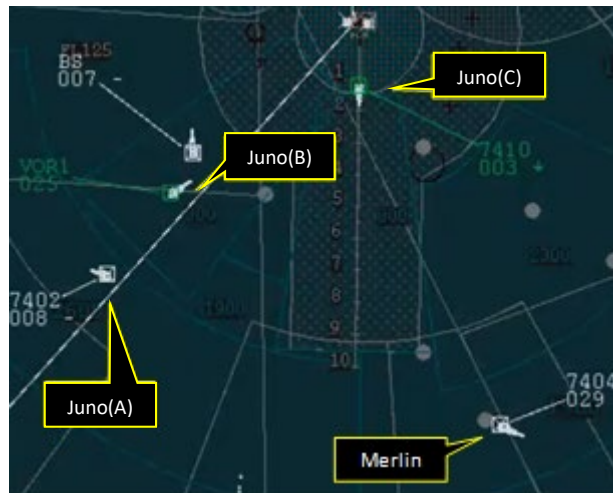
At 1037:56, the Shawbury Approach controller issued a turn onto 180° to [the pilot of] Juno(B), facilitating Juno(B)'s departure from the VOR hold into the Radar Training Circuit for a PAR instrument approach.

Figure 3 - (1037:56): Juno(B) issued a turn by the Shawbury Director.

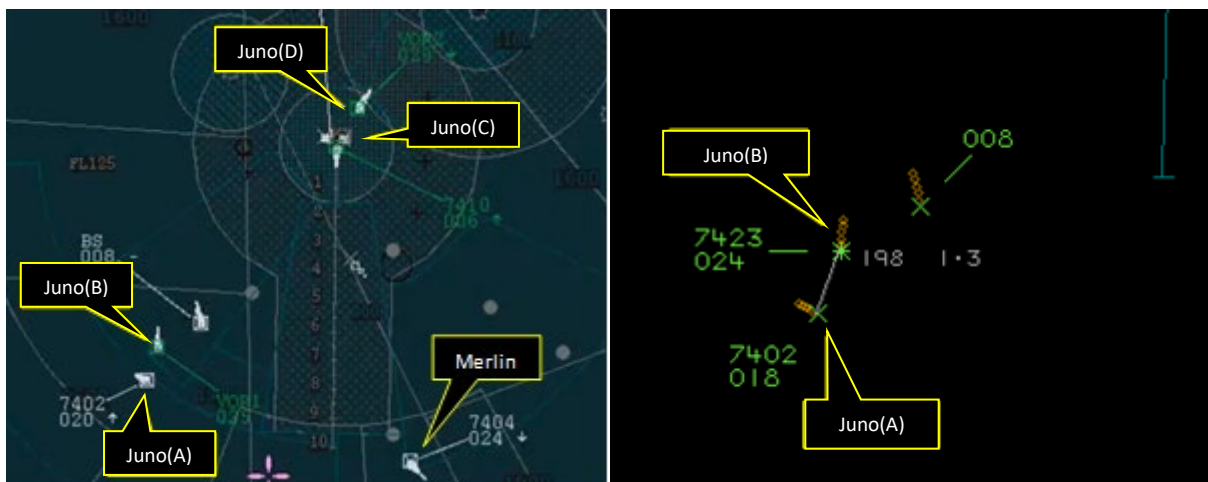
At 1039:05, Traffic Information was provided by the Shawbury Director to [the pilot of] Juno(A) on Juno(B); “Traffic left nine o’clock, half a mile, converging left right, Shawbury rotary, indicating five hundred feet above, taking your own terrain clearance stop climb if required”. Juno(A) [pilot] reported “not visual, stopping climb”. Juno(A) was passing 2200ft and subsequently levelled off, before descending to 2100ft.

Figure 4 - (1039:05) Traffic Information provided to Juno(A) on Juno(B).

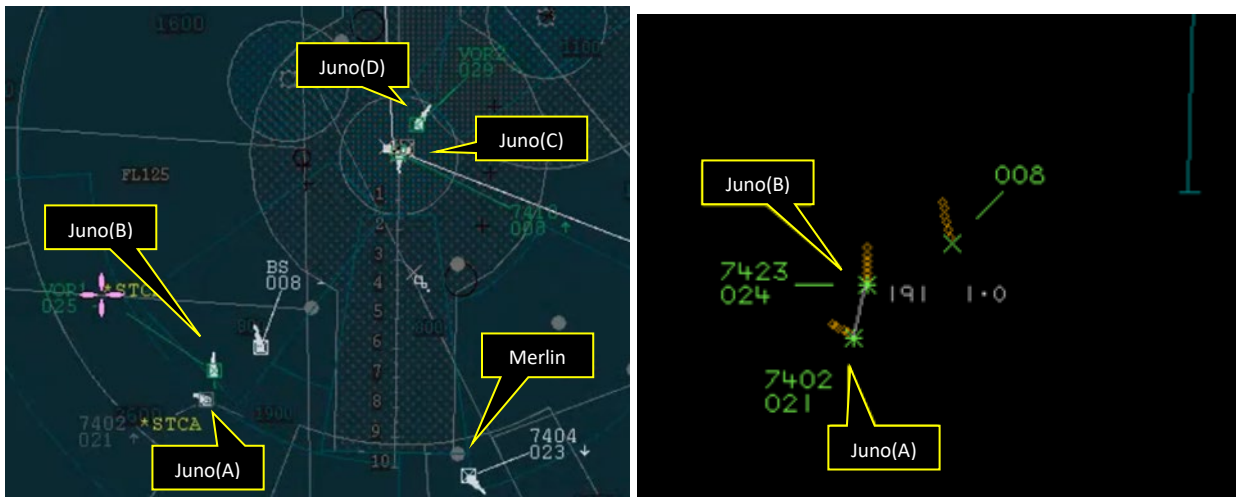
At 1039:14, after incorrectly calling to Juno(C) at 1039:01, Traffic Information was provided by the Shawbury Approach controller to [the pilot of] Juno(B), on Juno(A); “Traffic twelve o’clock, one mile, crossing right-to-left ahead, indicating three hundred feet below and climbing, are you visual?” Juno(B) pilot responded “negative, not visual, request deconfliction”. The Shawbury Approach controller provided an avoiding action turn onto 270° and reissued the Traffic Information.

Figure 5 - (1039:14) Traffic Information provided to Juno(B) pilot on Juno(A).

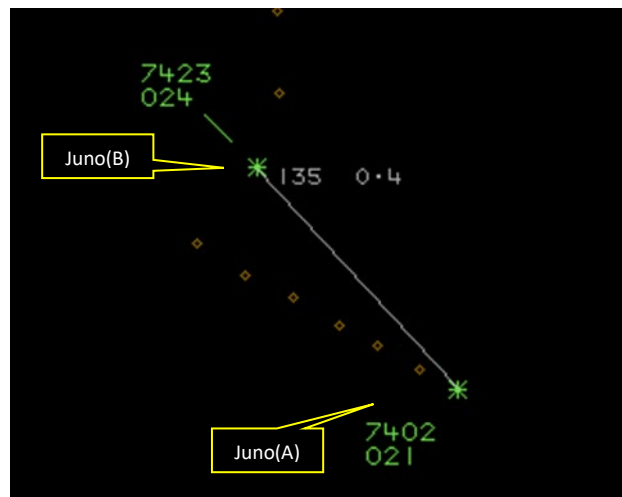
CPA was measured at 0.4NM and 300ft separation.

Figure 6 (1039:51): CPA.
