AIRPROX REPORT No 2023096

Date: 26 May 2023 Time: 1418Z Position: 5208N 00005W Location: 3NM SSE Gransden Lodge

PART A: SUMMARY OF INFORMATION REPORTED TO UKAB

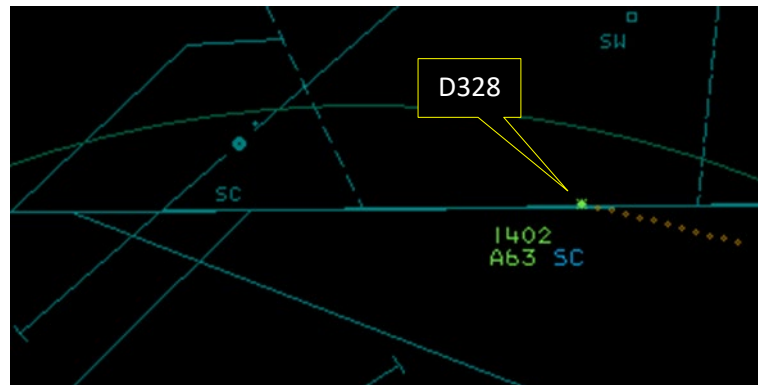
Figure 1 – 1413:50

At 1413:50, the D328 pilot made initial contact with the Cambridge controller and advised that they were descending to altitude 4000ft on QNH 1032hPa, inbound to the CAM and with information Lima. A Procedural Service was agreed, and the controller advised RW05 was in use and asked the pilot what type of approach they would like. The pilot responded that they'd like an NDB approach. The pilot was instructed to descend to altitude 3000ft and report their estimate for the CAM. The pilot read back the descent instruction and queried whether the controller was asking them to report passing the CAM. The controller asked the pilot if they were within a few miles of the airfield and the pilot responded that they were 7NM and 2min to the CAM. The pilot was cleared for

the NDB approach to RW05 and instructed to report at the CAM outbound. The pilot provided a full readback (Figure 1).

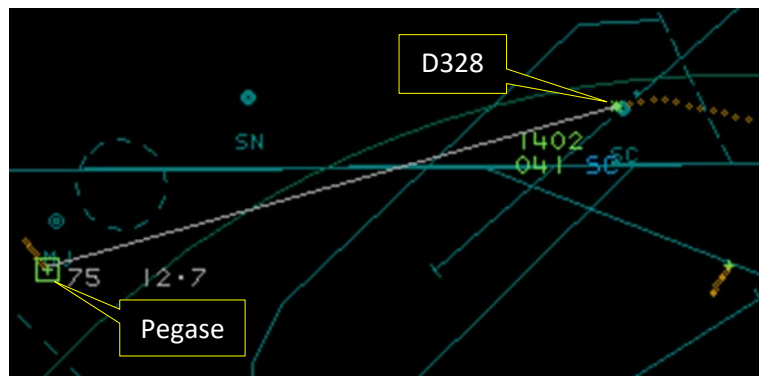
Figure 2 – 1415:30

At 1415:30, the D328 pilot reported CAM outbound, and the controller acknowledged and responded, “*roger, report base turn complete, caution Gransden Lodge Gliding site 10 miles southwest of Cambridge is active with six gliders*”. The pilot responded, “*that is copied, we’ll call you turning base*”. (Figure 2)

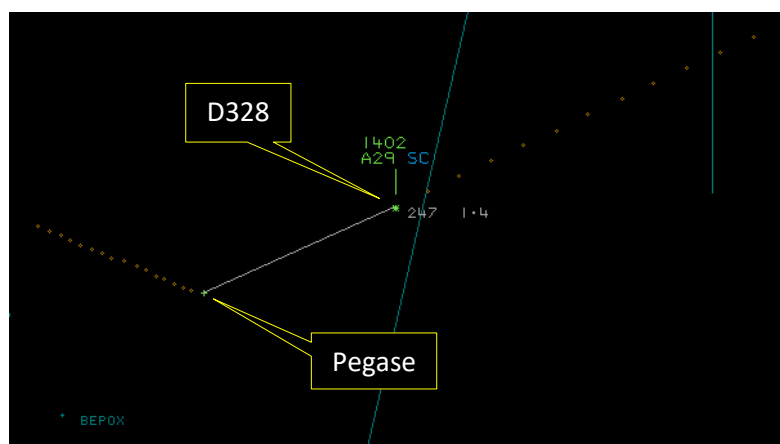
Figure 3 – 1418:10

At 1418:10, the controller advised the pilot that they were operating non-radar and to keep a good lookout when making the base turn; “*I believe there to be traffic in the vicinity of BEPOX tracking eastbound with no height information*”. The pilot responded that they had copied the traffic and the controller advised that the traffic was believed to be non-transponding and that it might not be visible on TCAS. The pilot acknowledged (Figure 3).

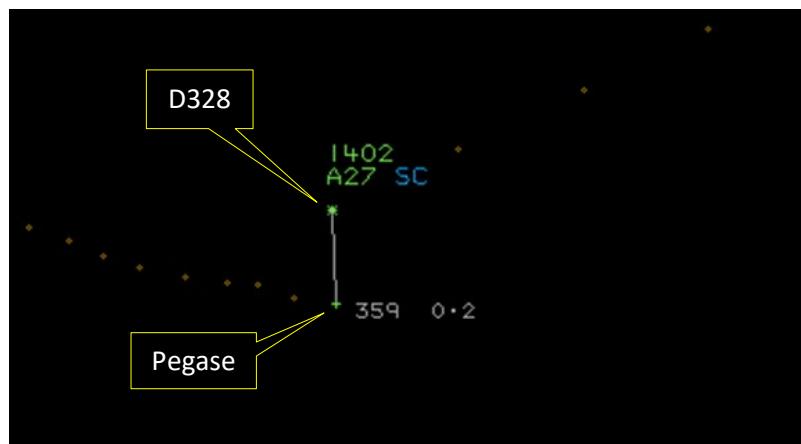
Figure 4 – 1418:28 CPA

At 1418:28, CPA occurred with the aircraft separated by 0.2NM and, [as reported by the D328 pilot on the RT], 100ft (Figure 4).

At 1418:40, the pilot reported, “I think the glider has just passed the lights 100 feet above us, just for information”. The controller acknowledged.

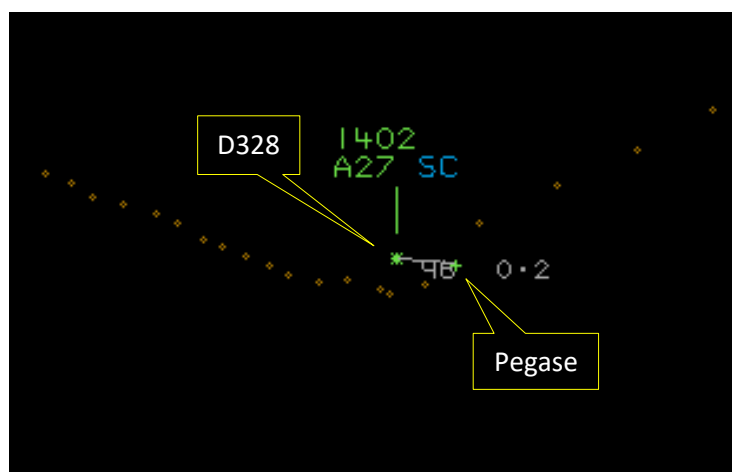
Figure 5 - 1418:30

The left-turn made by the pilot of the Pegase moments after CPA, apparent on the radar replay in Figure 5, was not observed in the GPS track data and the radar returns were assessed as spurious. The pilot of the Pegase had maintained a broadly straight course (+/- 5°) before and after CPA.

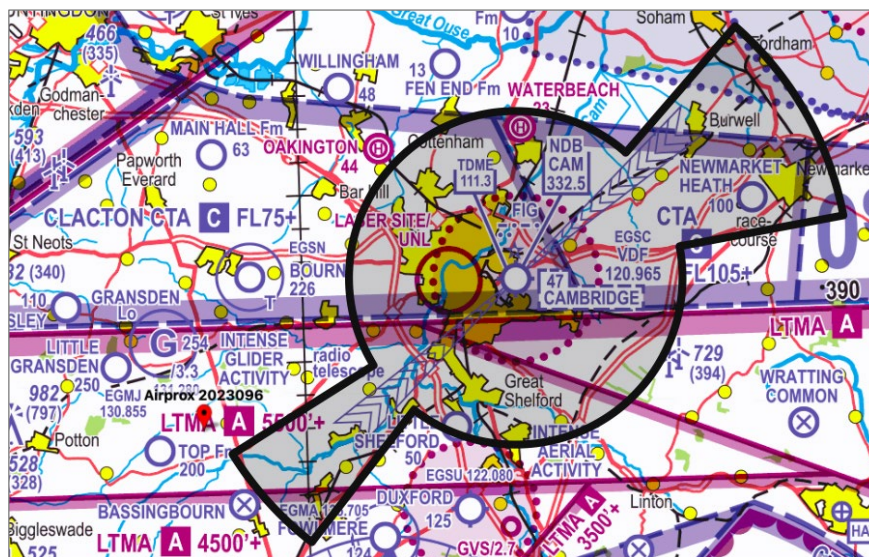
A Memorandum of Understanding between Cambridge International Airport and Cambridge Gliding Club (which operates Gransden Lodge) enables the airspace surrounding both sites to be shared between them in a manner that reduces the risk of an aircraft incident or accident. Under the MoU, glider pilots flying from Gransden Lodge are encouraged to contact Cambridge Approach when operating within 5NM of Cambridge Airport and within the approach and climb-out areas as illustrated in Figure 6. CPA in this incident was approximately 1NM outside the MoU area.

The diagram (as reproduced in Figure 6 above) was shown to members. Referring to the increased use of RNP approaches to both ends of the main runway, one member wondered why the defined area did not cover all approach paths to Cambridge, and suggested that the MoU ought to be revised.

An alternate viewpoint was proffered by other members, that an increase to the area defined in the MoU, particularly to the west of Cambridge Airport, would impinge upon the airspace near Gransden Lodge. It was conveyed that, a glider pilot may wish to operate in that area without suitable radio equipment installed in their glider, or without having possession of the requisite licence to be able to use such equipment, and that this would be precluded by an extension to the existing defined area.

The point was put to a vote, and the latter view, that the extant MoU balanced the positions of both airfield operators adequately, prevailed. Concluding this part of the discussion, members noted that the point of CPA had occurred outside the area defined in the MoU.
