AIRPROX REPORT No 2023105

Date: 18 May 2023 Time: 0929Z Position: 5210N 00057W Location: 7NM E of Daventry VOR/DME

PART A: SUMMARY OF INFORMATION REPORTED TO UKAB

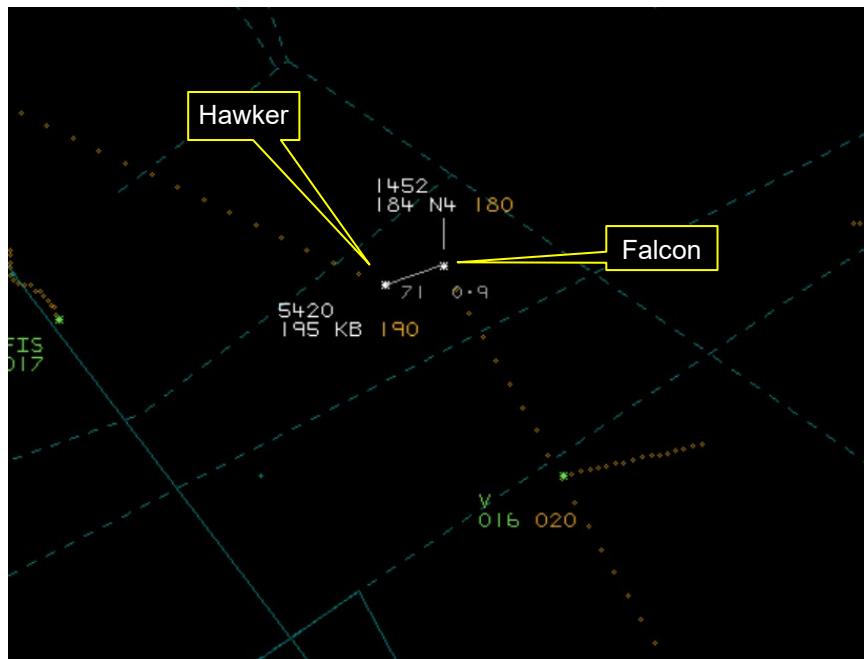
Figure 1 CPA (in absolute terms) 900ft V/0.9NM H (slant range of ~5578ft) at 0929:19

Radar interpretation had been carried out both by UKAB Secretariat and NATS; Figure 1 above shows the CPA in its most immediate sense – the closest 3-plane position that these two aircraft came together in this event – 0.9NM and 900ft. Figure 2 shows NATS’ calculation of the closest these two aircraft came in the vertical plane – 500ft at 1.9NM, 10sec earlier.

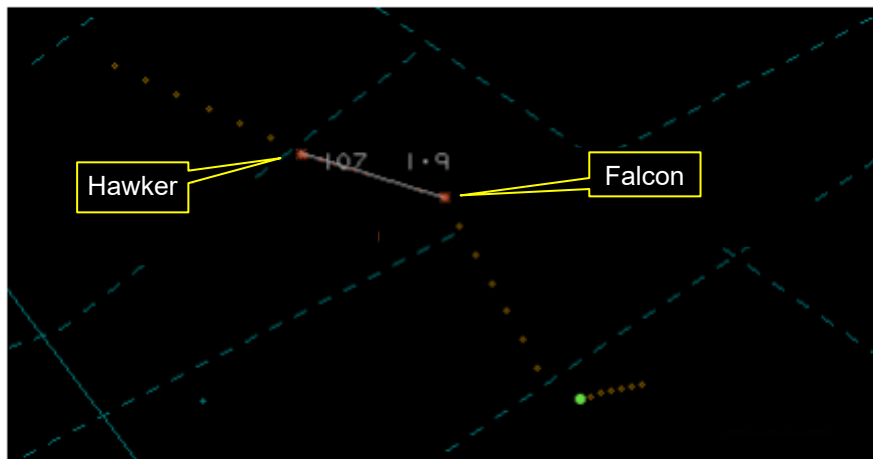
Figure 2 CPA (in vertical proximity terms) 500ft V/1.9NM H (slant range of ~11,555ft) at 0929:09
