AIRPROX REPORT No 2023098

Date: 29 May 2023 Time: 1149Z Position: 5348N 00055W Location: Brighton

PART A: SUMMARY OF INFORMATION REPORTED TO UKAB

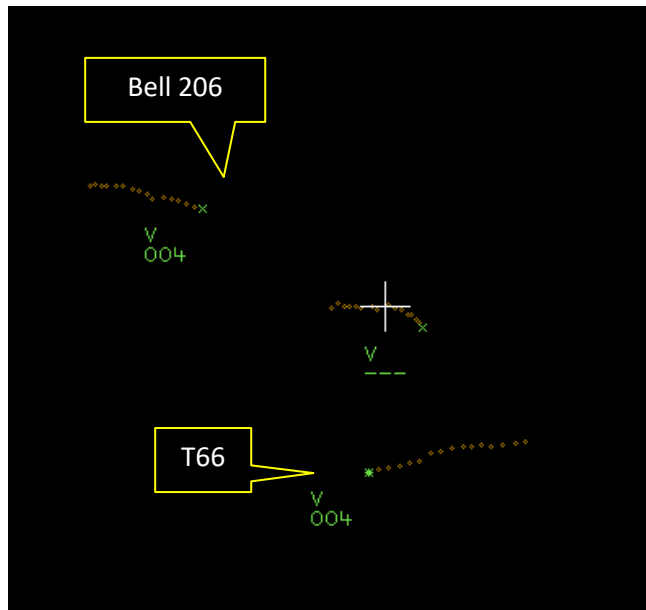
Figure 1 – 1147:25

The NATS area radar replay was assessed and both aircraft could be seen and identified using Mode S information. The approximate position of Brighton is marked with the white cross at Figures 1 and 2. At Figure 1, the Bell 206 can be seen northwest of Brighton indicating FL004 (radar QNH was 1029hPa, therefore add approximately 430ft). The T66 could be seen in a downwind position also indicating FL004.

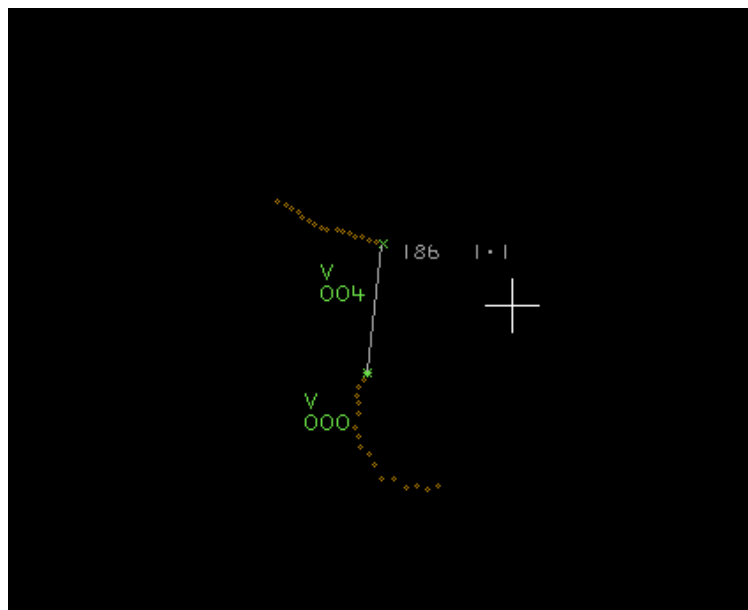
Figure 2 – 1148:30

The Bell 206 continued on a long straight-in final, and the T66 appeared to turn onto a base leg (Figure 2).

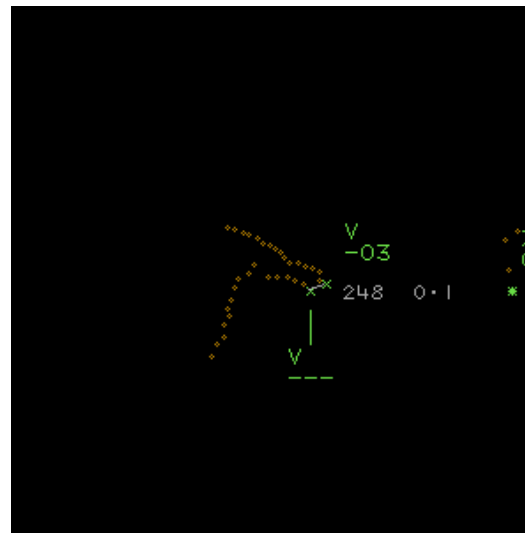
Figure 4 - 1149:34

The two aircraft continued to close until at 1149:35 (Figure 4) the Mode C on the T66 dropped from the radar replay (probably due to their low height).

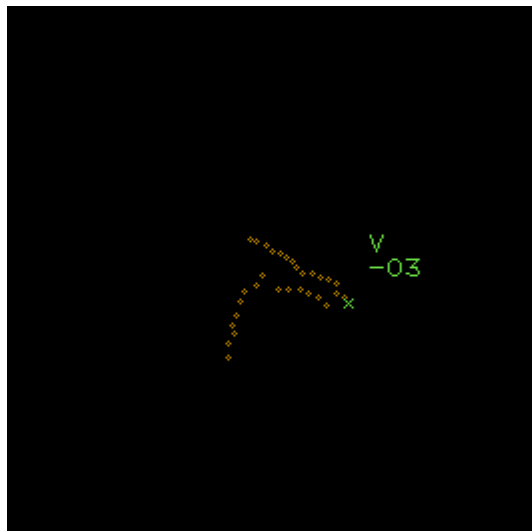
On the next radar sweep, the T66 had completely faded from radar (probably below radar cover) and CPA would have occurred at or around this time. Unfortunately the exact separation could therefore not be determined.

Figure 5 - 1149:38 T66 faded from radar.
