**AIRPROX REPORT No 2023101**

Date: 26 May 2023 Time: 1238Z Position: 5258N 00047W Location: 11NM WSW of Cranwell.

**PART A: SUMMARY OF INFORMATION REPORTED TO UKAB**

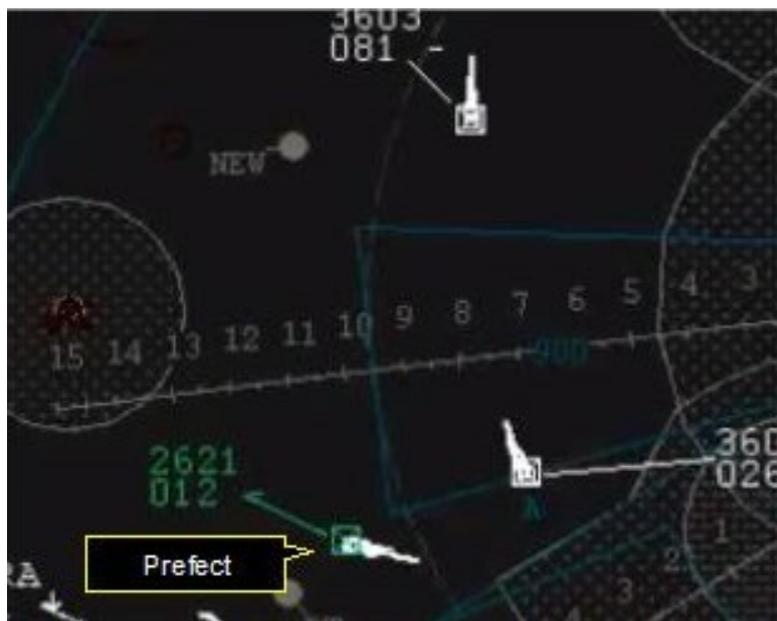
Figure 1 (1236:53). Prefect turned inbound for the instrument recovery. Separation unknown.

At 1236:53 the Prefect [pilot] was turned inbound for the instrument recovery with the Cranwell Director initially issuing a heading of 060° which was amended to 070° at 1237:34. During this period no radar returns were present between the Prefect and the extended centreline for Cranwell RW08RH.

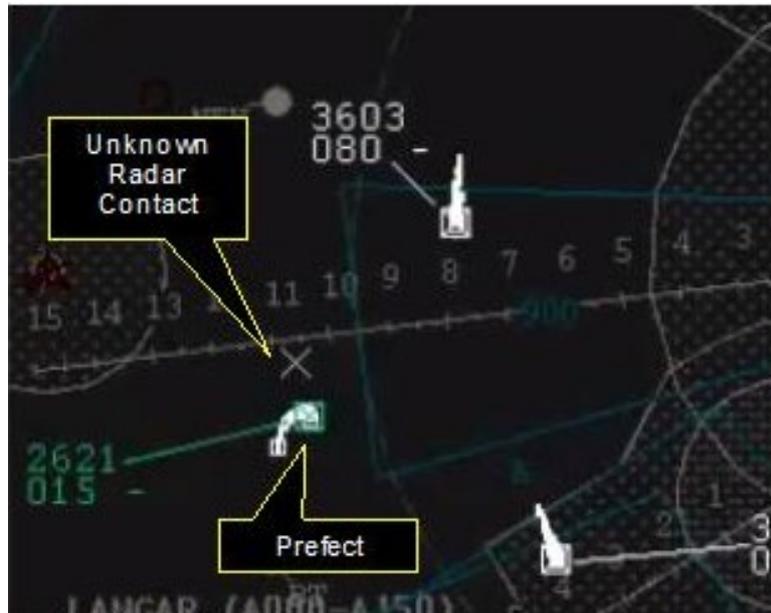
Figure 2 (1237:59). Unknown radar contact displayed. Separation estimated as 1.0NM

At 1237:59 an unknown radar contact with a 'non-cooperative only' return was displayed to the north of the Prefect by approximately 1NM and tracking north. This radar contact was displayed intermittently on a northbound track crossing the extended centreline for Cranwell Runway 08RH. The closest point of approach was unknown but estimated by the Prefect [pilot] as 0.1NM and 0ft [vertical] separation.

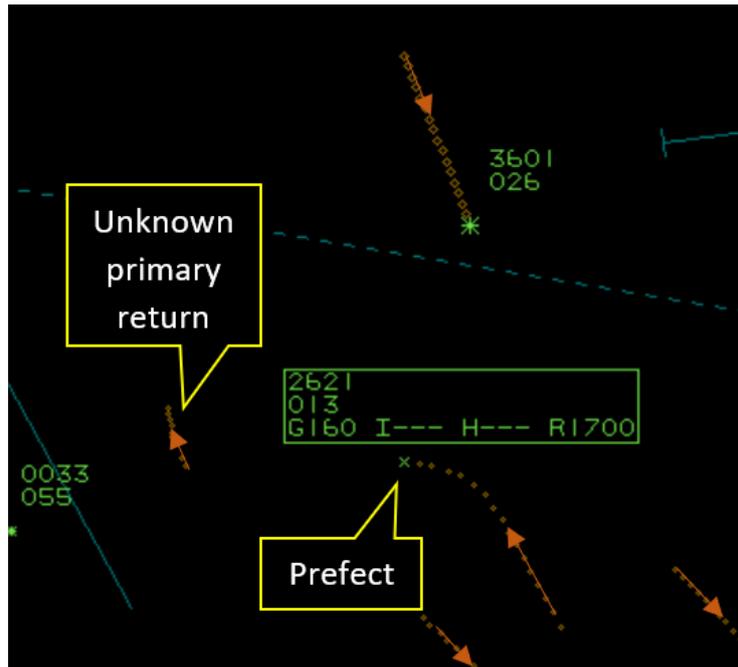
An analysis of the radar replay determined the position of the Prefect throughout but with no defined trace of the microlight or hang glider, although some intermittent primary returns were observed. A primary return observed briefly at 1235 reappeared at 1235:15 (Figure 3).

Figure 3 (1235:15) The Prefect turned on to heading 280° as directed.

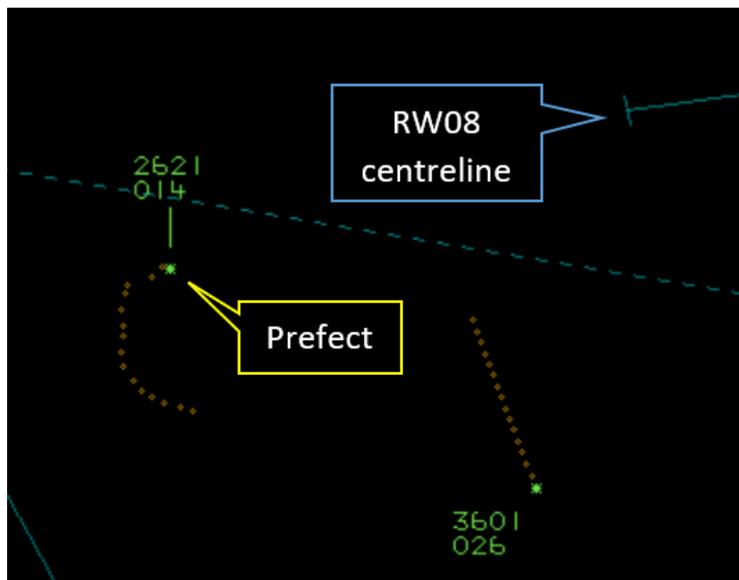
At 1237:53 the Prefect pilot was reported as notifying the Cranwell Air Traffic Control trainee of an Airprox, which appeared to coincide with a right turn on to a heading of 060° as directed by the Cranwell Director, after which, at 1238:00, the Prefect pilot had turned on to an intercept heading for the approach to RW08. It could be seen on radar that at some point during or after the right turn, that a slight left turn was also depicted on the radar returns (Figure 4).

Figure 4 (1238:00) The Prefect in right turn to 060° for the approach to RW08.

The left hand turn and slight climb was interpreted as the most likely point of the reported closest point of approach, but the separation distances were unknown.
