**AIRPROX REPORT No 2023111**

Date: 09 Jun 2023 Time: 1243Z Position: 5130N 00051W Location: 3NM NW of White Waltham

**PART A: SUMMARY OF INFORMATION REPORTED TO UKAB**

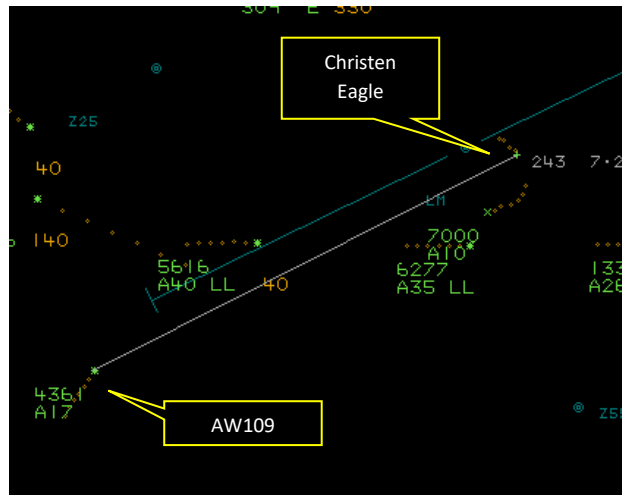
Figure 1 (1240:30): Traffic Service issued to the AW109 pilot by the Northolt Radar controller.  
(Separation: 7.2NM )

At 1240:30, the Northolt Radar controller identified the AW109 at an altitude of 1700ft and provided a Reduced Traffic Service due to operating below the Terrain Safe Level.

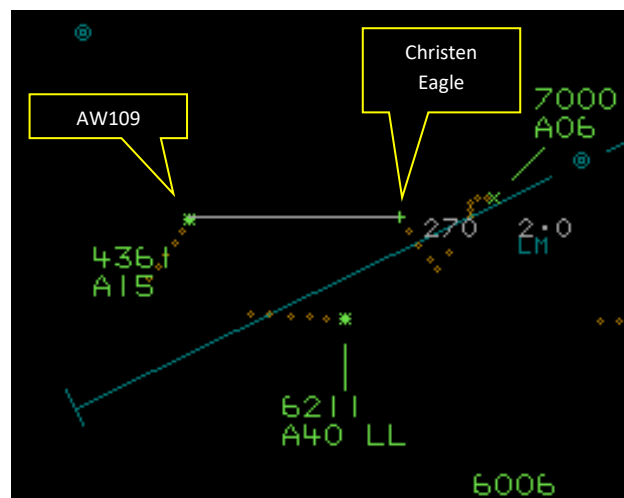
Figure 2 (1242:10): Northolt departure contacted the Northolt Radar controller.  
(Separation: 2.0NM)

At 1242:10, the Northolt departure contacted the Northolt Radar controller on climb-out, passing 3000ft and conducting the 6 Xray SID. The aircraft had been identified, cleared to proceed with the SID and issued Radar Control.

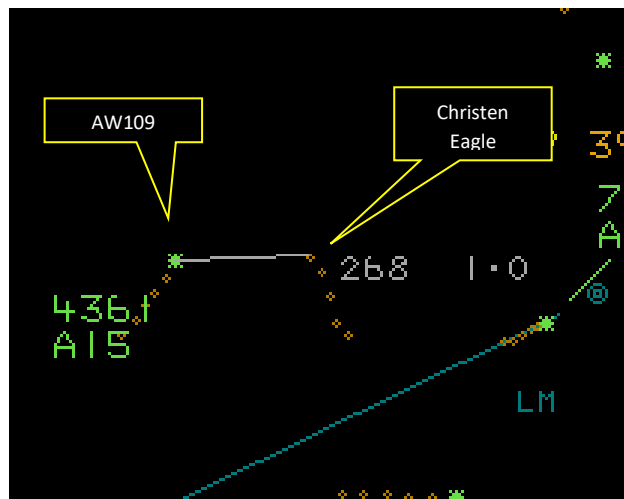
Figure 3 (1242:41): Radar contact lost on the Christen Eagle.  
(Separation: 1.0NM)

At 1242:41, the Christen Eagle no longer appeared on radar to the Northolt Radar controller.

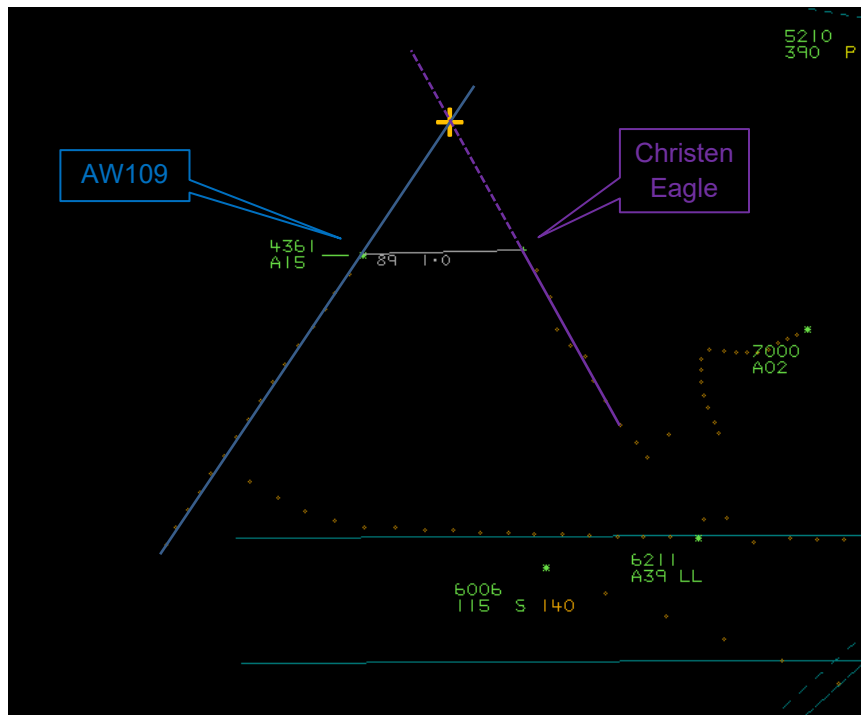
Figure 4: CPA marked with orange cross at 1243:01

Radar tracking had been examined for the period; the AW109 could be followed as a Mode S contact at 1500ft throughout on a constant north-easterly heading. A primary contact, presumed to be the Christen Eagle, appeared departing the White Waltham area at 1242:14 turning onto and maintaining a north-westerly heading. The primary contact disappeared at 1242:41 and reappeared at 1243:14. Using GPS data provided by the Christen Eagle pilot, it was possible to identify the CPA when overlaid to the primary contact trace. CPA occurred at 1243:01 and was measured as <0.1NM H and <50ft V as shown in Figure 4.
