**AIRPROX REPORT No 2023144**

Date: 29 Jun 2023 Time: 1428Z Position: 5250N 00239W Location: 3NM N Shawbury

**PART A: SUMMARY OF INFORMATION REPORTED TO UKAB**

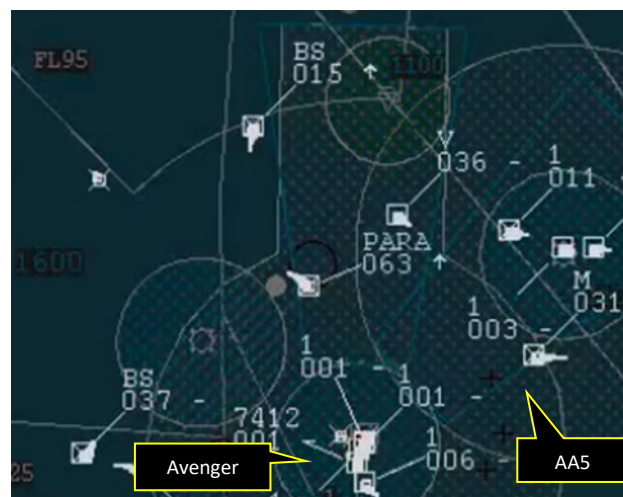
At 1425:40, the Shawbury Tower controller requested release for the departure of the Avenger, from the Shawbury Approach controller. All runway departures are subject to call for release at RAF Shawbury, iaw local orders and as such climb-out restrictions are not routinely passed to Shawbury Tower. The Shawbury Approach controller approved the release of the Avenger iaw the pre-briefed departure profile of runway track, climbing FL60 initially. The climb-out restriction was not passed to the Shawbury Tower controller by the Shawbury Approach controller.

Figure 1 - (1425:40): Avenger release approved by the Shawbury Approach controller.

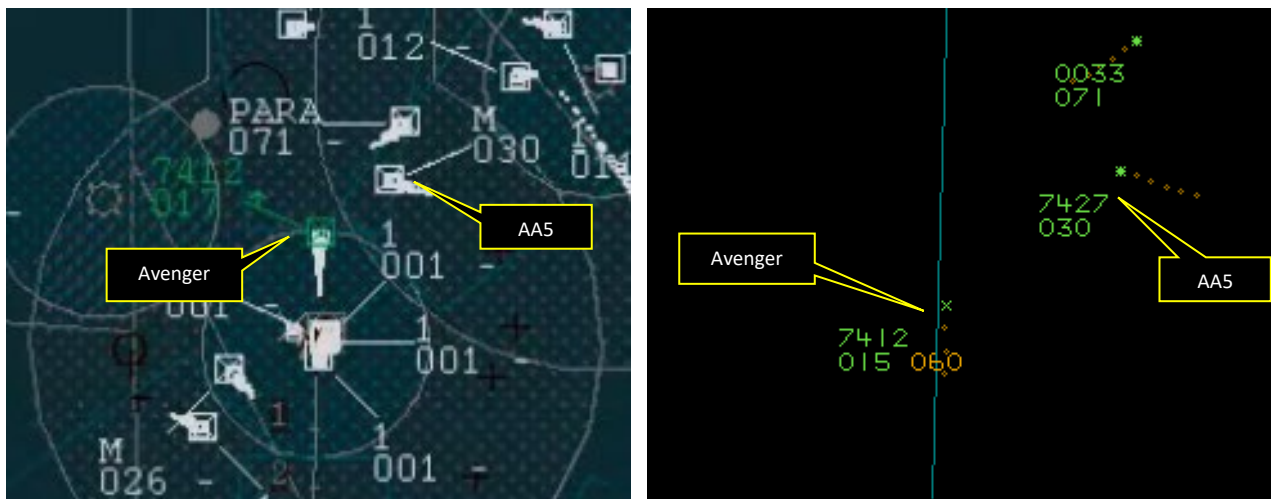
At 1427:24, the Shawbury Zone controller passed Traffic Information to the AA5 [pilot] on the Avenger. *“Traffic believed to be you has traffic left two o’clock, one and a half miles, crossing left right ahead, fast-moving Beech two hundred climbing out of Shawbury, indicating nine hundred feet below, climbing”*. The AA5 pilot reported visual with the traffic. At no point had the Shawbury Zone controller been informed that the Avenger had been cleared to climb through the climb-out restriction and the controller therefore assumed the Avenger would climb not above 1600ft QFE iaw the climb-out restriction.

Figure 2 - (1427:24): Traffic Information passed to the AA5 pilot on the Avenger.  
(Separation: 1.6NM)

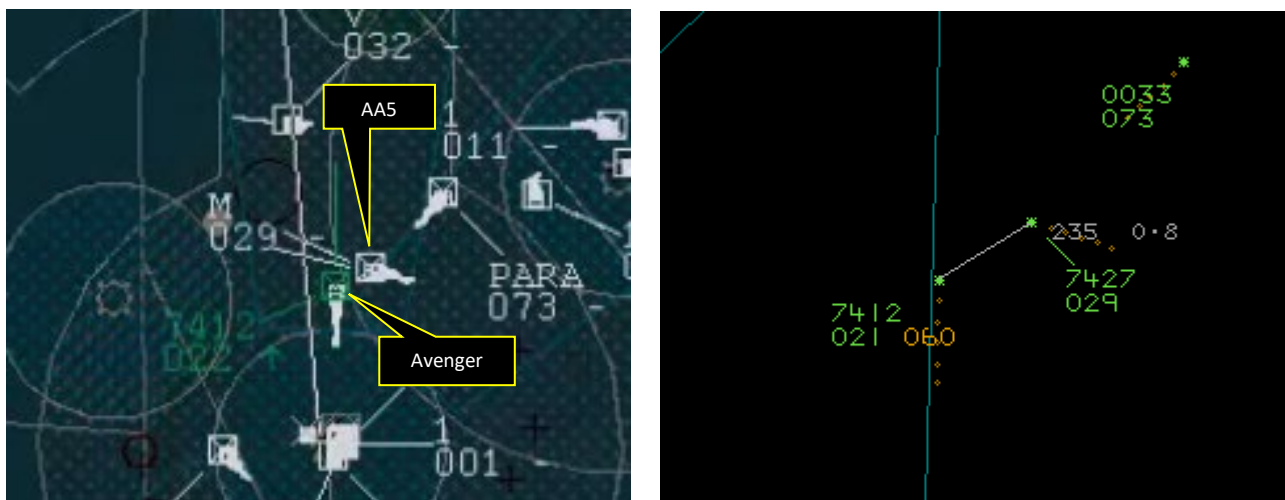
At 1427:44, the Shawbury Approach controller responded by providing a Traffic Service and issuing Traffic Information to the Avenger [pilot] on the AA5, “Traffic right, half a mile, crossing right to left, indicating five hundred feet above”. The Avenger pilot responded with “looking for the traffic”. At 1427:58, the Avenger pilot reported a TCAS RA.

Figure 3 - (1427:44): Traffic Information passed to the Avenger pilot on the AA5.  
(Separation: 0.8NM)

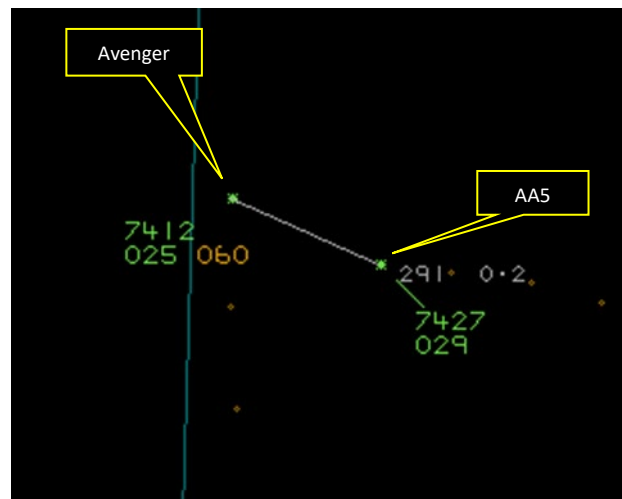
CPA was measured at 0.2NM and 400ft separation.

Figure 4 - (1427:58): CPA.
