AIRPROX REPORT No 2023125

Date: 11 Jun 2023 Time: 0929Z Position: 5318N 00247W Location: 2.5NM SE Liverpool Airport

PART A: SUMMARY OF INFORMATION REPORTED TO UKAB

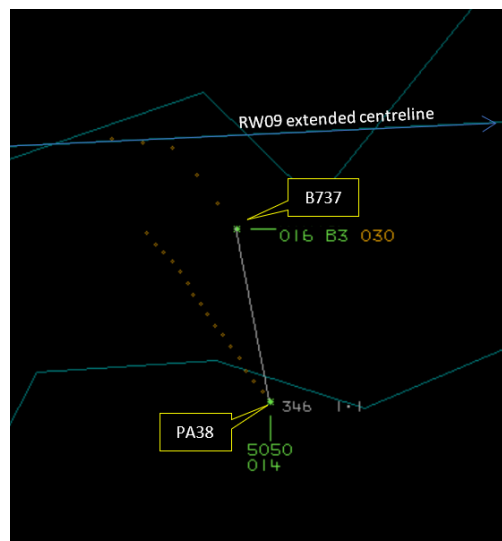
An analysis of the NATS radar replay was undertaken and both aircraft were positively identified from Mode S data as they departed from RW09 at Liverpool (Figure 1).

Figure 1 – Time 0929:02 separation 1.1NM and 200ft.

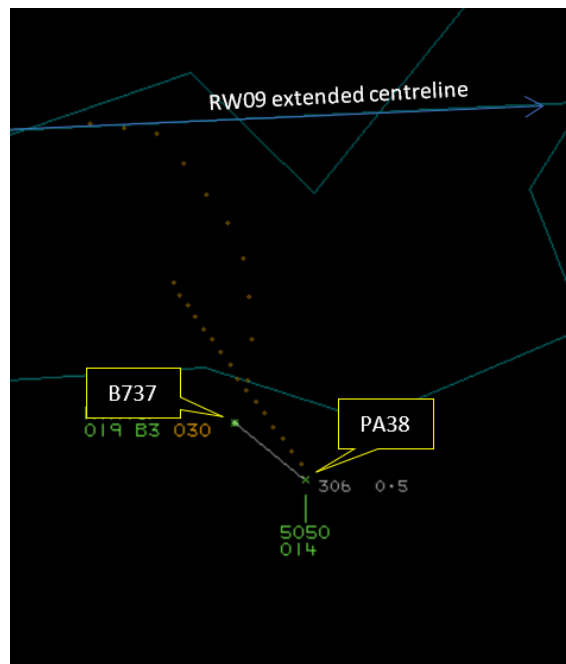
The closest point of approach was at 0929:24 as the B737 passed behind the PA38 during the turn onto 210° (Figure 2).

Figure 2 – Time 0929:24 CPA separation 0.5NM and 500ft.
