AIRPROX REPORT No 2023119

Date: 02 Jun 2023 Time: ~1223Z Position: 5044N 00155W Location: Alderney, Bournemouth

PART A: SUMMARY OF INFORMATION REPORTED TO UKAB

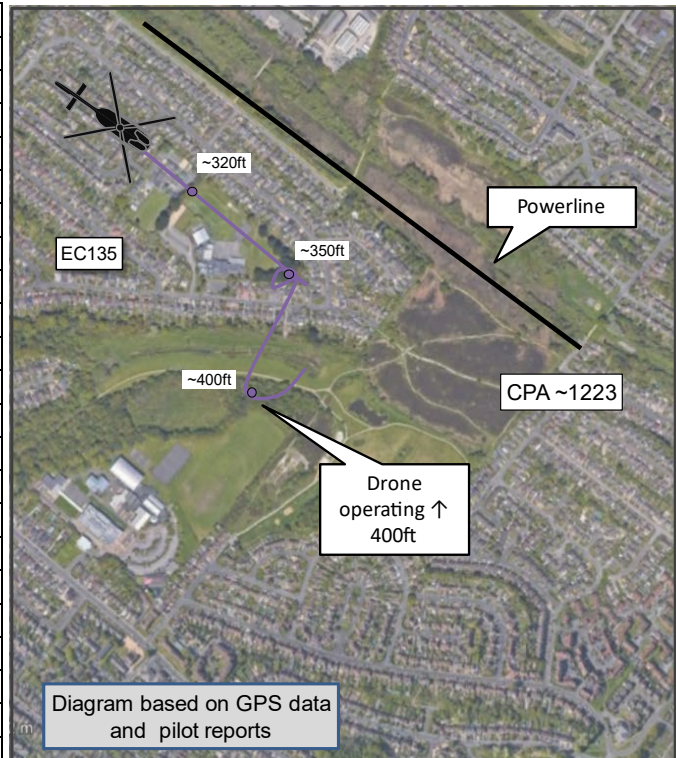
The EC135 pilot supplied a GPS data file, from which the diagram at the top of the report was compiled.

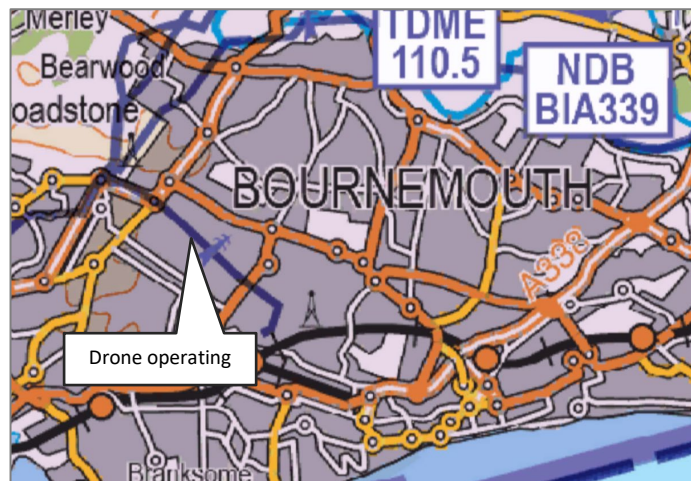
The NATS radar replay was analysed but, unfortunately, neither the EC135 nor the Matrice displayed on the radar. Figure 1 shows the CAA 1:250,000 VFR chart indicating the area where the drone had been operating and the proximity of the powerlines. The distance between the reported position of the drone and the powerlines was approximately 0.2NM. The position of the Matrice was outside the Bournemouth FRZ.
