**AIRPROX REPORT No 2023128**

Date: 21 Jun 2023 Time: 1045Z Position: 5212N 00010W Location: 2NM NW Gransden Lodge

**PART A: SUMMARY OF INFORMATION REPORTED TO UKAB**

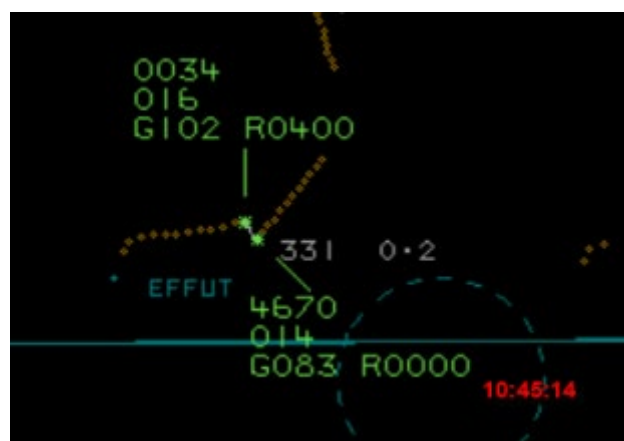
Figure 1

[The DR400 C/S] was then observed to turn west and then it turned towards the east, towards the path of [B206 C/S] and descending. Closest Point of Approach occurred at 1045:14 and was recorded on Multi-Track Radar as 0.2NM and 200ft. See Figure 1.

Closest Point of Approach occurred at 1045:14 and was recorded on Multi-Track Radar as 0.2NM and 200ft. The incident was resolved by the pilot of [the DR400] turning port side to move away from the helicopter.

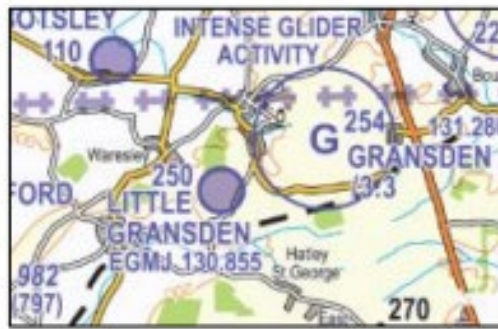
Figure 2

[The B206’s] position was 2.1NM, Radial 351° from Little Gransden and 1.1NM from the edge of the circle that denotes the Gransden Lodge gliding site. See Figure 2, image taken from VFR 1:250,000 South England Chart.
