**AIRPROX REPORT No 2023142**

Date: 24 Jun 2023 Time: 1101Z Position: 5238N 00512W Location: 17NM WSW Bardsey Island

**PART A: SUMMARY OF INFORMATION REPORTED TO UKAB**

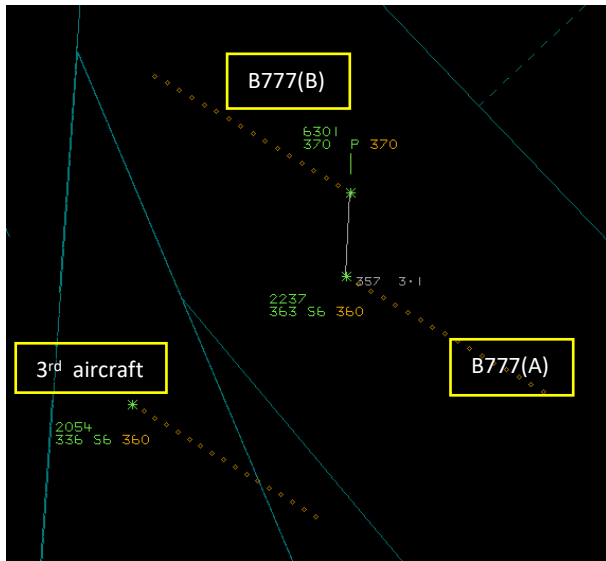
1100:50 Aircraft were at their closest point 2.8NM laterally and 800ft vertically. B777(A) label showed F362 descending.

Figure 1: 1100:47 showing the closest vertical separation as recorded on radar between B777(A) and (B).

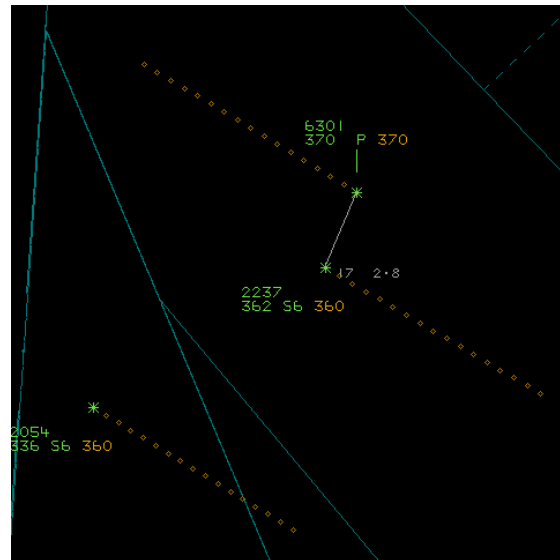
Figure 2: 1100:51 showing the closest horizontal separation as recorded on radar between B777(A) and (B).
