AIRPROX REPORT No 2023156

Date: 20 Jul 2023 Time: 1300Z Position: 5212N 00012E Location: Cambridge City Airport

PART A: SUMMARY OF INFORMATION REPORTED TO UKAB

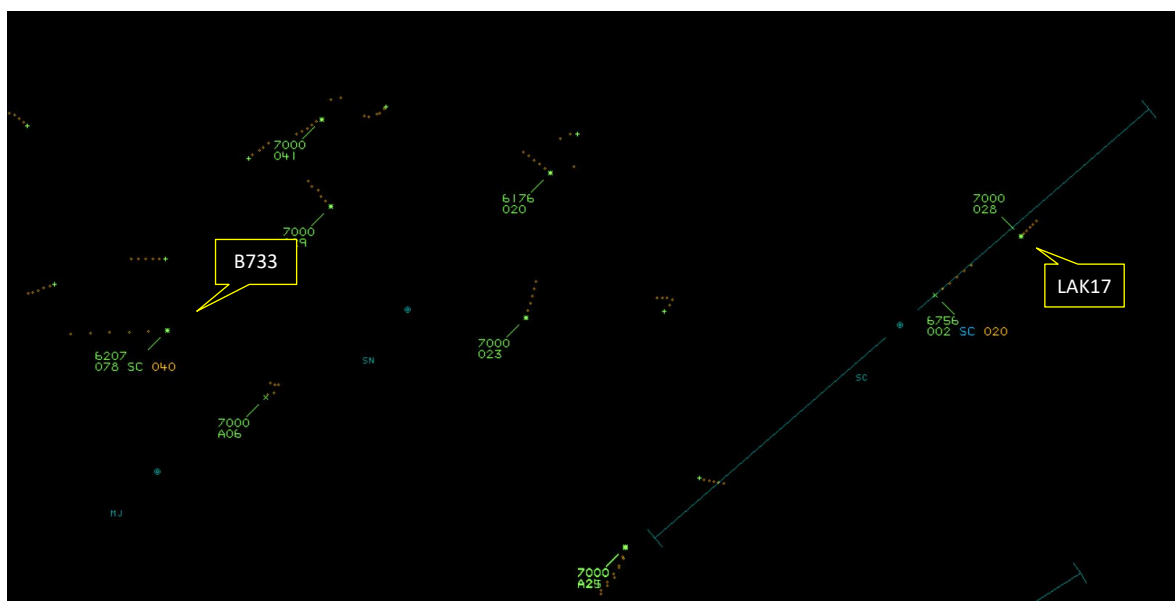
Figure 1 – 1257:00

At 1257:00 the pilot of the B737 had called, advising that they were “*passing 7700ft, descending 4000ft QNH 1015, direct CAM*” (Figure 1).

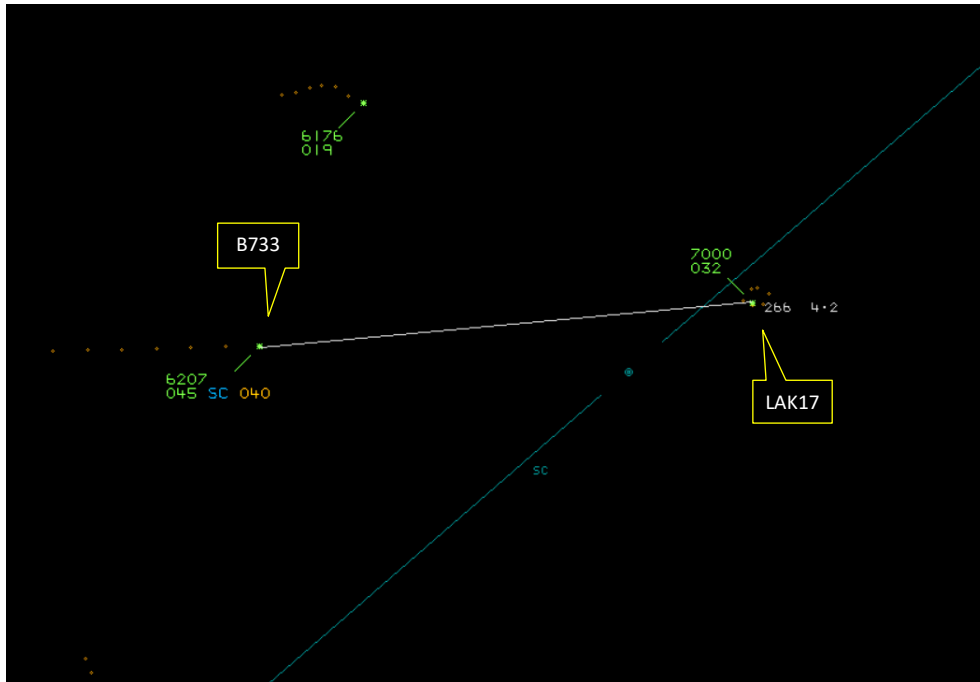
Figure 2 – 1258:58

At 1258:58 the controller had then requested a position and level report from the pilot of the LAK17 (Figure 2).

The pilot had reported “at flight level, er, 3200ft just over the east end of the airfield”, to which the controller replied “traffic, Boeing 737 4000ft routeing into the Cambridge overhead” which had been acknowledged by the LAK17 pilot “thank you”.

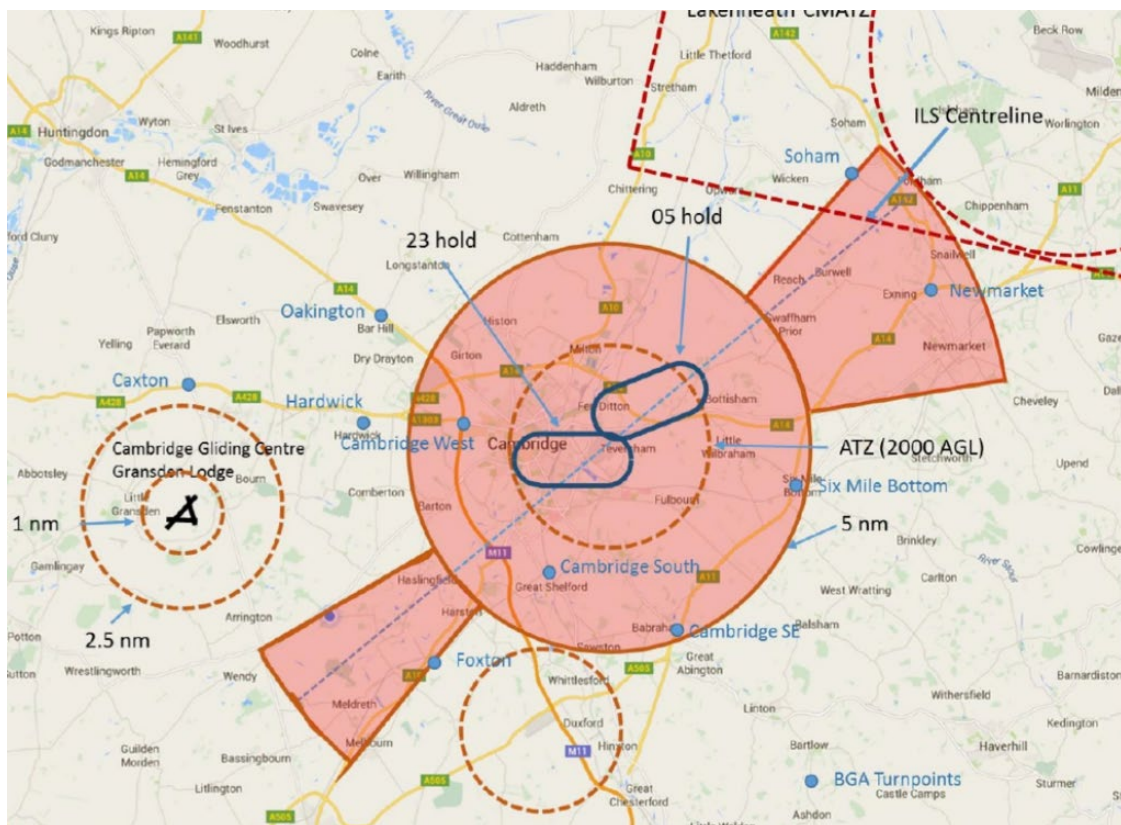
Those gliders operating out of Gransden Lodge to the west of Cambridge are encouraged to follow the Memorandum of Understanding (MoU) between Cambridge Gliding Club and Cambridge ATC. An extract of the MoU is below, and identifies an area (shaded in red) (in Figure 3) identified by coordinates but not referenced by name, (although one glider pilot had been heard to reference the "RMZ"), within which glider pilots are encouraged to speak to Cambridge ATC. For Cambridge ATC; *"When Cambridge Radar is not operating, aircraft inbound to Cambridge IFR from the West (QTE 250-275°) will not be descended below 4000ft AMSL until less than 10 DME from the CAM unless Essex Radar is able to confirm that the aircraft is laterally clear of the Gransden Lodge 1.0NM avoid. Aircraft wishing to make a straight-in Instrument Approach to RW05 (including visual approach) shall be advised to "avoid overflying Gransden Lodge Gliding site below 4000ft" unless it is clear that the aircraft has no possibility of getting within 1.0NM of Gransden Lodge."* This had been the clearance applied by the controller to the B737.

* To endeavour to contact Cambridge Approach on VHF channel 120.965 when operating within 5NM of Cambridge Airport and within the approach and climb out areas as illustrated [at Figure 3].

* To endeavour to avoid the instrument holding patterns outlined in blue shown in Figure 3 (above) and if unable to do so to inform Cambridge Approach on VHF channel 120.965.
