AIRPROX REPORT No 2023154

Date: 22 Jun 2023 Time: ~1007Z Position: 5021N 00442W Location: IVO St Austell

PART A: SUMMARY OF INFORMATION REPORTED TO UKAB

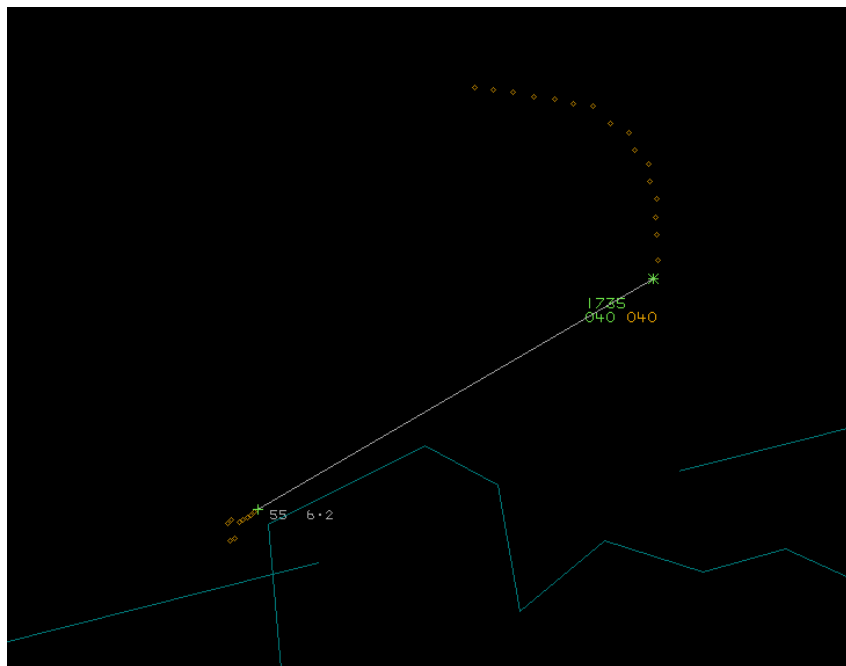
Figure 1 - 1005:42

An analysis of the NATS radar replay was undertaken. The A320 could be identified using Mode S data and could be seen positioning for an approach as described by the pilot. At 1005:10 the NATS radar displayed a primary-only contact 6NM from the A320. This contact remained on the radar for approximately 30sec (see Figure 1) and faded from radar at 1005:46. The primary contact could not be identified and it is not known whether this was the microlight seen by the A320 pilot or not. Note that Newquay ATC does not have access to the NATS radars and the Newquay investigation found that there had been no corresponding radar contact on the Newquay radar in the area.

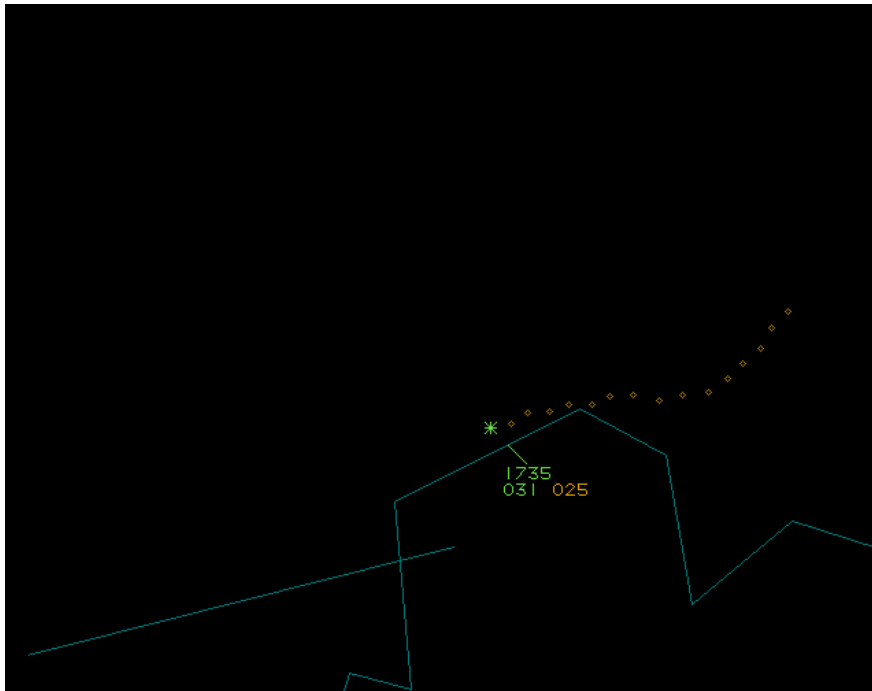
Figure 2 – 1007:04

The A320 continued with the approach, and the pilot described seeing the flex-wing microlight when intercepting the ILS altitude, at around 1007. At that time, the primary-only radar contact had faded and there were no other radar returns in the vicinity, see Figure 2. The flex-wing microlight pilot could not be traced.
