AIRPROX REPORT No 2023150

Date: 22 Jun 2023 Time: ~1015Z Position: 5056N 00201W Location: 6NM SE Compton Abbas

PART A: SUMMARY OF INFORMATION REPORTED TO UKAB

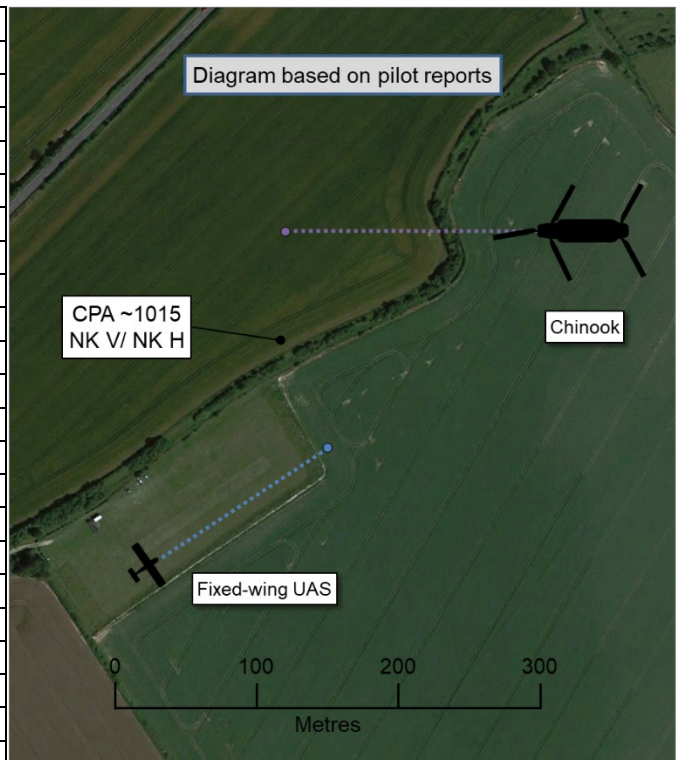
An analysis of the NATS radar replay was undertaken. Neither aircraft was observed on radar at the time of CPA. The diagram was constructed by an integration of the pilot's narrative reports. The separation at CPA could not be determined.
