**AIRPROX REPORT No 2023169**

Date: 03 Aug 2023 Time: ~1411Z Position: 5420N 00237W Location: 4NM E Kendal

**PART A: SUMMARY OF INFORMATION REPORTED TO UKAB**

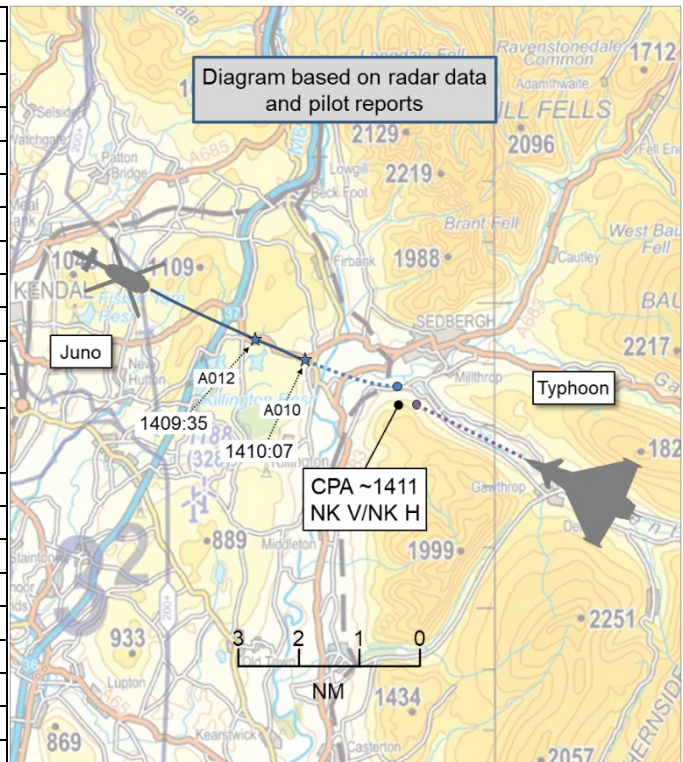
An analysis of the NATS radar replay was undertaken. The Juno was identified using Mode S data and was observed to have been east of Kendal when the radar returns faded. The Typhoon was not observed on radar, nor could it be observed during a review of MLAT and ADS-B data. The track of the Typhoon in the diagram above has been shown as an approximation of the actual track which could not be determined. The exact moment of CPA, and the separation of the aircraft at CPA, could not be determined.
