**AIRPROX REPORT No 2023178**

Date: 10 Aug 2023 Time: 1617Z Position: 5611N 00319W Location: 0.5NM E Portmoak

**PART A: SUMMARY OF INFORMATION REPORTED TO UKAB**

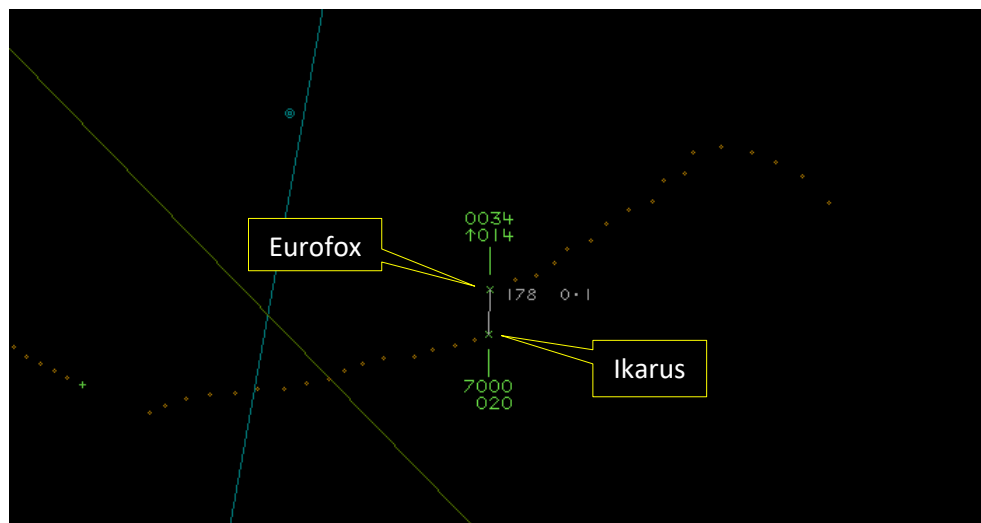
Figure 1 – CPA at 1616:43

An analysis of the NATS radar replay was undertaken and both aircraft could be positively identified from Mode S data.

The Eurofox and Ikarus pilots shared an equal responsibility for collision avoidance and not to operate in such proximity to other aircraft as to create a collision hazard.<sup>2</sup> If the incident geometry is considered as head-on or nearly so then both pilots were required to turn to the right.<sup>3</sup> An aircraft
