AIRPROX REPORT No 2023158

Date: 21 Jul 2023 Time: ~0846Z Position: 5113N00134W Location: IVO Thruxton Aerodrome

PART A: SUMMARY OF INFORMATION REPORTED TO UKAB

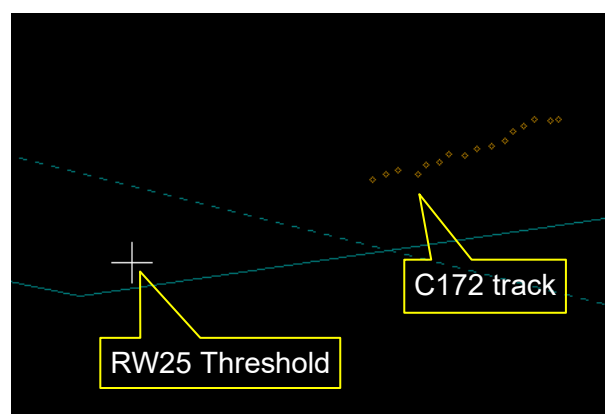
Figure 1: Snapshot at the point the C172 disappears from radar.
The PA28 was not seen on radar.
