AIRPROX REPORT No 2023159

Date: 21 Jul 2023 Time: ~1315Z Position: 5201N 00307W Location: 4NM ENE Talgarth

PART A: SUMMARY OF INFORMATION REPORTED TO UKAB

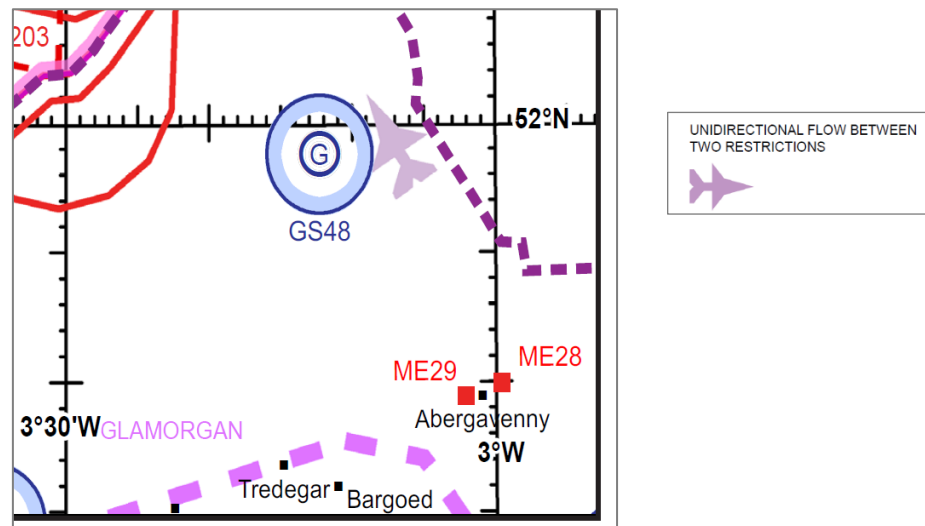
Figure 1 – UK Military Low Flying Area 7

The UK Military Low Flying Handbook provides the following extract of a diagram of Low Flying Area 7, with a 'Uni-directional flow between two restrictions' in the area of the Talgarth glider site (marked as GS48).

The Talgarth/Hay Bluff gap, as described in the UK Military Low Flying Handbook (UKMLFHB), should be flown in a north-westerly direction by military aircraft at low-level. This document also warns of ridge soaring activity when the wind is from the north-west. The reason for such directional flow systems is to reduce the MAC risk between military aircraft when flying down prominent valleys or between airspace restrictions. The Texan crew was compliant with this regulation, and expected gliding activity at the site, confirmed by their visual acquisition of gliders as they passed. Given the prevalence of Airprox reports here, measures have been taken to increase liaison between military aircrew and glider operators in the Black Mountains. Changing the Low-Level Common frequency to VHF has increased the potential for all airspace users to communicate on a radio, but it does not necessarily help at this location, as gliders are unlikely to be listening out on Low-Level Common. Further liaison is planned, including a visit to the Talgarth site by the RAF, and review of the procedures in the UKMLFHB to try and reduce the risk of MAC in the Black Mountains area. It should be recognised that all aircraft involved have differing needs when accessing this airspace and it's not simple to balance the risk of MAC through regulation. A mutually agreeable compromise should be reached to complete this in the safest possible way.

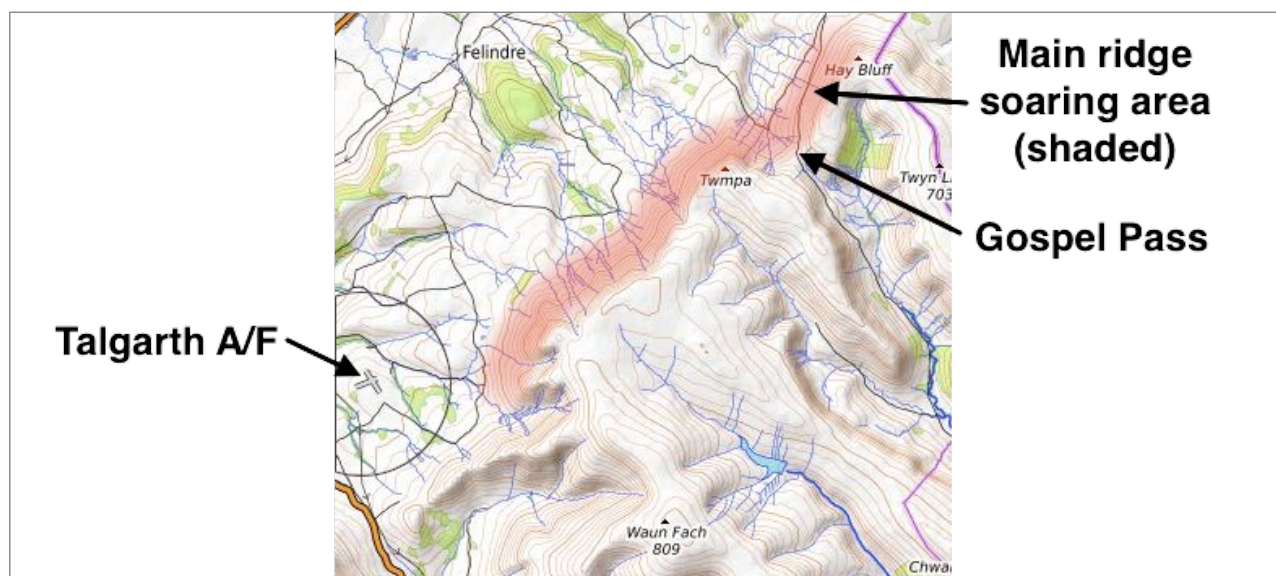
Figure 2 – Ridgeline between Talgarth and Hay Bluff

The ridge-line shown in Figure 2 between Talgarth gliding site (515848N 0031215W) and Hay Bluff (520122N 0030610W) is one of several in this area used by gliders and paragliders, either of which may be found soaring this ridge during daylight hours in even the lightest of winds between northerly and westerly. Gliders routinely fly close to these ridges and across the mouth of Gospel Pass at various altitudes. Low-flying military aircraft are frequently observed crossing Gospel Pass south-to-north, and there have been at least two previous Airprox here in similar circumstances (Airprox reports 2015123 and 2022239).
