AIRPROX REPORT No 2023167

Date: 04 Aug 2023 Time: 1222Z Position: 5129N 00114W Location: 1NM SSW CPT

PART A: SUMMARY OF INFORMATION REPORTED TO UKAB

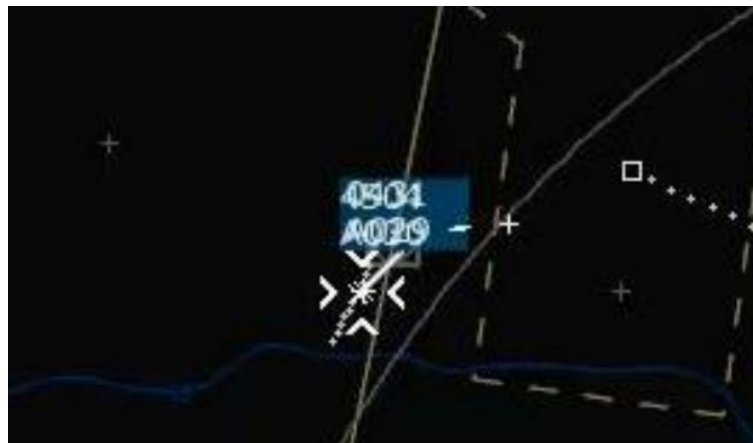
Figure 2 - 1222:28. AW109 and DA40 at the closest point.

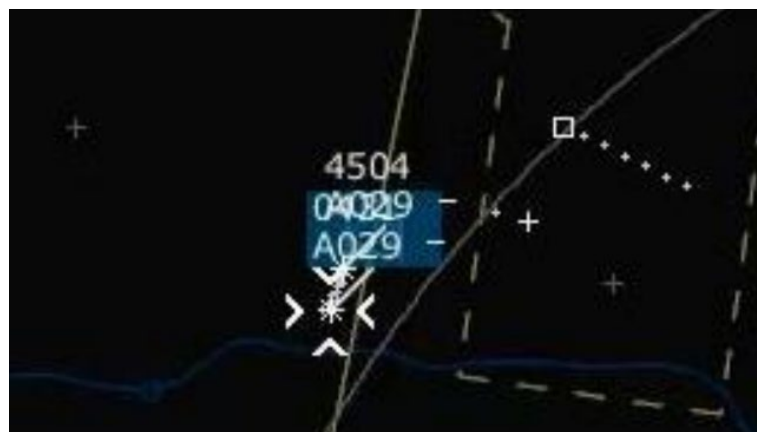
Figure 3 - 1222:44. The pilot of the AW109 reported an Airprox.

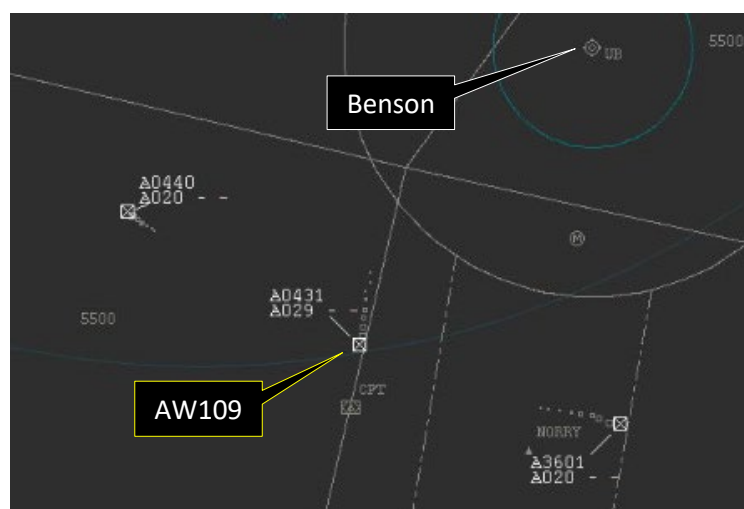
Figure 4 - 1221:28. Radar display as seen by the Oxford controller.

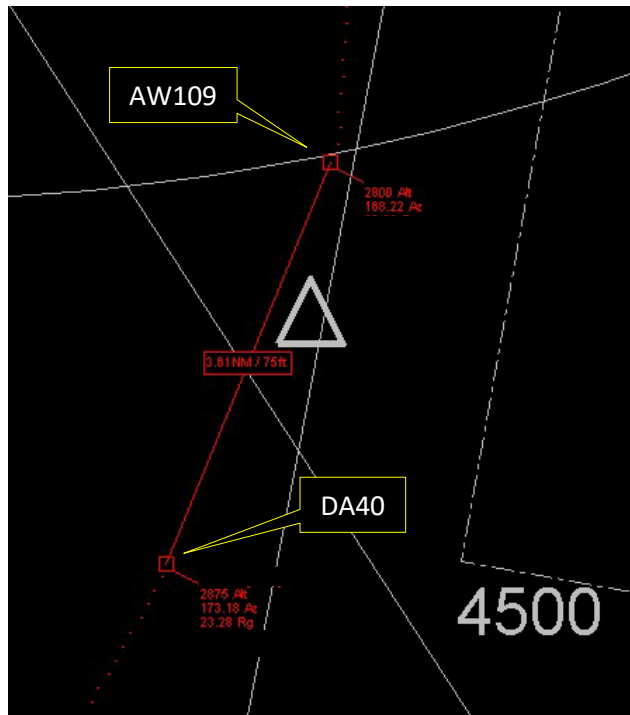
Figure 5 - 1221:37. Raw data not available to the controller. Separation displayed as 75ft V/ 3.6NM H.

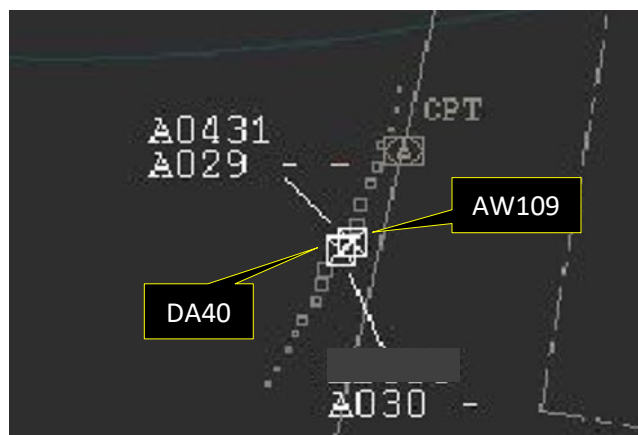
Figure 6 - 1222:26. Radar display as seen by the Oxford controller.

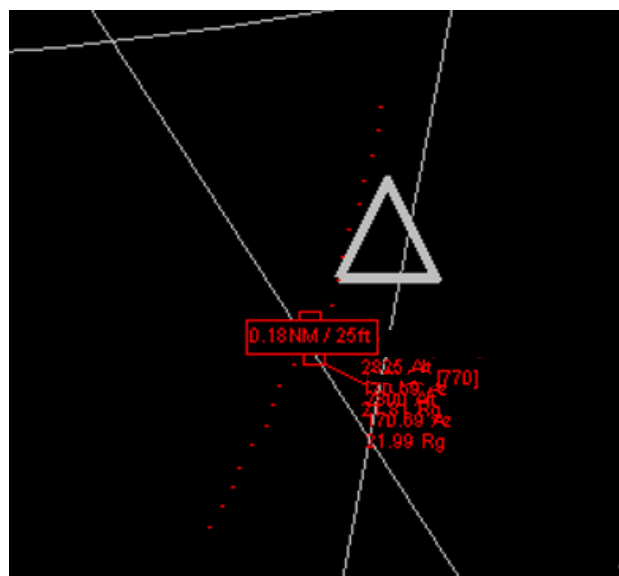
Figure 7 - 1222:31 (after CPA).
Raw data not available to the controller. Separation displayed as 25ft V/0.18NM H.

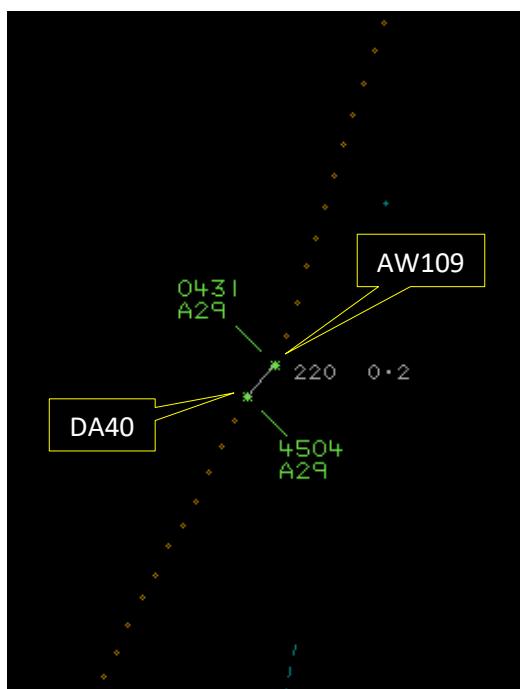
Figure 8 - 1222:26

An analysis of the NATS radar replay was undertaken and both aircraft could be positively identified from Mode S data. It was determined that CPA occurred between the radar sweeps of 1222:26 (Figure 8) and 1222:30 (Figure 9). The diagram was constructed and the separation at CPA determined from the radar data.
