**AIRPROX REPORT No 2023176**

Date: 06 Aug 2023 Time: 0925Z Position: 5251N 00102W Location: Nottingham Heliport

**PART A: SUMMARY OF INFORMATION REPORTED TO UKAB**

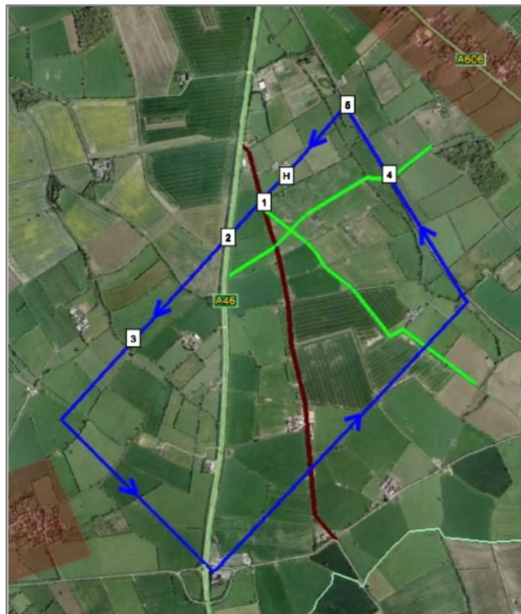
Figure 1 – extract from Nottingham Heliport website Pilot Information

The following diagrams show routes and training circuit area for flights to and from Nottingham Heliport. Circuits are to be flown at 1000ft on East Midlands airport QNH and pilots are encouraged to ascend and descend from this height as quickly as is safely possible when departing and approaching the site paying particular attention to the location of public rights of way that surround the heliport.

Pilots should also be aware that the CTA for East Midlands Airport starts 1500ft above the heliport site and radio protocol is to be in accordance with the procedures outlined below – See 'Radio Contact'

All pilots should exercise good airmanship to not unnecessarily overfly inhabited areas and any aircraft leaving and joining the circuit area will be instructed to do so avoiding any of the local villages (shaded in red)

Finally, the Board noted that the Nottingham Heliport Arrival and Departure Procedures stated that 'Pilots should also be aware that the CTA for East Midlands Airport starts 1500ft above the heliport site ...'. Members agreed that this could be misinterpreted, in that the base of the East Midlands Airport CTA at that location was 1500ft AMSL, some 1197ft above the heliport site's published elevation of 303ft.
