AIRPROX REPORT No 2023172

Date: 07 Aug 2023 Time: 1404Z Position: 5211N 00103W Location: 5NM WSW Northampton

PART A: SUMMARY OF INFORMATION REPORTED TO UKAB

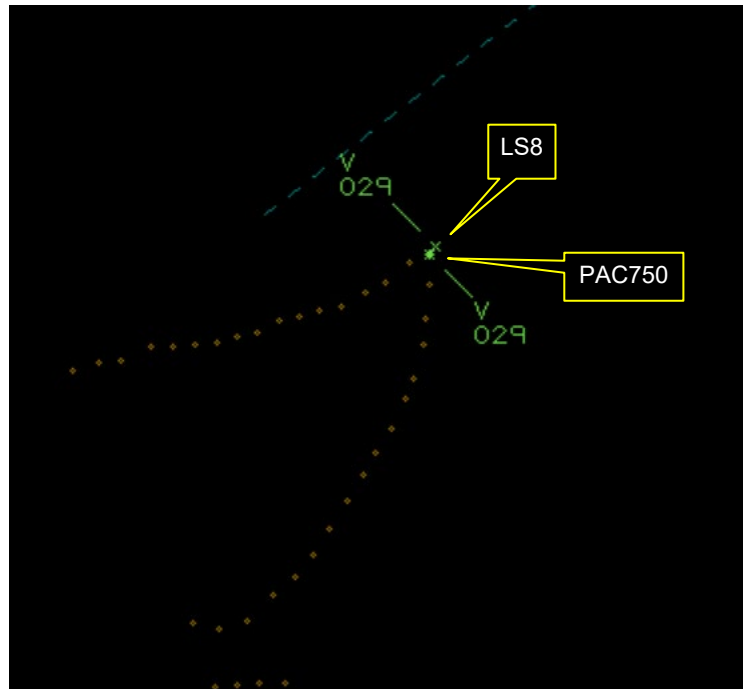
CPA 1404:26 ~20ft V/<0.1NM H
