AIRPROX REPORT No 2023186

Date: 19 Aug 2023 Time: 1053Z Position: 5211N 00005E Location: 3.5NM SSW Cambridge

PART A: SUMMARY OF INFORMATION REPORTED TO UKAB

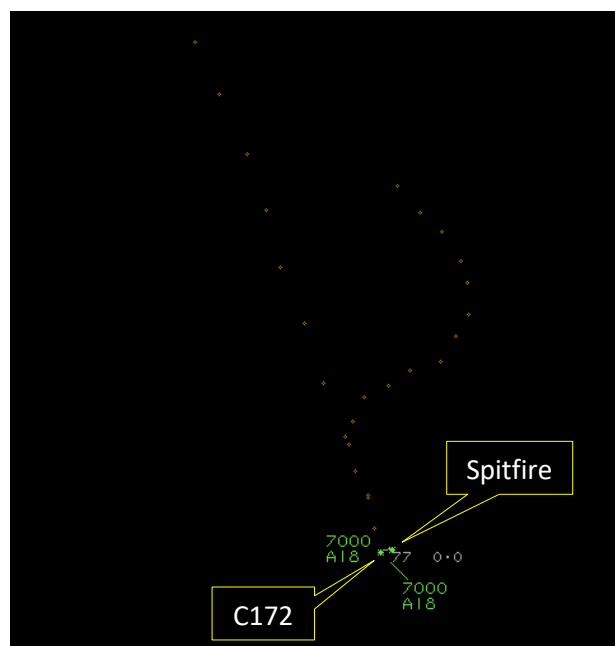
Figure 1 – CPA at 1053:10

An analysis of the NATS radar replay was undertaken and both aircraft could be positively identified from Mode S data. The diagram was constructed and the separation at CPA determined from the radar data.

The Spitfire and C172 pilots shared an equal responsibility for collision avoidance and not to operate in such proximity to other aircraft as to create a collision hazard.¹ If the incident geometry is considered as converging then the C172 pilot was required to give way to the Spitfire.² If the incident geometry is considered as overtaking then the C172 pilot had right of way and the Spitfire pilot was required to keep out of the way of the other aircraft by altering course to the right.³
