AIRPROX REPORT No 2023188

Date: 20 Aug 2023 Time: 1507Z Position: 5149N 00044W Location: Halton ATZ

PART A: SUMMARY OF INFORMATION REPORTED TO UKAB

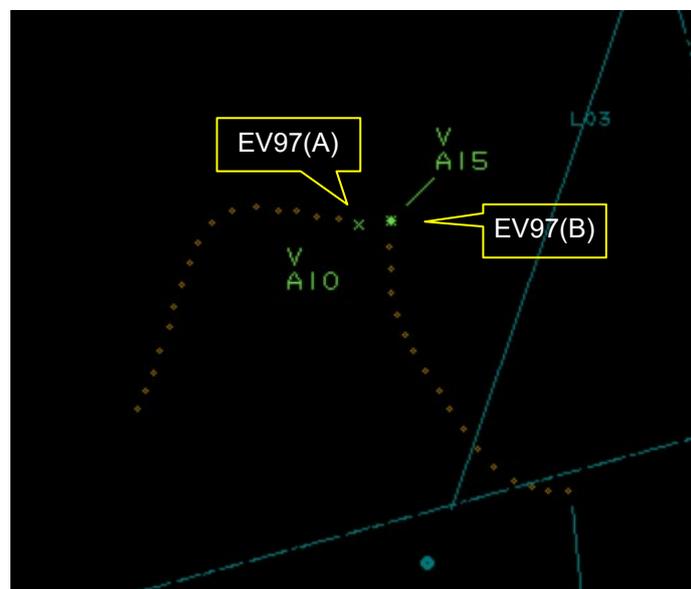
CPA 1507:22 500ft V/0.1NM H
