AIRPROX REPORT No 2023187

Date: 20 Aug 2023 Time: 1353Z Position: 5208N 00037W Location: 4NM N Cranfield

PART A: SUMMARY OF INFORMATION REPORTED TO UKAB

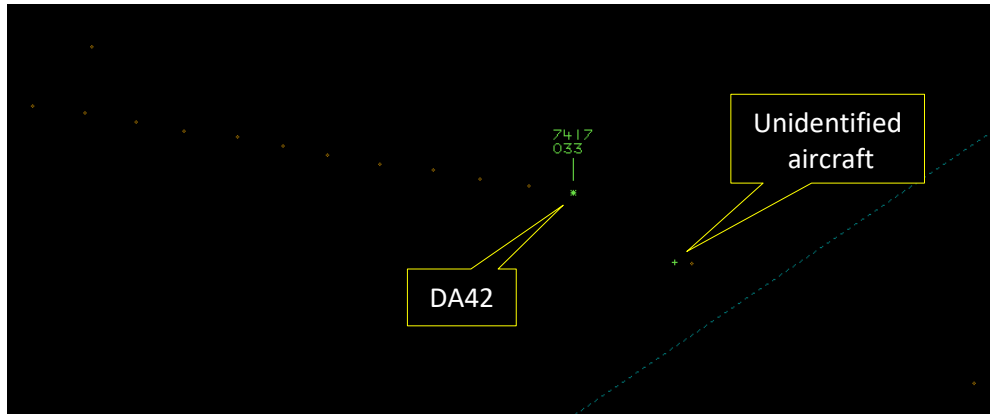
Figure 1 – CPA at 1352:37

An analysis of the NATS radar replay was undertaken and the DA42 could be positively identified from Mode S data. A primary-only return was observed on radar in the vicinity of the DA42 but the

aircraft could not be identified (Figure 1). The UKAB Secretariat obtained EC device data from which the track of the LS1 could be determined. It was by combining the various data sources that the diagram was constructed and the separation at CPA determined.
