# AIRPROX REPORT No 2023183

Date: 16 Aug 2023 Time: ~1356Z Position: 5224N 00214W Location: Kidderminster

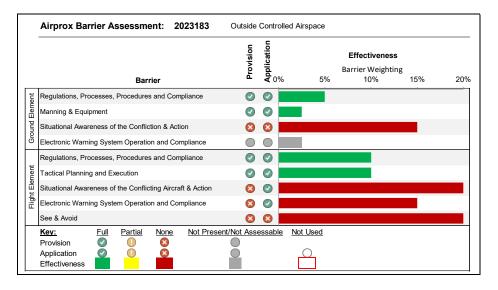
**Situational Awareness of the Confliction and Action** were assessed as **ineffective** because the paragliders had probably not been visible on the Birmingham controller's radar.

Situational Awareness of the Conflicting Aircraft and Action were assessed as ineffective because neither pilot had known that the other aircraft had been operating in the vicinity.

**Electronic Warning System Operation and Compliance** were assessed as **ineffective** because the CWS carried by the paraglider could not detect the transponder on the C208 and the TCAS I on the C208 could not detect the paragliders' CWS.

**See and Avoid** were assessed as **ineffective** because neither pilot had seen the other aircraft in time to take effective avoiding action.
