AIRPROX REPORT No 2023202

Date: 02 Sep 2023 Time: ~1338Z Position: 5205N 00019W Location: Old Warden

PART A: SUMMARY OF INFORMATION REPORTED TO UKAB

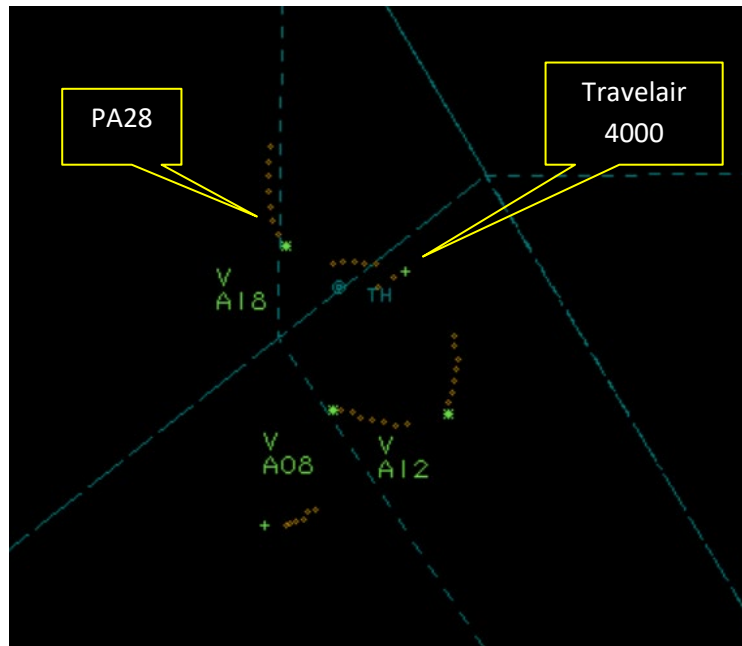
Figure 1 - 1335:04

An analysis of the NATS radar replay was undertaken. The PA28 could be identified on radar using Mode S data. The Travelair 4000 could not be positively identified, however, despite there being two primary-only contacts in the Old Warden area, as one aircraft clearly left the circuit to the west, it seemed likely that the Travelair 4000 was the aircraft positioned to the northeast of the airfield in Figure 1.

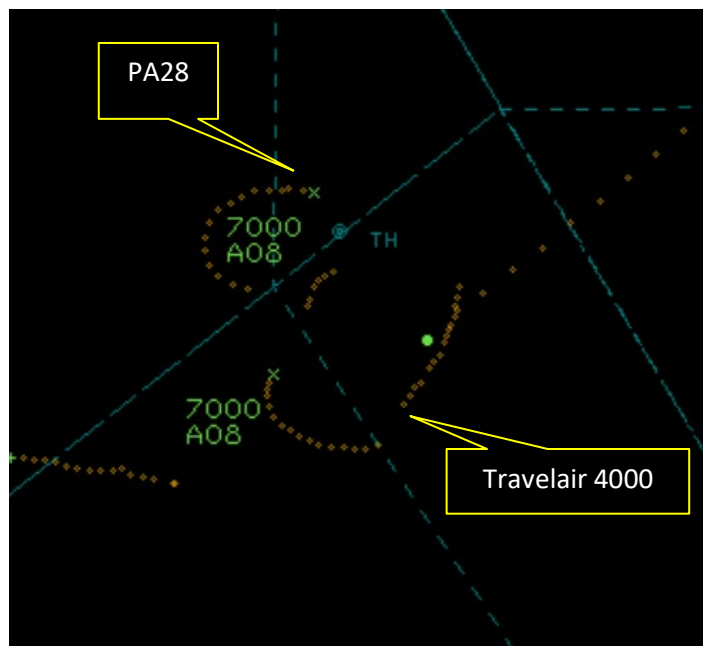
Figure 2 - 1336:39

This aircraft flew a downwind track, before disappearing from radar at 1336:36 (Figure 2). Meanwhile the PA28 could be seen positioning via an overhead join.

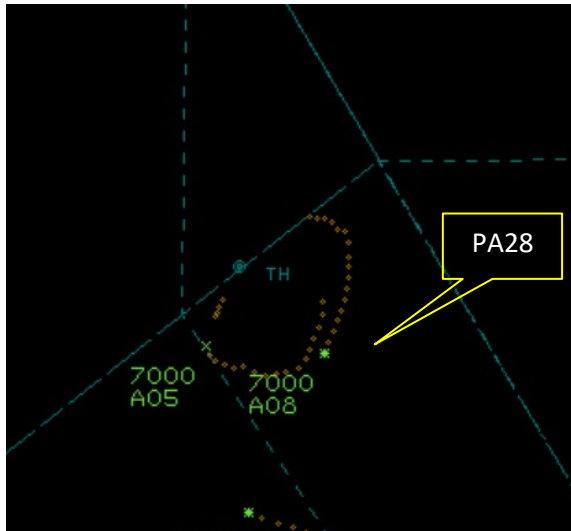
Figure 3 -1338:26

The PA28 could be seen flying a standard circuit, downwind and turning base until it too faded from radar at 1338:38. The Airprox was therefore not visible on the radar and the exact separation could not be ascertained.

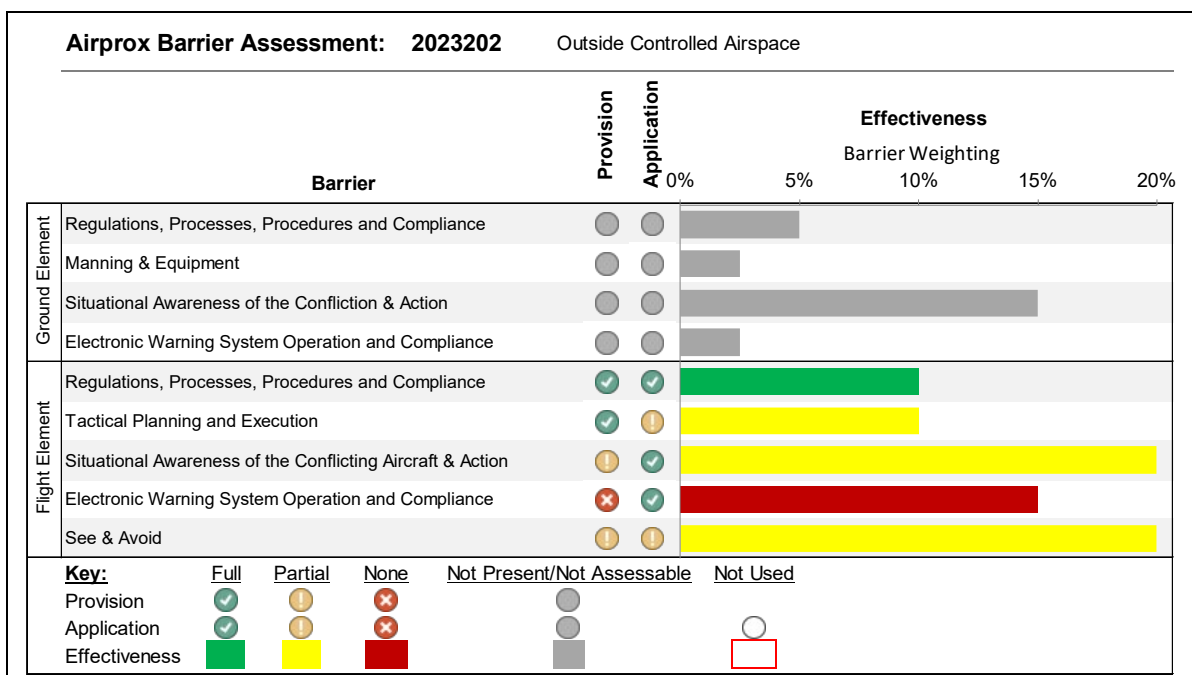
Tactical Planning and Execution was assessed as **partially effective** because the PA28 pilot had not identified all of the aircraft in the circuit on joining through the overhead and subsequently did not integrate with the Travelair 4000 in the circuit.

Situational Awareness of the Conflicting Aircraft and Action were assessed as **partially effective** because the PA28 pilot had only generic situational awareness that non-radio aircraft could be operating in the visual circuit, but not specific information on the Travelair 4000. The Travelair 4000 pilot had no situational awareness that the PA28 pilot would turn in front of them when on final.

Electronic Warning System Operation and Compliance were assessed as **ineffective** because the CWS on the PA28 could not detect the non-transponding Travelair 4000.

See and Avoid were assessed as **partially effective** because although it was a non-sighting by the PA28 pilot, the Travelair 4000 pilot saw the PA28 and took avoiding action, albeit late.
