## **AIRPROX REPORT No 2023200**

Date: 26 Aug 2023 Time: 1009Z Position: 5116N 00147W Location: 2NM NW Netheravon

# PART A: SUMMARY OF INFORMATION REPORTED TO UKAB

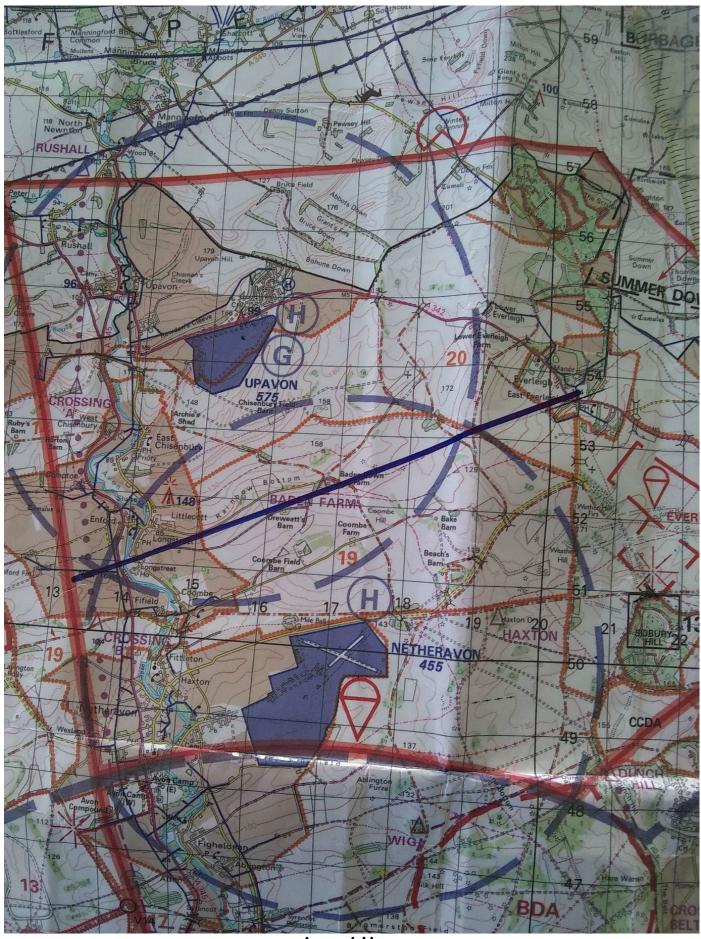
Annex A Map

- 4. Netheravon and Upavon airfields have their primary runways on approximate headings of northeast and south-west. The general layout of the overlap of the Netheravon ATZ and the Upavon gliding protection area is also north-east and south-west. It is therefore agreed that a notional line is drawn halfway between the airfields which will be used be used as a line of segregation. The line to the SW extends as far as the D125 boundary and to the NE to Everleigh village at Grid 205537; see map at Annex A. Aircraft from each respective airfield will not cross that line during normal circuit procedures when both airfields are active.
- 5. Authorising officers are to ensure that aircrew are familiar with the geographical features that identify this segregation line.

The Netheravon and Upavon Airfield Operator has notified the Board Secretariat that, in light of this Airprox incident, the LoA between Netheravon and Upavon has been reviewed, amended and reissued to all pertinent personnel.
