AIRPROX REPORT No 2023199

Date: 28 Aug 2023 Time: 1346Z Position: 5107N 00031E Location: 4NM WSW of Headcorn

PART A: SUMMARY OF INFORMATION REPORTED TO UKAB

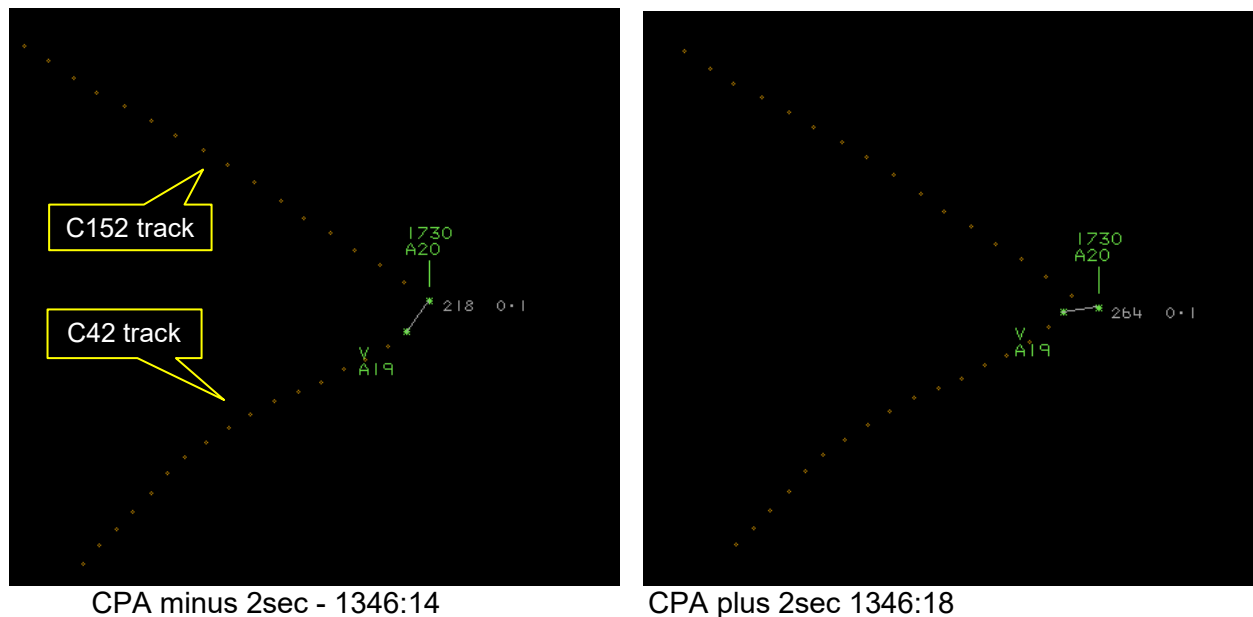
At 1345:24 the C152 had been approximately 2NM south of Old Hay tracking southeast at 2000ft. Another contact squawking 7000 had been tracking northeast converging with an indicated altitude of 2300ft. The distance between the two aircraft had been 1.49NM.

At 1346:06 the C152 pilot had requested a frequency change to Lydd Approach on 120.705MHz. The unknown aircraft had been continuing on a northeasterly track and the distance between the two aircraft had been 0.37NM and both aircraft indicating 2000ft.

At 1346:10 the minimum distance between the C152 and the unknown aircraft had been 0.12NM and both aircraft indicating 2000ft.
