**AIRPROX REPORT No 2023215**

Date: 06 Sep 2023 Time: 1401Z Position: 5052N 00314W Location: Dunkeswell

**PART A: SUMMARY OF INFORMATION REPORTED TO UKAB**

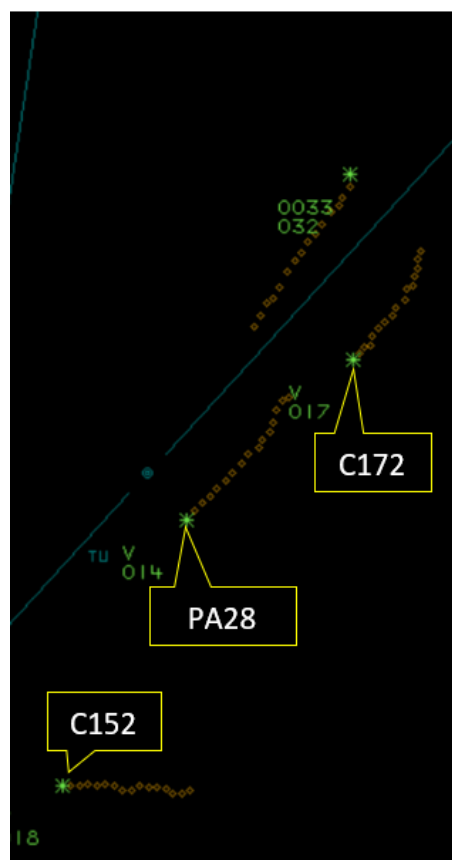
Figure 1: Time 1358:04

At 1358:04, the pilot of the C152 was joining the airfield circuit from the east on a wide right base on to a final approach for RW04. A PA28 was downwind and ahead of [the C172] joining the circuit from a long downwind position. The C152 pilot initiated a wide right base leg as described in their report (see Figure 1). The C152 pilot reported making a number of radio calls to confirm the airfield circuit and to clarify the position of the PA28 with the PA28 pilot. The C172 pilot reported having been aware of the radio calls of 2 other aircraft.

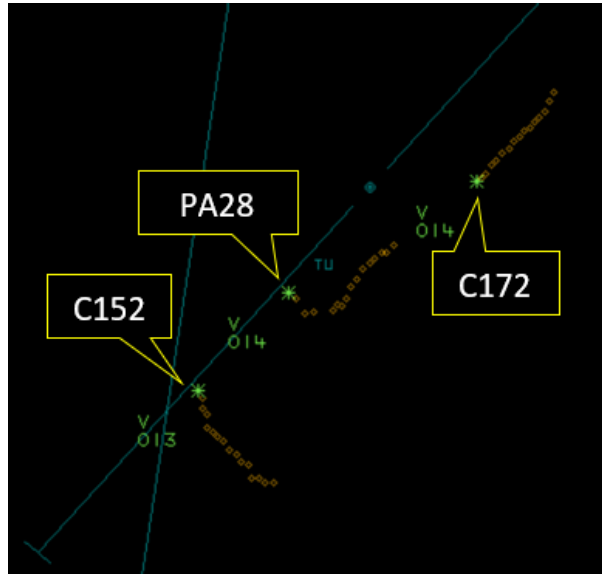
Figure 2: Time 1359:12

Both the C152 and PA28 turned on to the final approach at 1359:12, with the PA28 ahead of the C152 (Figure 2).

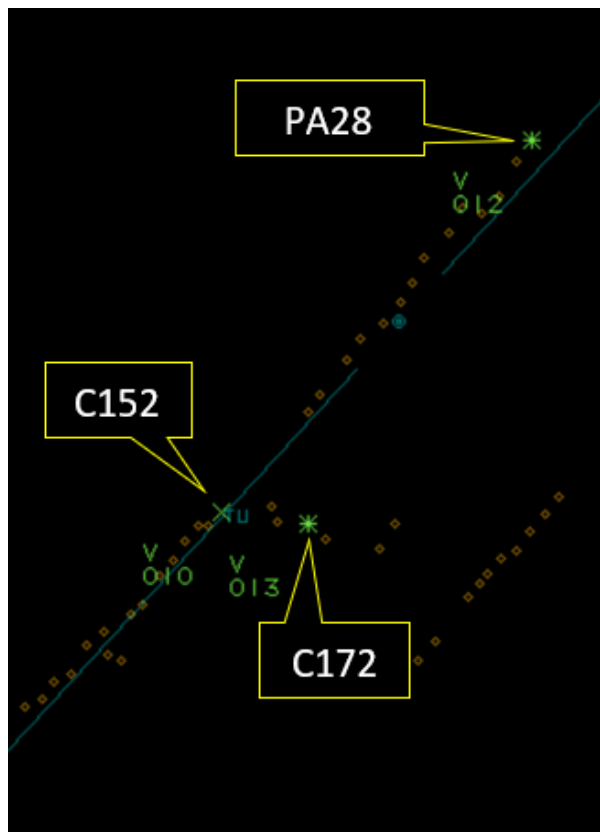
Figure 3: Time 1400:49 separation 0.4NM and 200ft.

At 1400:49 the PA28 was going around and the C172 closed on the C152 from a right-base position (Figure 3), and continued to do so during the final approach (Figure 4).

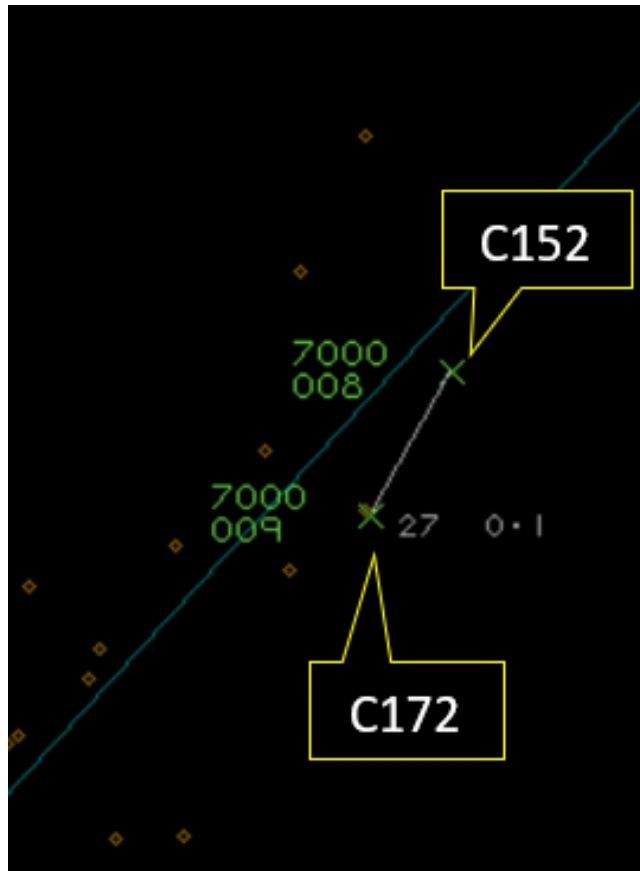
Figure 4: Time 1401:22, separation 0.1NM and 100ft.

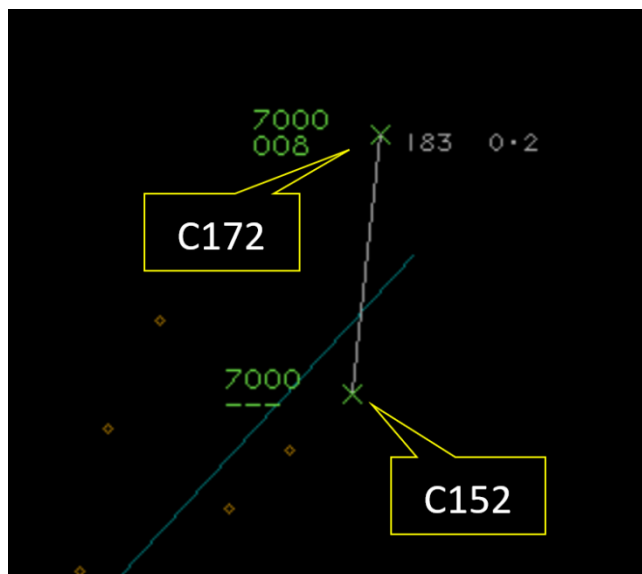
On the next radar sweep (Figure 5) the C172 was observed to have overtaken the C152; therefore CPA is assessed to have been <100ft and <0.1NM at time 1401:26.

Figure 5: Time 1401:30, C172 ahead of the C152 by 0.2NM.
