AIRPROX REPORT No 2023229

Date: 29 Sep 2023 Time: ~1342Z Position: 5116N 00124W Location: 12NM NE Andover

PART A: SUMMARY OF INFORMATION REPORTED TO UKAB

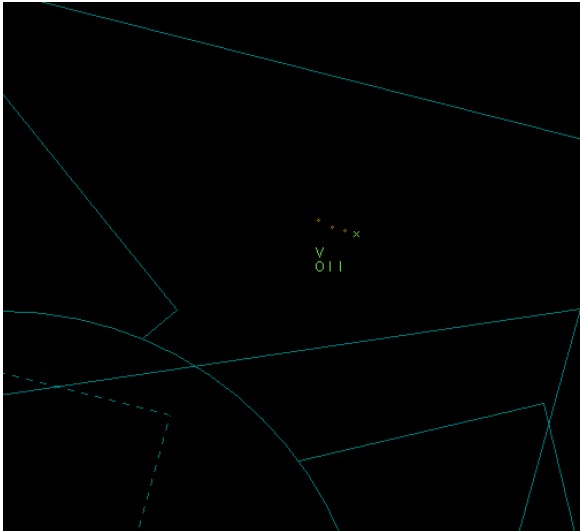
Figure 1 – 1343:39

An analysis of the NATS radar replay was undertaken. The Chinook could not be seen on radar until 1343:39, after the CPA reported to ATC by the Chinook pilot. At 1345:41, just before the Airprox was called on the Odiham frequency, the Chinook could be seen to make a slight left turn. No other traffic could be seen on the radar at any time.
