**AIRPROX REPORT No 2023217**

Date: 08 Sep 2023 Time: 1509Z Position: 5111N 00026E Location: 8NM WNW Headcorn

**PART A: SUMMARY OF INFORMATION REPORTED TO UKAB**

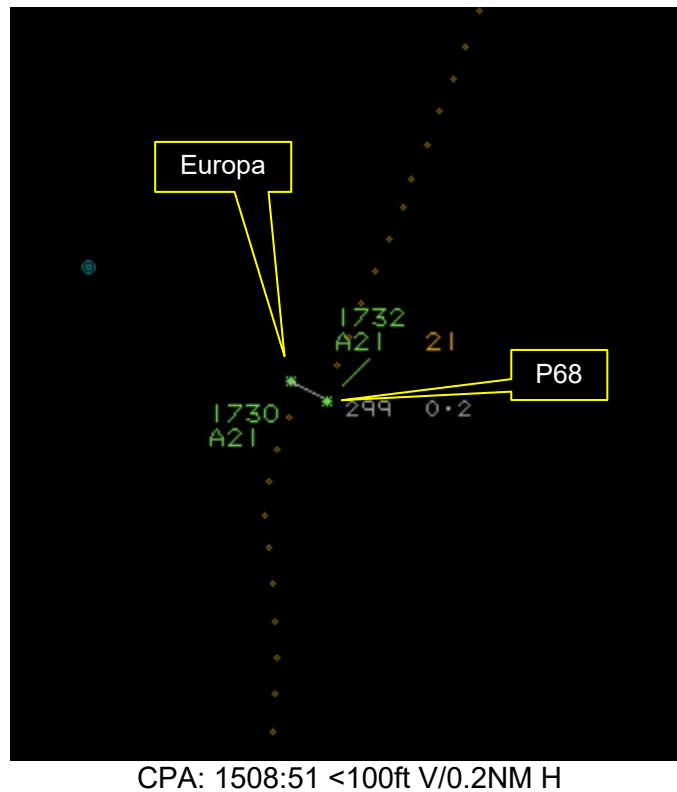
Both aircraft were tracked by radar and their respective flightpaths shown above. Although at the CPA both aircraft showed the same level (2100ft on SPS (1013hPa)) and the CPA is recorded as '0ft V', the Europa in its approach to that point and afterwards fluctuated from 2000ft to 2100ft and the vertical separation may well therefore have been best described as '<100ft'.

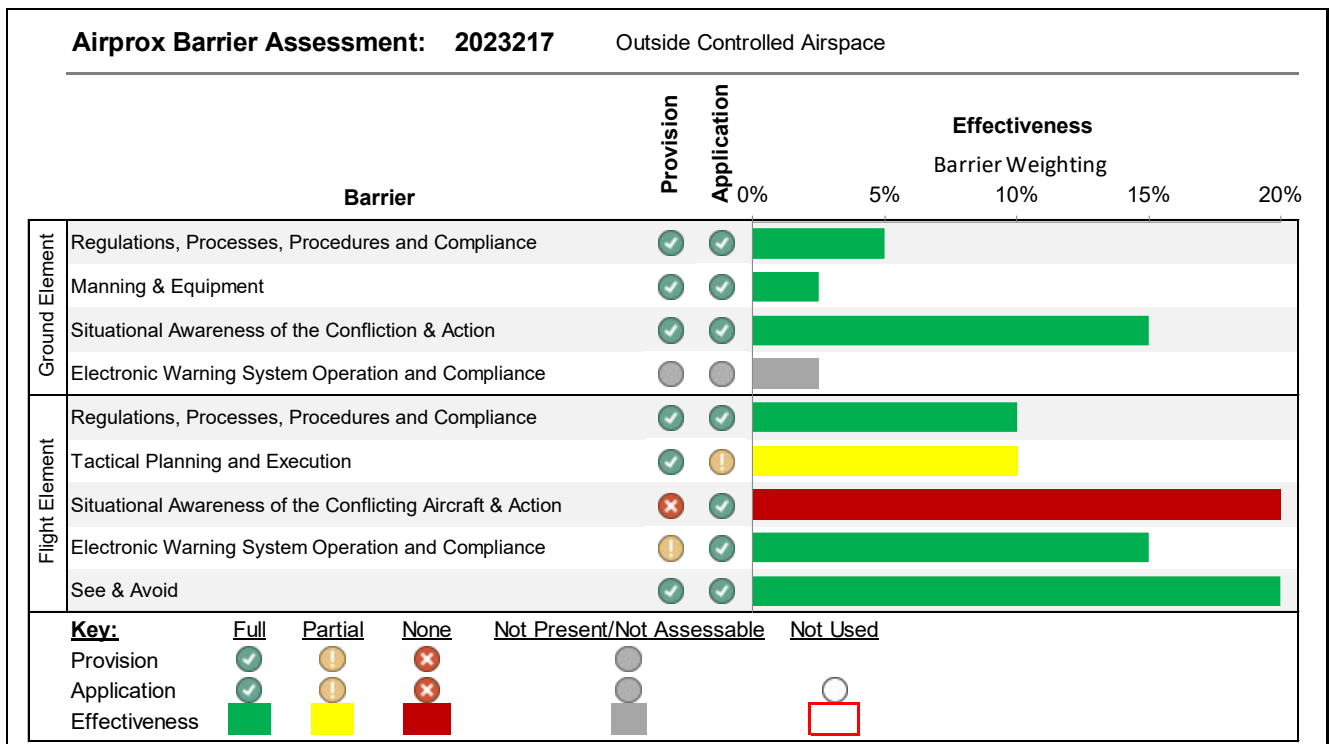
**Tactical Planning and Execution** was assessed as **partially effective** because, having gained visual with the Europa, the P68 pilot could have considered further increasing separation between the 2 aircraft and the Europa pilot could have considered taking a higher level of Air Traffic Service in that operating area.

**Situational Awareness of the Conflicting Aircraft and Action** were assessed as **ineffective** because the Europa pilot had no situational awareness of the presence of the P68.
