AIRPROX REPORT No 2023218

Date: 13 Sep 2023 Time: 1307Z Position: 5318N 00248W Location: 3NM SSE Liverpool

PART A: SUMMARY OF INFORMATION REPORTED TO UKAB

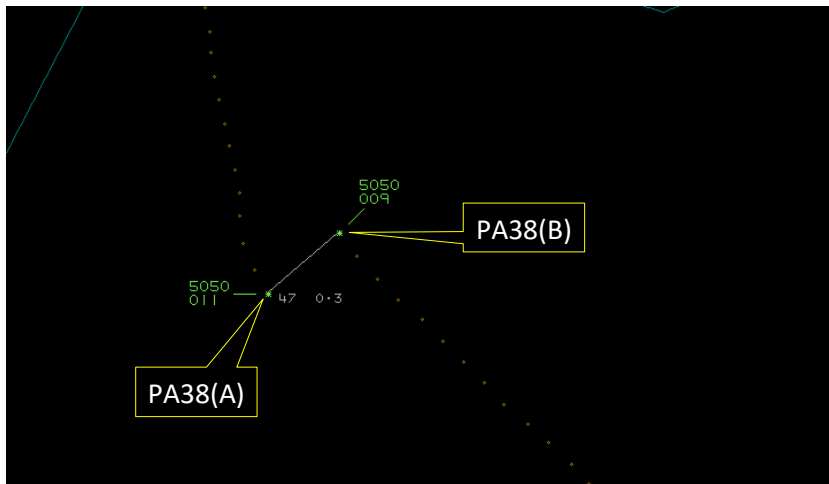
Figure 1 – CPA at 1306:47

An analysis of the NATS radar replay was undertaken and both aircraft could be positively identified from Mode S data. The aircraft were depicted on the radar replay as flying at Flight Levels. A suitable conversion factor was used to determine their altitudes. The diagram was constructed and the separation at CPA determined from the radar data.

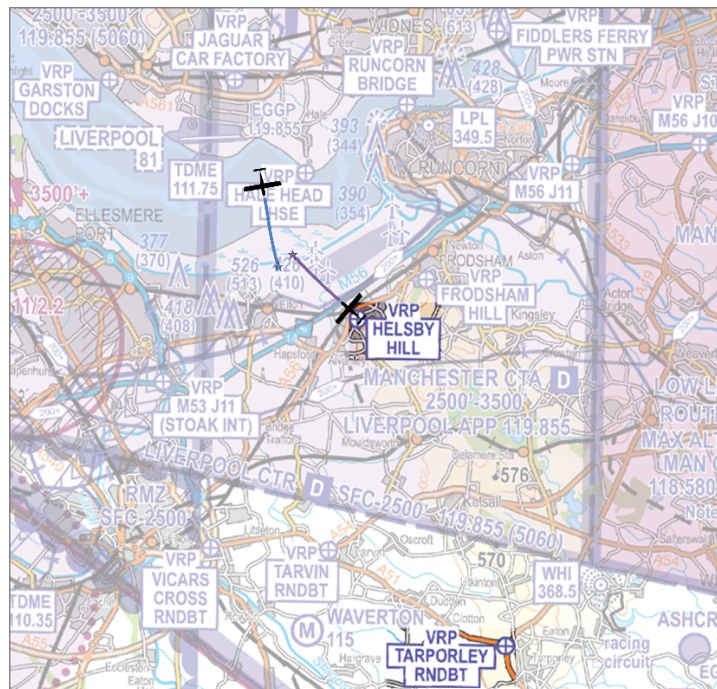
Figure 2 – Visual Reporting Points

Investigation Findings: Liverpool Airport was on RW09, Hawarden was on RW22. Hawarden had inbound traffic for RW22 squawking 0435 utilising the Radar Manoeuvring Area (RMA). Inbound VFR Liverpool traffic from the south was therefore routed inbound from Tarporley Roundabout towards Helsby Hill for RW09. This routing is in direct conflict with any departing VFR traffic routing southbound to leave via Tarporley, however it does keep the traffic away from the RMA and Hawarden traffic.
