AIRPROX REPORT No 2023219

Date: 13 Sep 2023 Time: 1449Z Position: 5155N 00212W Location: 1NM NW Gloucester Airport

PART A: SUMMARY OF INFORMATION REPORTED TO UKAB

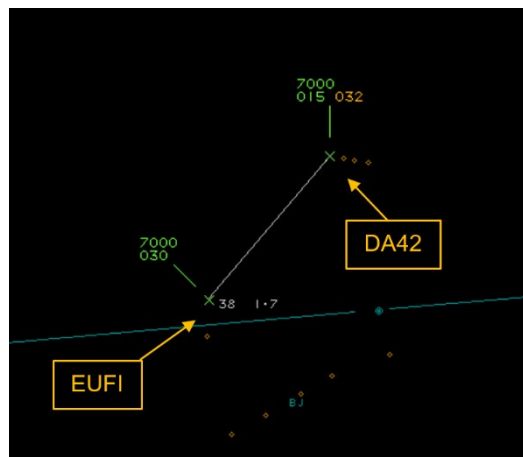
Figure 1 - 1449:04

The first part of the [Typhoon] pilot’s reply was unintelligible but they continued; “*and confirm you’re good with a 1200ft pattern, QFE?*” (Figure 1 at **1449:04**).

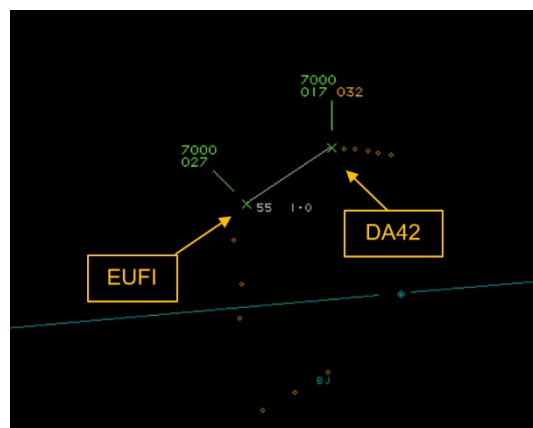
The controller replied “*QFE 1019*” to which the [Typhoon] pilot responded “*10... we’ve been handed 1018 for RW12 (sic)*”. The controller then confirmed the QFE for RW22 as 1018 (Figure 2 at **1449:13**).

Figure 2 – 1449:13 – [Typhoon] observed in the descent

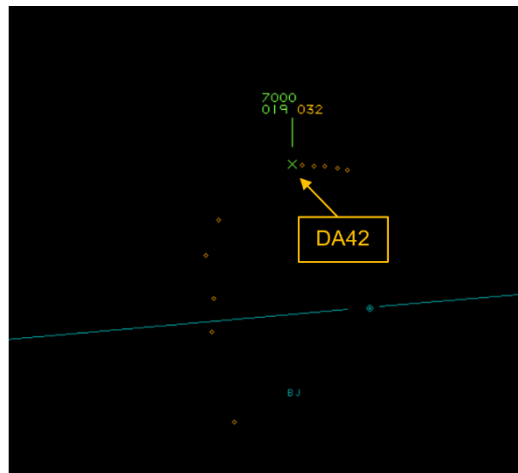
The [Typhoon]’s radar return disappeared from the radar replay at **1449:20** which was coincidental with the [Typhoon] pilot’s readback of the QFE and “(expletive) *my bad – apologies – someone just went over the top*” (Figure 3).

Figure 3 - 1449:20 – EUFI radar return disappeared.

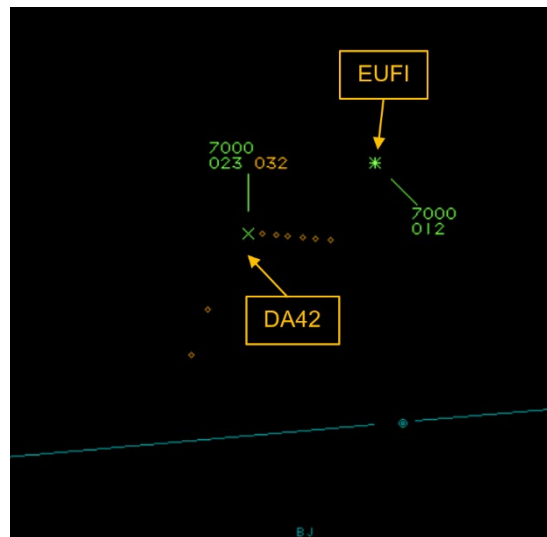
The [Typhoon] pilot then continued; “*Roger – twin engine just over the top – I was in the descent through 3000ft. I was probably about 2000ft. Confirm there is nothing else to affect if I turn in?*” (Figure 4 at **1449:33**).

Figure 4 – 1449:33 – [Typhoon] radar return reappeared.

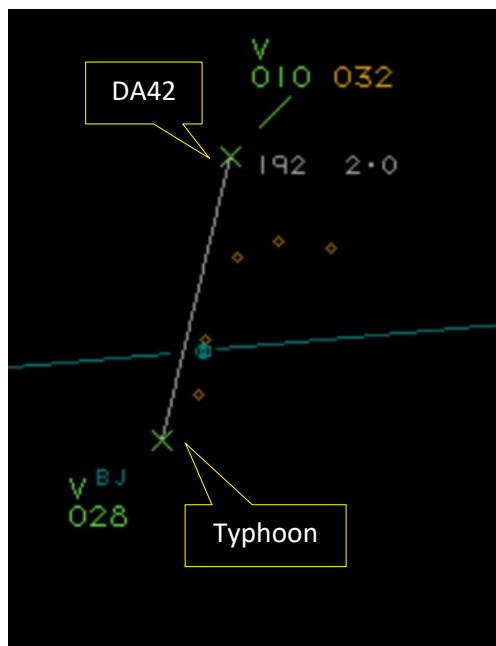
Figure 5 – DA42 appeared on radar at 1448:47

An analysis of the NATS radar replay was undertaken and both aircraft could be positively identified from Mode S data. The Typhoon was approaching from the east and manoeuvred into the overhead. At 1448:47, the Typhoon was southbound and the DA42 had just become visible on radar 2NM bearing 012° from the Typhoon (Figure 5).

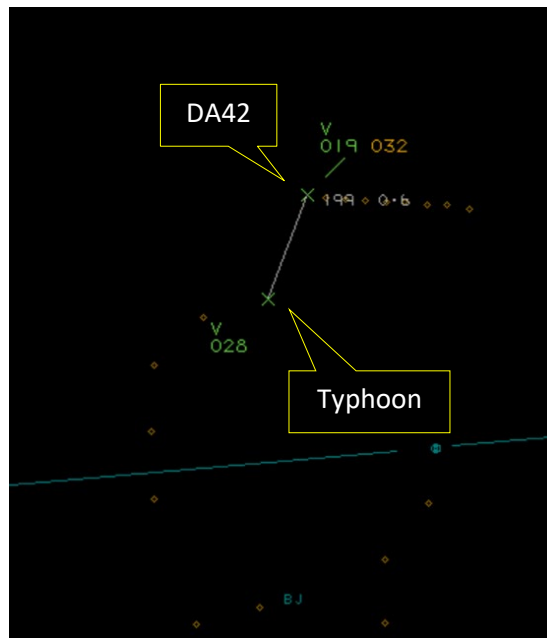
Figure 6 – Time 1449:20

The Typhoon made a right turn after appearing to cross the centreline of RW27/09 at FL028. At 1449:20, the Typhoon was descending and being repositioned for an approach to RW22 while the DA42 was climbing out to the west after departing from RW04. The Typhoon continued to display FL028 at this time, but had momentarily displayed FL030 beforehand (Figure 6).

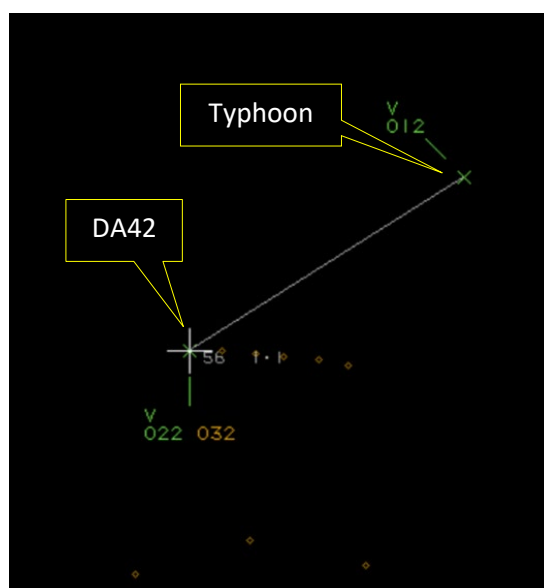
Although the Typhoon was displaying FL028 and the DA42 FL019, the Typhoon was descending and the DA42 was climbing. The Typhoon pilot had reported an aircraft passing above them, and the Typhoon disappeared from radar immediately after the 1449:20 radar sweep and reappeared to the northeast of the DA42's track at 1449:35 displaying FL012 (Figure 7).

Figure 7 – The Typhoon reappeared on radar at 1449:35

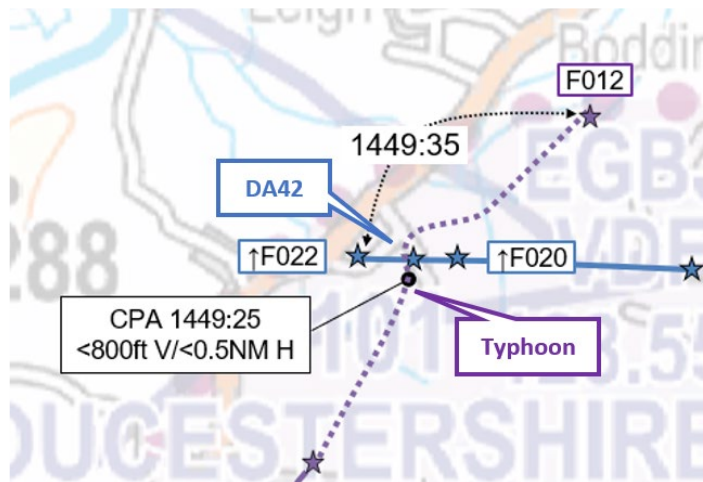
The CPA was calculated at 1449:25 based on the estimated position of the Typhoon relative to the DA42 (Figure 8).

Figure 8 – CPA at 1449:25
